Humber Refinery.

- ? On April 16th 2001 at approx 14.20hrs a pipe failed leaking, Liquid LPG out of a 6inch pipe line.
- ? An Explosion occurred when the LPG got into a heater, some 45mtrs away.
- ? The following shows the extent of the damaged caused.
- ? Fire was declared out at 17.10hrs.

April 16th 2001 Gas Plant Blast

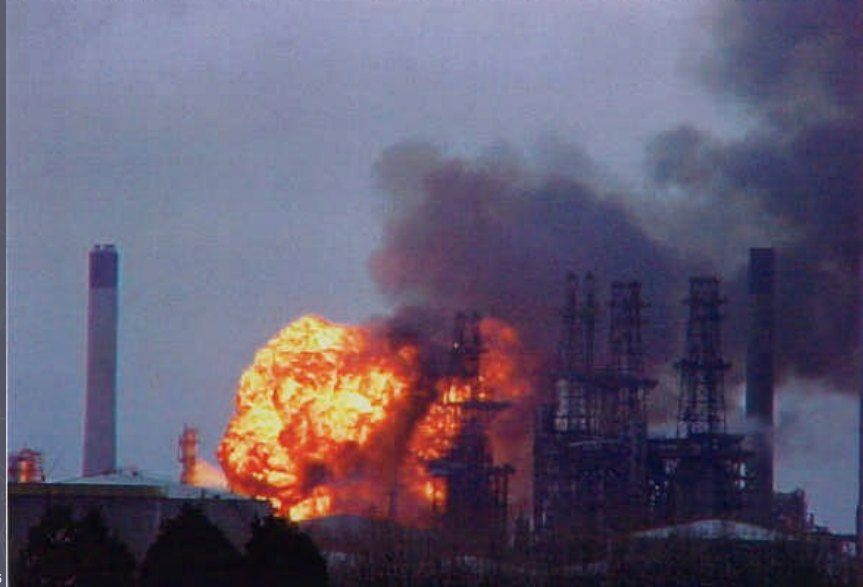
Final Blast est. to have gone 120 to 150mtrs into the air.

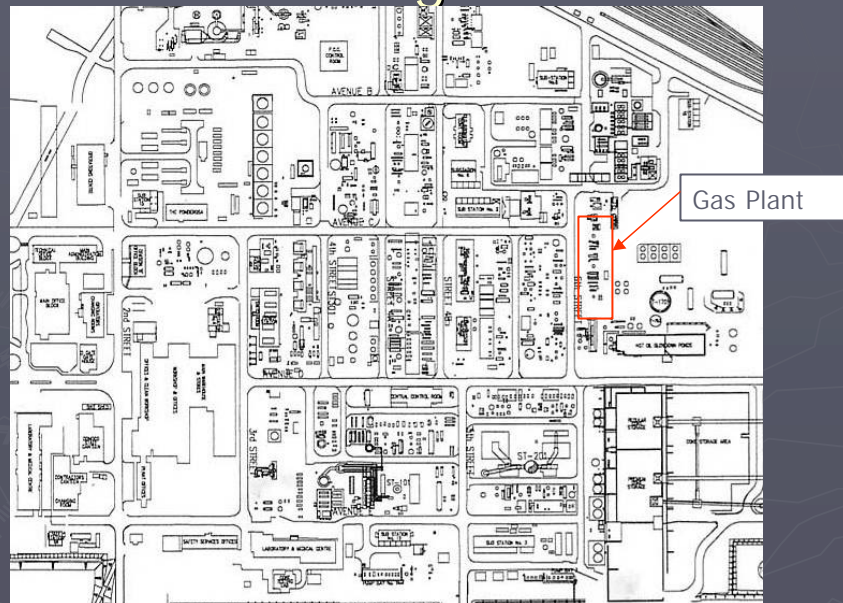
Main Damage Area

This is the area where most of the damage occurred. This covered buildings such as substations and pump houses.

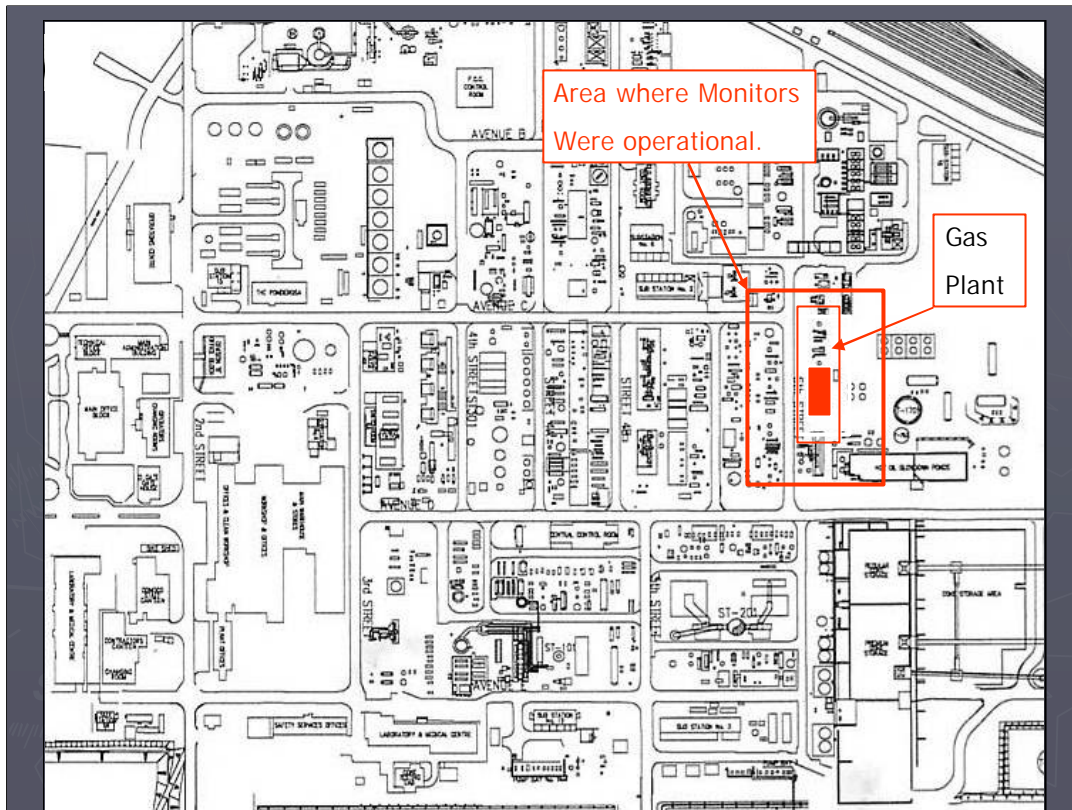
When I arrived on scene in the outer area marked, was where the operations and our fire crews had got turret and trailer monitors to work. They had also operated pump drenchers on the a joining units where possible, which told me the size of the area first covered by the fire.

The red box was the area on fire when I arrived on scene. I asked operators and fire crews to shut down any equipment that was not required.

Because the monitors were not quite reaching into the fire, I requested one of our 2000gpm monitors to be brought in and set up. When operational, water reached into the centre of the fire.

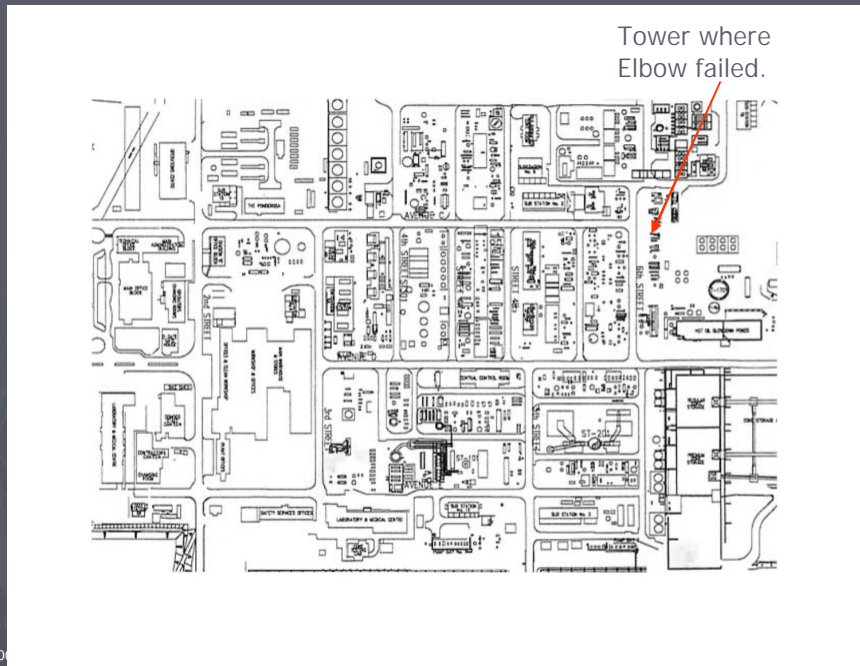
Elbow that failed.

Here is the layout of the unit areas with the tower pointed out where the elbow failed.

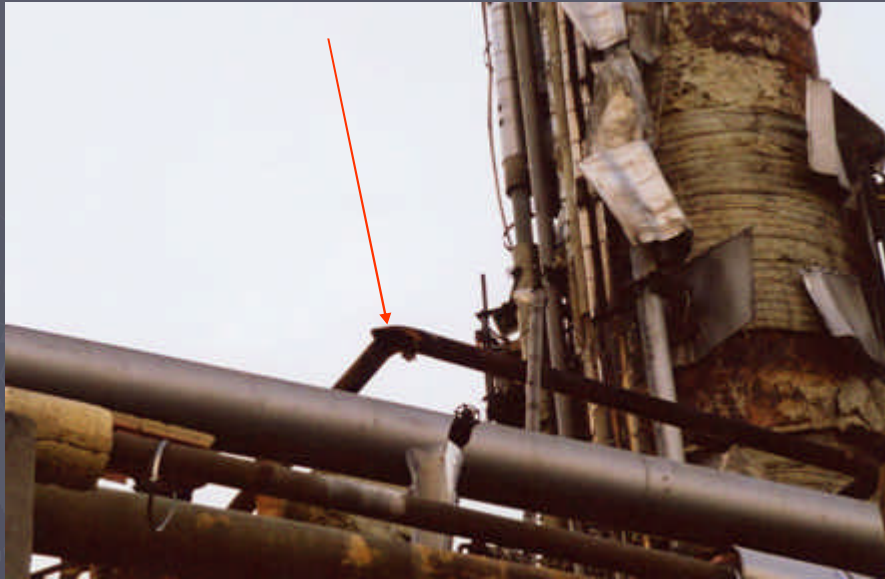
Failed
Elbow.

View looking up from the ground towards the tower showing the failed elbow.

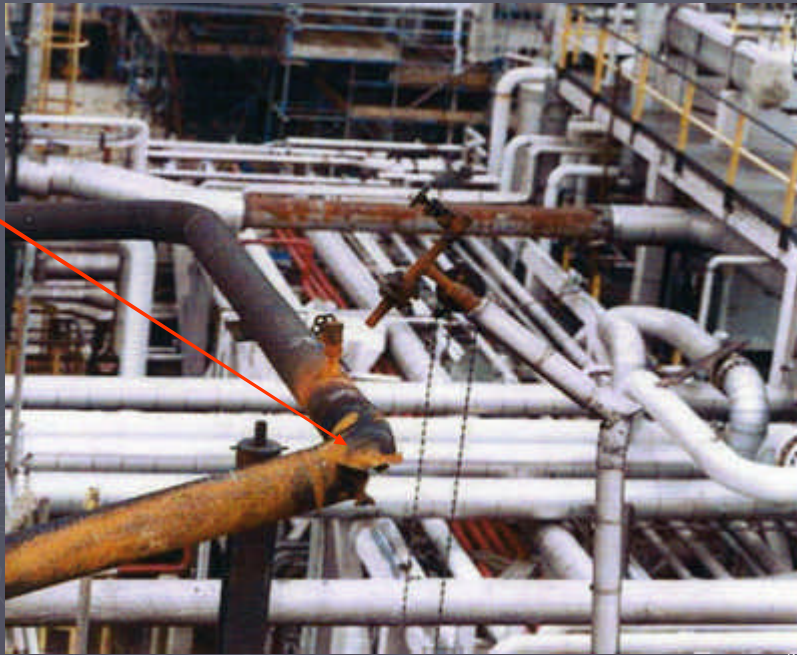
Another view of failed elbow looking towards the East.

? Gas Plant.
Pipe failed
off Tower
on right.

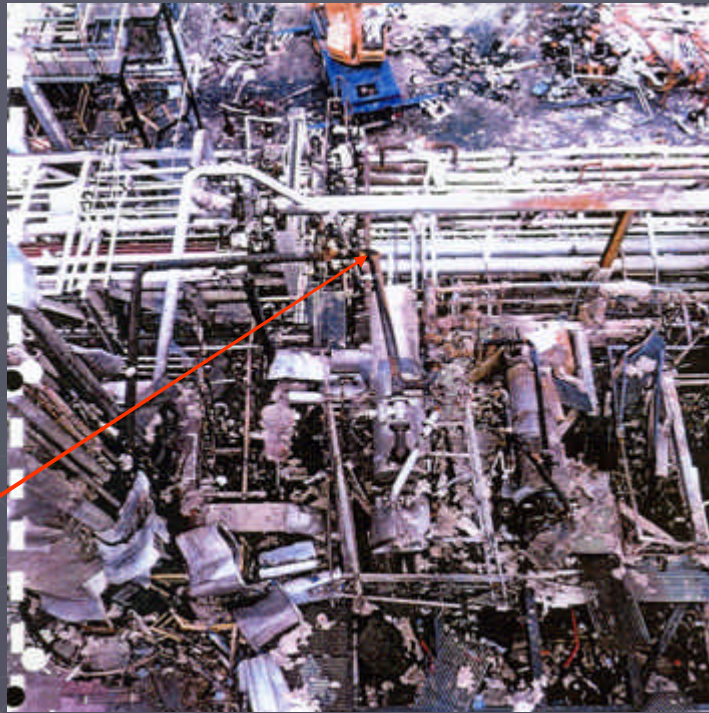
Failed
Elbow.

This is a view from above the unit where the elbow failed. Crane was moved into area after the blast.

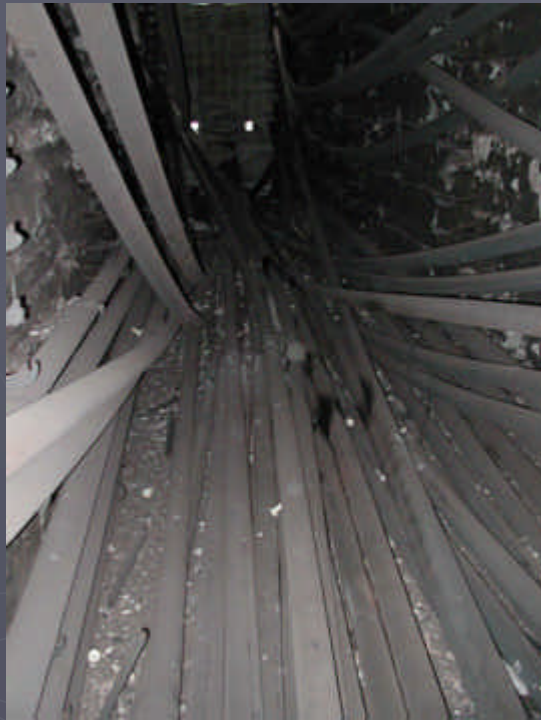
? This is the inside of the heater where the LPG leak found its ignition source.

This is a view into the heater where it is suspected the LPG found its ignition source.

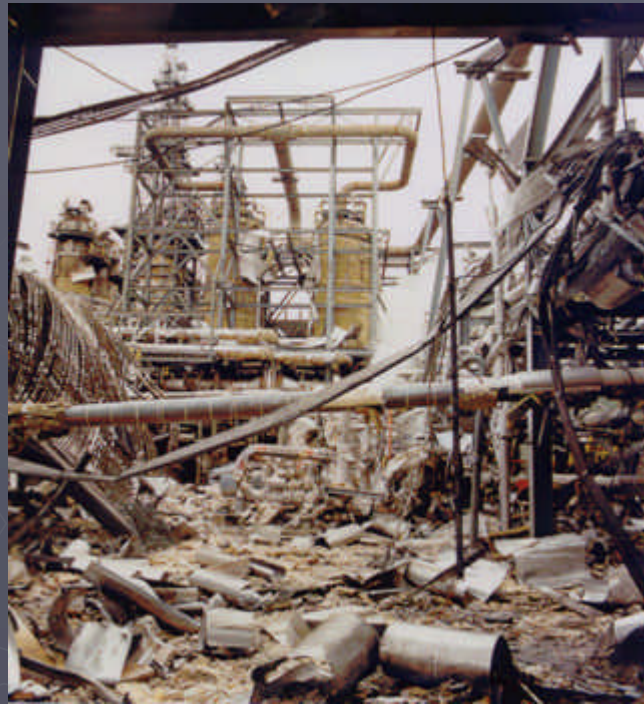
? Closed
Blow Down
Area to
South off
LPG Main
Leak.

This is a view to the south through the closed blow down area. See to the left of the picture the inside remains of one of the unit fin fans.

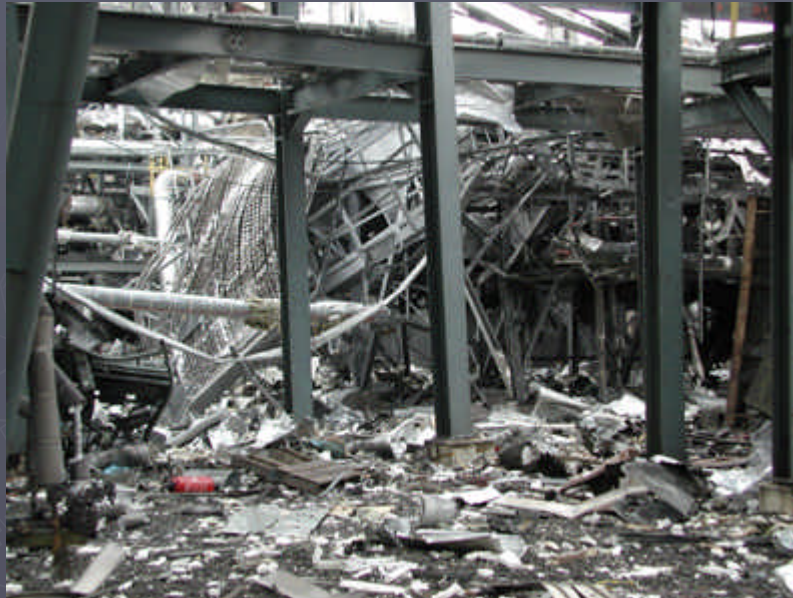
Remains of a Fin Fan Closed Blow down

Another view through the closed blow down area.

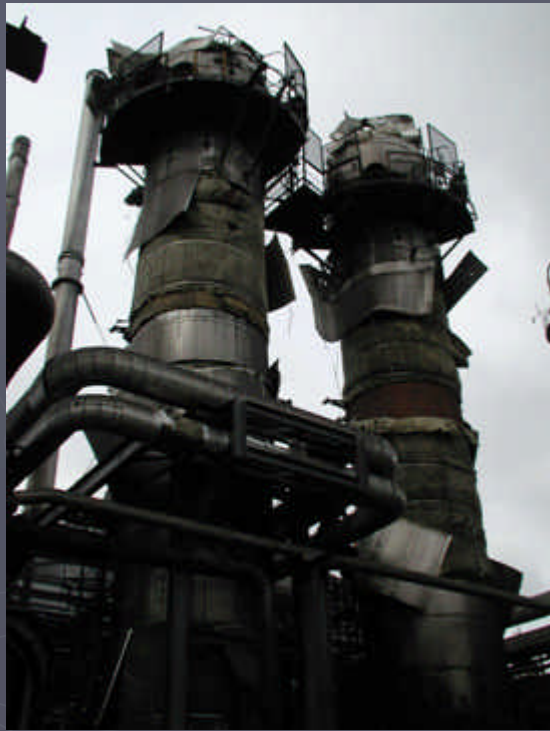
? Insulation
stripped from
two towers
caused by the
blast.

Two towers in the area with the insulation stripped of by the blast.

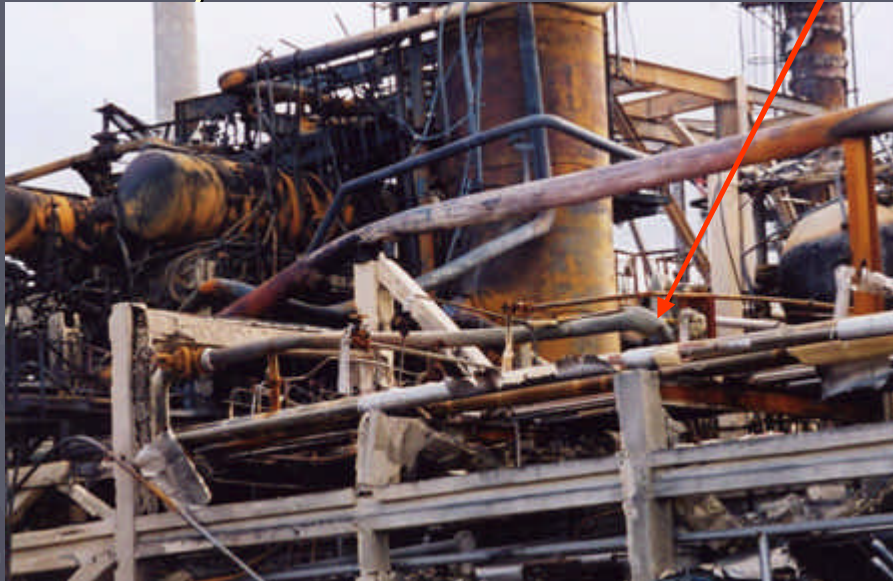
Probably the last elbow that failed.

This was most likely the elbow that failed giving the biggest explosion. Once this failed it would have emptied all the LPG from out of the tower just to the left.

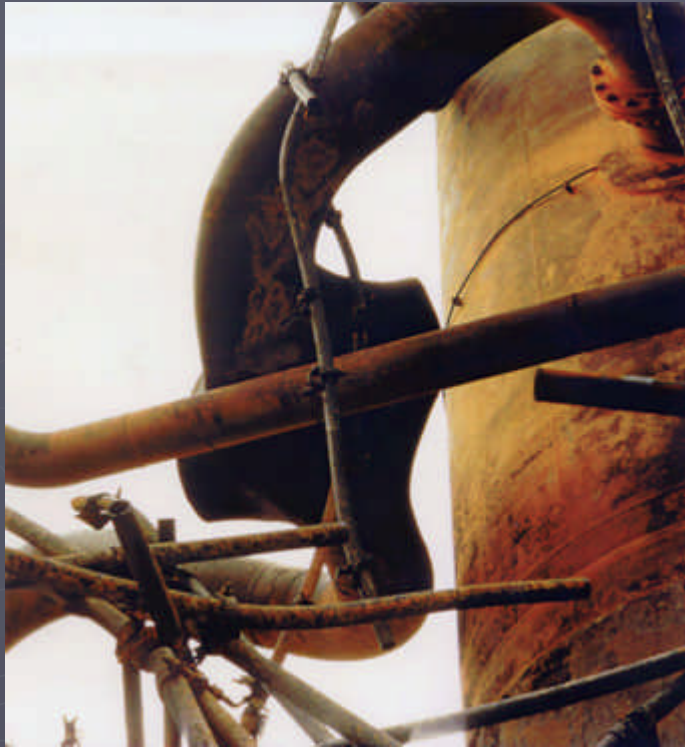
? Most likely the last pipe that failed.

View of the failed pipe.

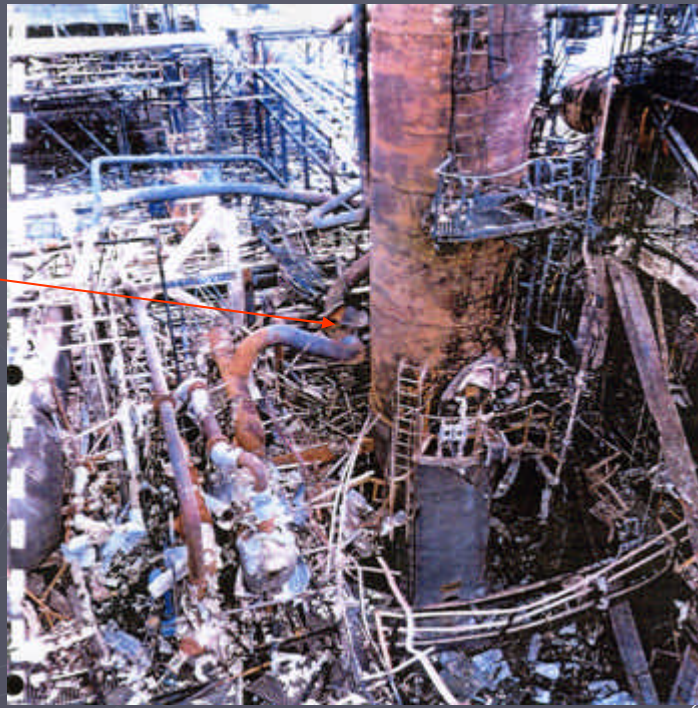
View of
elbow
that
emptied
tower

This is another view from above looking down onto what was most likely the last pipe to fail. With this failing all the LPG will have been released from the tower.

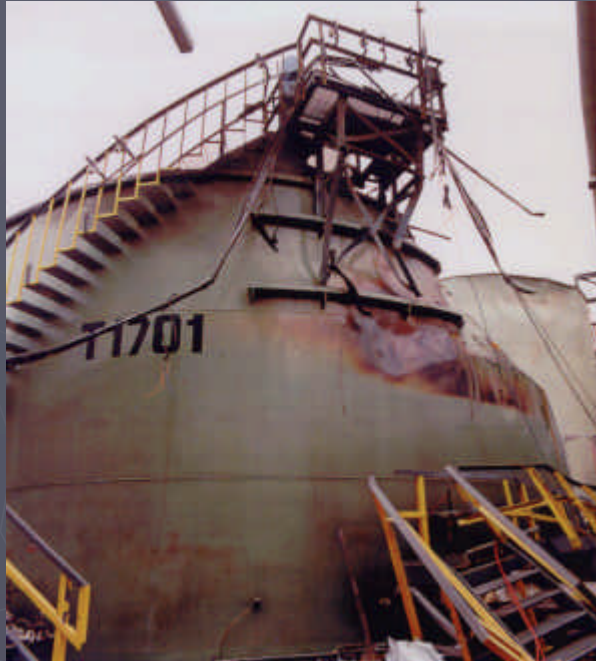
- T1701 Water Tank. Note Burn marks where Tank has been on Fire

This is the tank that all the water from the coke drums comes to separate the water from any oil. The tank had a floating roof and we had a rim seal fire.

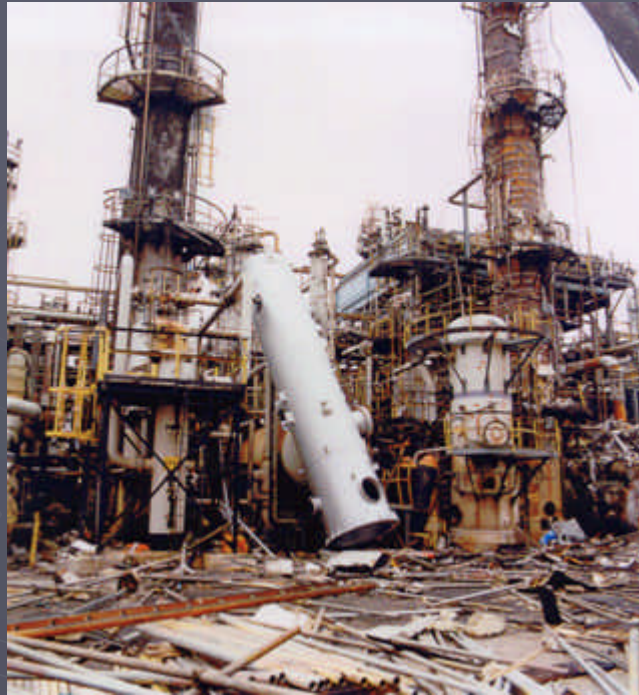
? Tower
blown
over.
25mtrs
from Gas
Plant.

This is a view from the gas plant looking towards the west. The tower was a new one being installed and was only bolted to the ground.

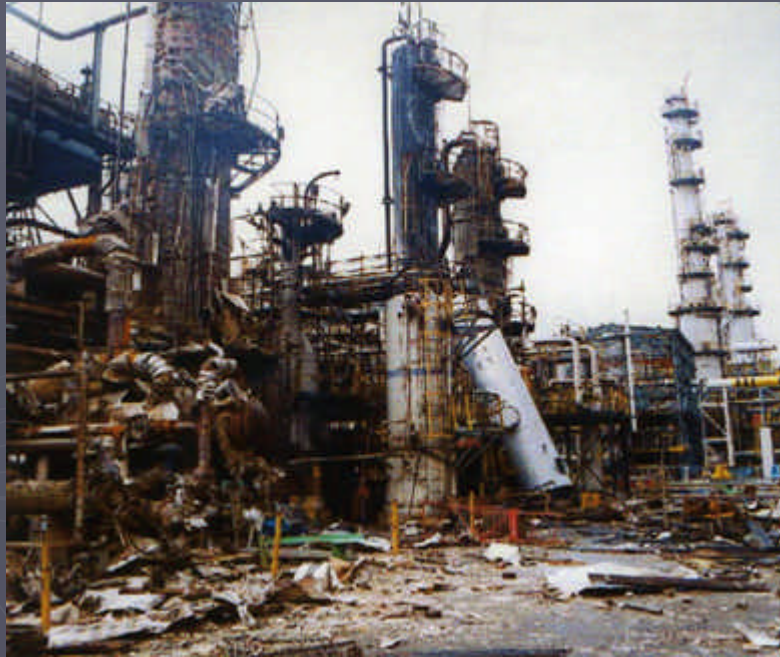
Second view of tower leaning. (Taken from HSE document)

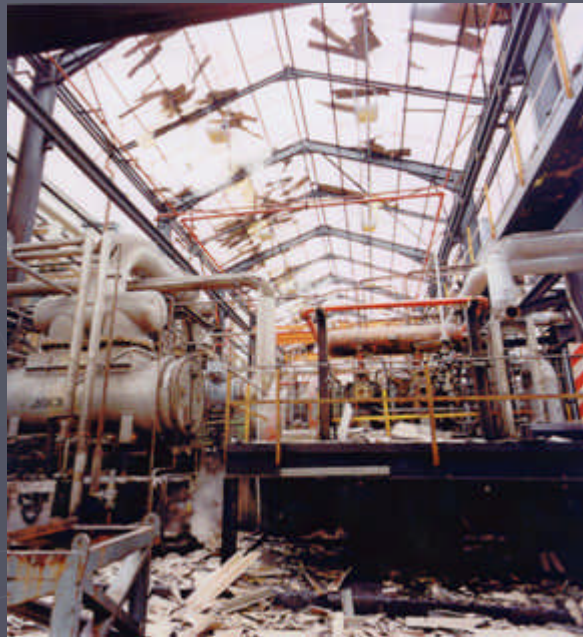
? 300
Compressor
House approx
120mtrs from
Elbow that
failed and
resulting Blast

This is a view of the remains of the Compressor house building and roof. The sheets from the roof and walls were all broken.

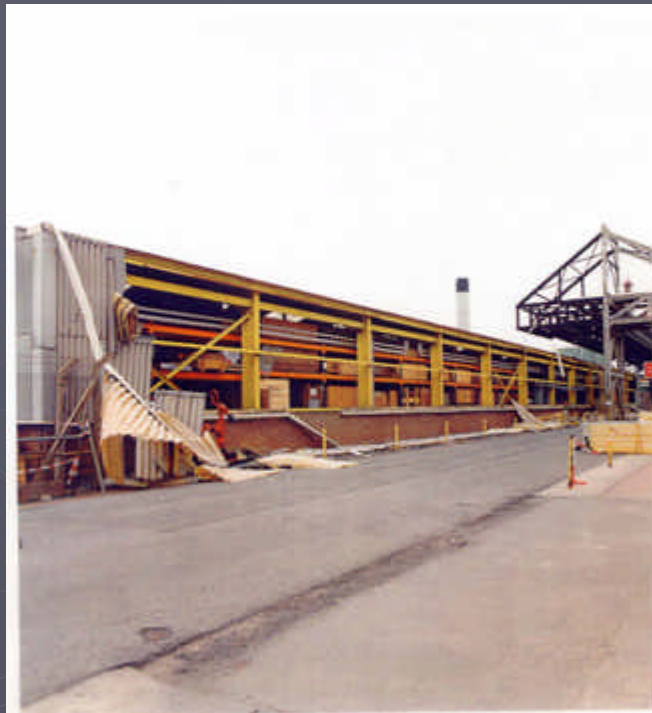
? Stores
Wall 3rd
St. approx
300mtrs
from Blast
Area.

This is a view of the wall on the main stores. This side of the building was towards the blast area, although there was much plant between it and the blast area.

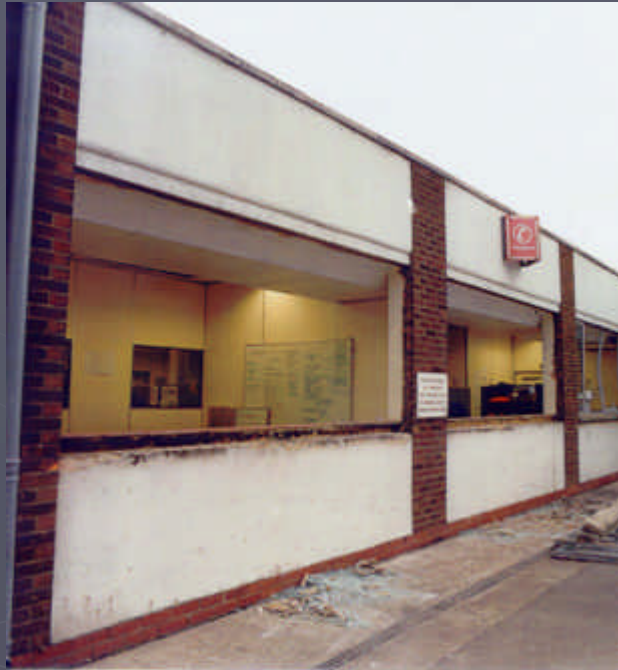
? Lab Building
Ave E.
Approx
300mtrs
from Blast
Area. All
windows
out.

This is a view of the lab front. The window at the left went in and the others came out.

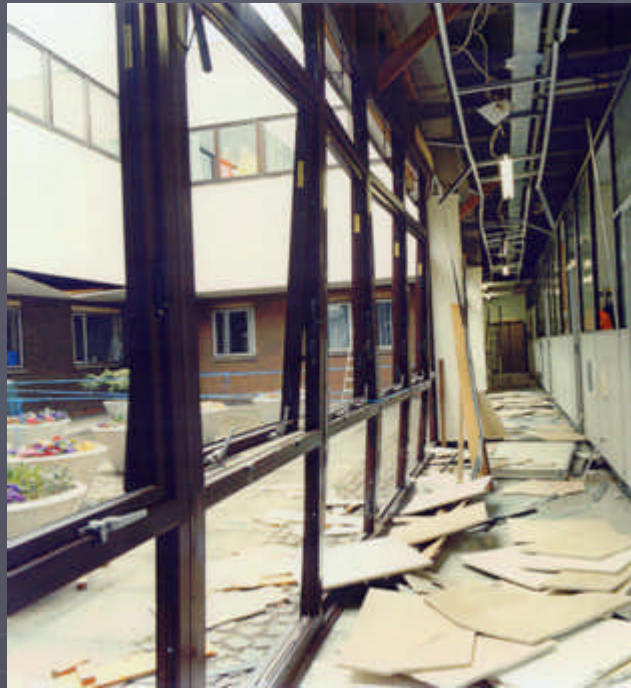
? Main Admin
Quadrangle.
Approx
425mtrs
from Blast
Area.

This is in the main Admin building. As can be seen the ceiling has all fallen in and the windows along the side have all been broken.
