U.S. CHEMICAL SAFETY AND HAZARD INVESTIGATION BOARD

CATASTROPHIC VESSEL FAILURE

D. D. WILLIAMSON & CO., INC.

REPORT No. 2003-11-I-KY

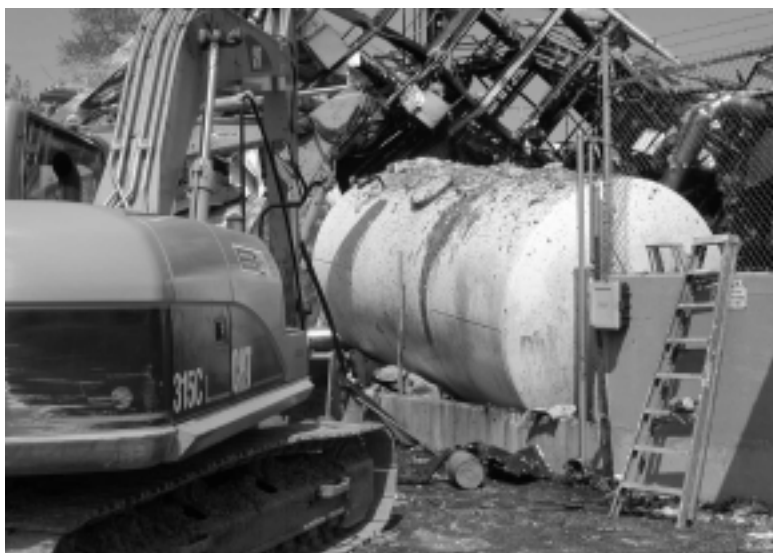
Figure 3. Aqua ammonia storage tank prior to removal from diked area.

The aqua ammonia storage tank was knocked off its foundation and piping was ripped loose, which resulted in the 26,000-pound aqua ammonia leak. An ammonia vapor cloud traveled southwest from the storage tank, toward neighboring homes.

The force of the explosion and impact with at least a portion of feed tank #2 pushed the 12,000-gallon horizontal aqua ammonia storage tank off its foundation saddles and approximately 10 feet to the west. This movement ruptured a line underneath the tank. The open valve on this line, located at the tank, was intact; however, it was buried in debris and caramel liquid.

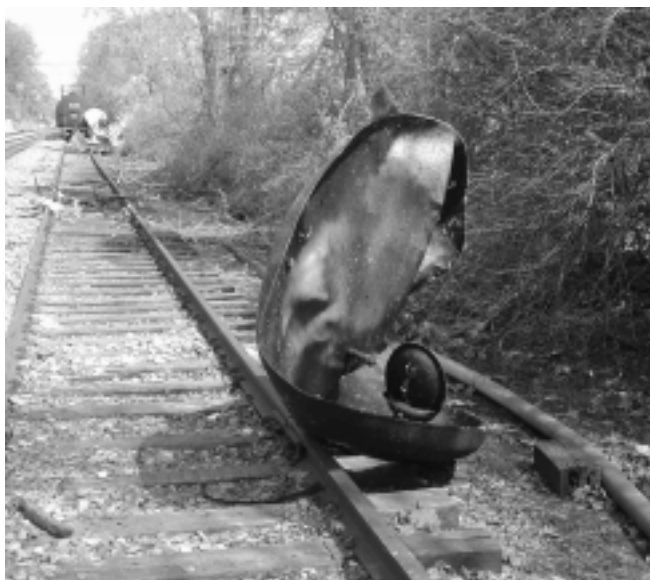
Figure 5. Feed tank #2, top head.

- The top head separated at the weld seam and flew approximately 100 yards to the west, landing on the CSX rail line on the north side of the facility (Figure 5).

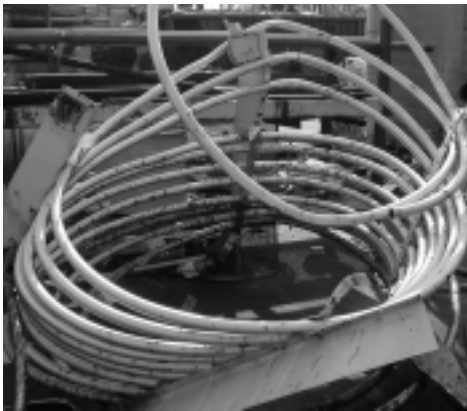
Figure 7. Steam coil ejected from feed tank #2 (photographed in relocated position).

The internal steam coil from tank #2 (Figure 7) was found approximately 30 feet to the south of the tank's original location. As the feed tank came apart, the coil was ejected and broke apart transversely. The coil retained its round configuration, indicating that the tank did not fail because of an internal deflagration or detonation, which would be expected to deform the coils—but because of pressure exerted somewhat evenly around the circumference of the vessel. CSB tested the coil to determine if a steam leak could have been a causal factor in the incident but was unable to determine whether the coil broke prior to, or as a result of, the explosion. No leaks were found in the intact portions of the coil.

- **Failure of the steam coil inside feed tank #2:** A failure of the steam coil could have generated sufficient pressure—from the steam (130 psi) and the vaporization of water—to cause the vessel explosion. Although the coil was torn apart, CSB could not determine if this failure was pre- or post-incident.

The second operator, however, observed only liquid coming from the top of the feed tank prior to the explosion—not vapor or steam. It is likely that a major coil failure would have released steam through the agitator seal. The feed tank drawings noted that the steam coil was hydrostatically tested at 50 psi—which is much less than the 130-psi working pressure.

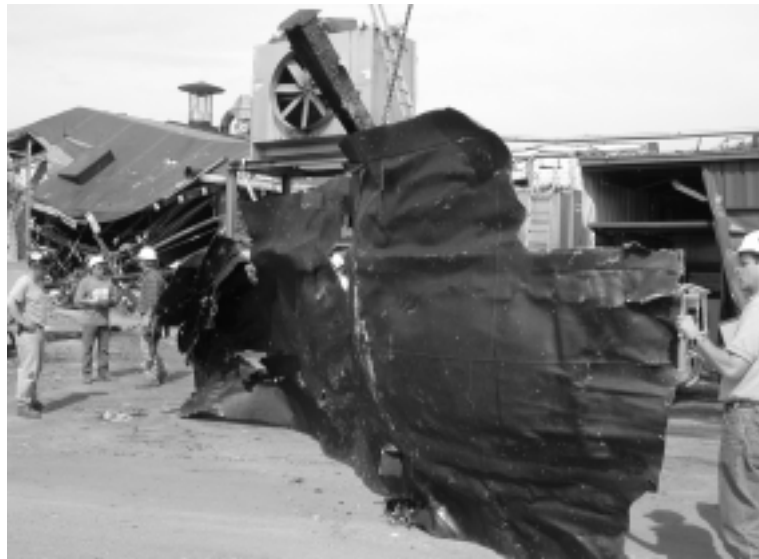
Figure 6. Feed tank #2 shell, after recovery.

- The shell split open in a roughly vertical line. It appears that it was propelled off its foundation and struck the aqua ammonia storage tank, located 15 feet to the west, and then ricocheted 20 feet to the northeast, hitting the bottom of the spray dryer structure and toppling it (Figure 6).

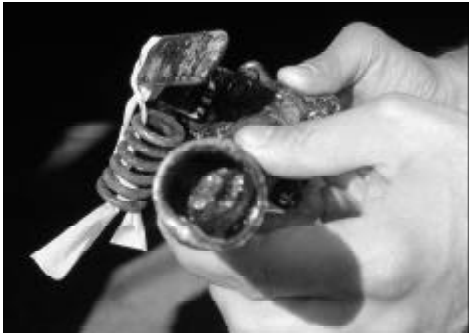
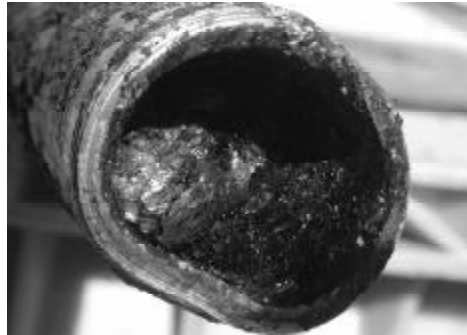
The 1-inch vent valve and a portion of the vent pipe were recovered in a parking lot, approximately 250 feet west of the tank's original location. The valve and pipe were plugged with a hard, sticky black material—typical of overcooked caramel color liquid (Figures 8 and 9). As observed by CSB, the valve appeared to be approximately one-quarter open; however, due to the effects of the explosion, CSB was unable to ascertain the valve position prior to the event.

Figure 8. Plugged 1-inch vent pipe.

Figure 9. Closeup of vent pipe pluggage.

- The operators observed caramel liquid leaking from the agitator shaft seal at the top of the feed tank, which indicated excess temperature and pressure on the tank. It is likely that the caramel liquid also flowed into the 1-inch vent line, filling and plugging it.

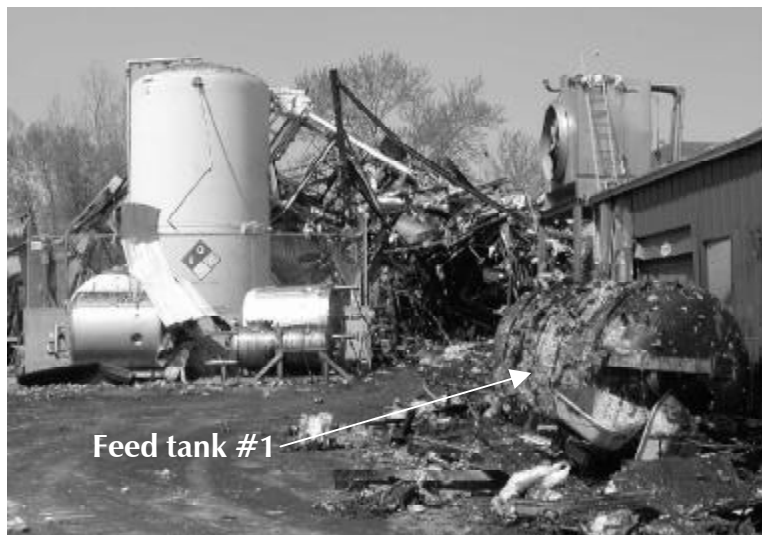
Figure 10. Feed tank #1

Feed tank #1 was propelled to the south and landed on its side, approximately 150 feet from its original location (Figure 10).

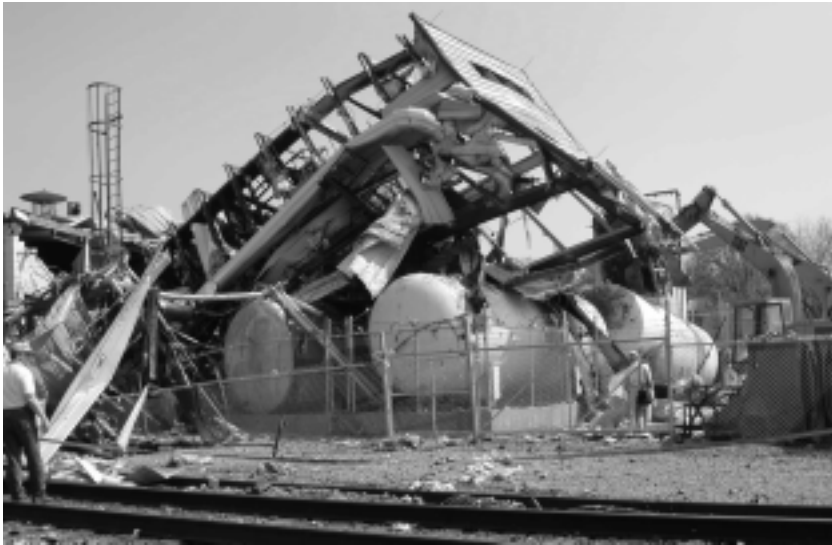
Figure 11. Collapsed spray dryer structure.

- The spray dryer area at the west end of the DDW site was totally destroyed (Figure 11).
- A concrete block wall to the east of the spray dryer area collapsed.
- A 6-inch gas line ruptured; however, automatic valves prevented release of the natural gas.
