U.S. CHEMICAL SAFETY AND HAZARD INVESTIGATION BOARD

INVESTIGATION REPORT

DUST EXPLOSION

WEST PHARMACEUTICAL SERVICES, INC.

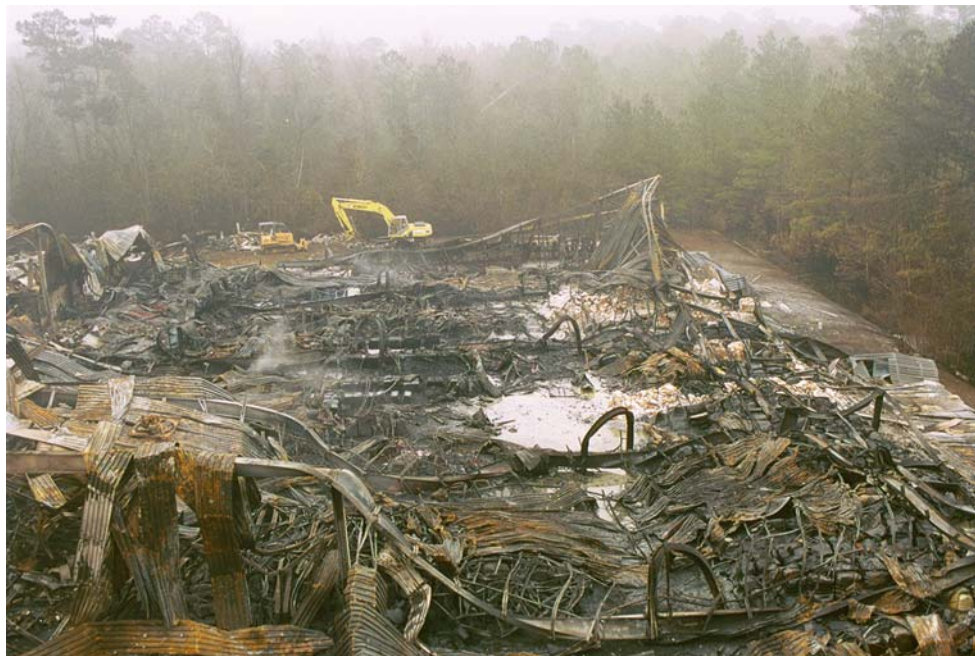
Figure 7. Remains of ACS warehouse viewed from compounding area.

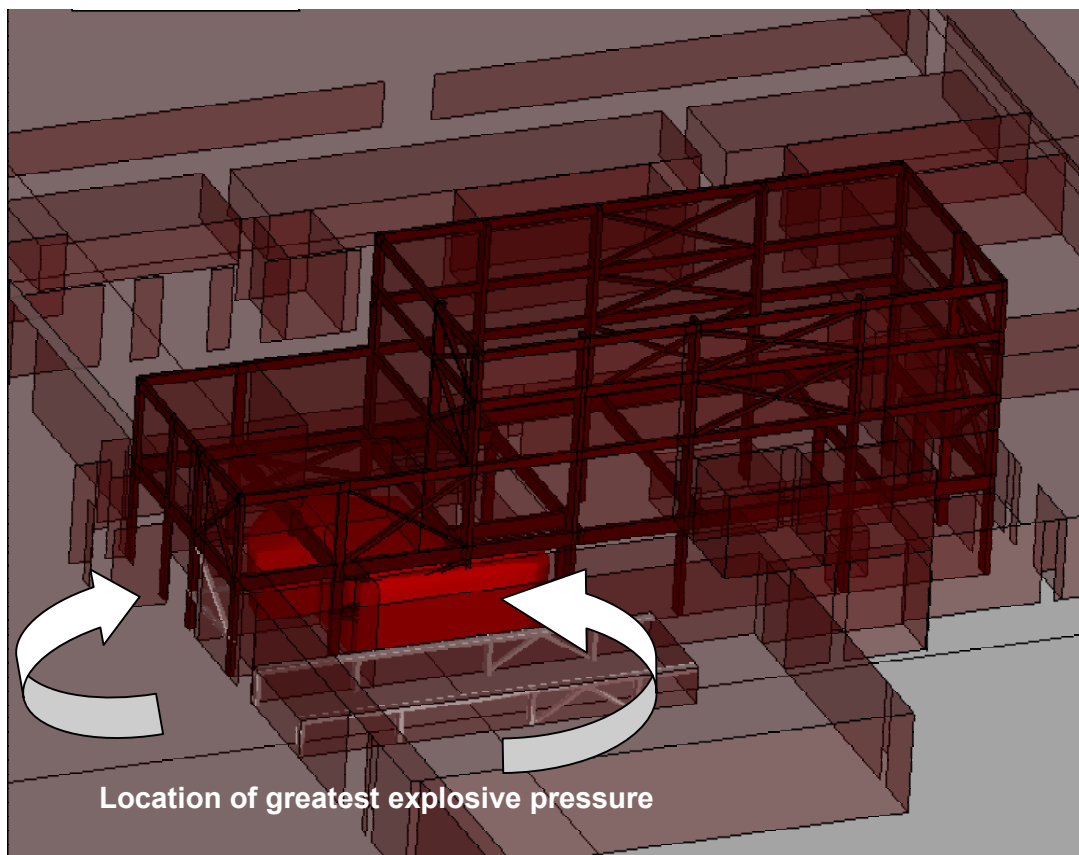
Figure 10. Location of maximum explosive force.
