# Storage Tank Explosion and Fire in Glenpool, Oklahoma April 7, 2003

## Pipeline Accident Report

NTSB/PAR-04/02

**Abstract:** About 8:55 p.m., central daylight time, on April 7, 2003, an 80,000-barrel storage tank at ConocoPhillips Company's Glenpool South tank farm in Glenpool, Oklahoma, exploded and burned as it was being filled with diesel. Gasoline had been removed from the tank earlier in the day. The resulting fire burned for about 21 hours and damaged two other storage tanks in the area. The cost of the accident was \$2,357,483. There were no injuries or fatalities. Nearby residents were evacuated, and schools were closed for 2 days.

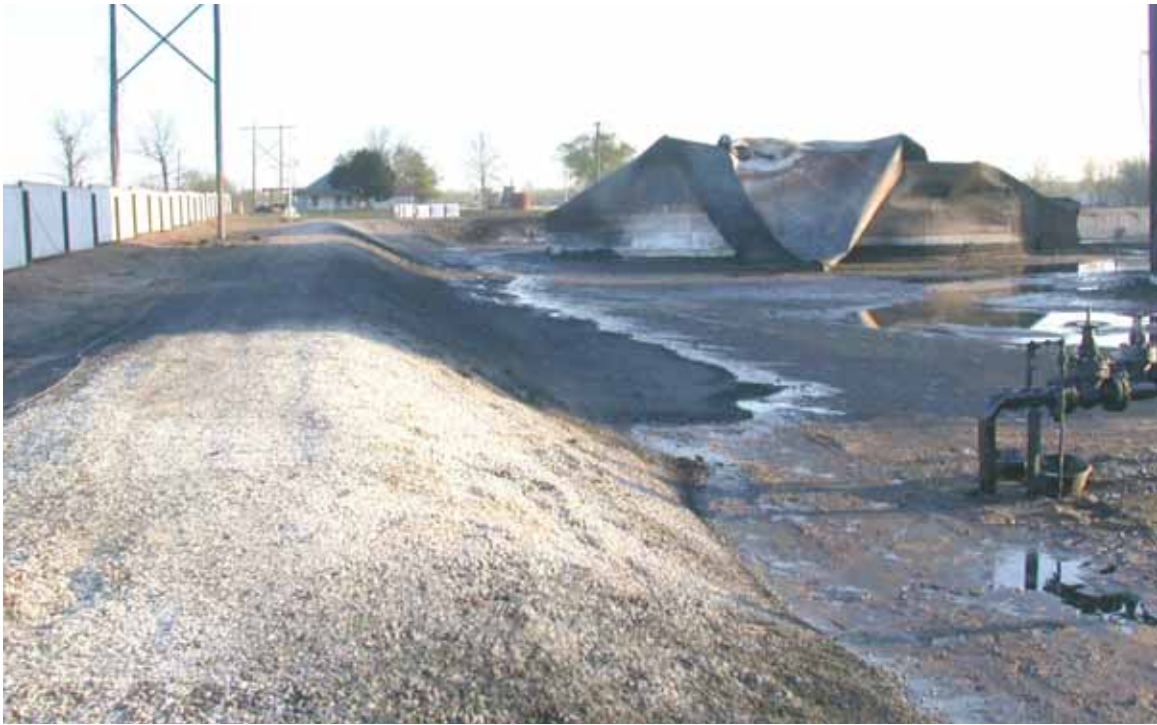
The Explorer operator at the Glenpool tank farm stated that he observed a fireball but that he was near operating pumps and did not hear an explosion. He described the accident as a flash, followed by smoke and fire, after which the fire totally engulfed tank 11. He said he went to his truck and drove to the Explorer control room, where he called the Explorer central control dispatcher. He said he then drove in his truck toward the fire to verify its location. It was determined that about 8:55 p.m., after tank 11 had been filling with diesel for about 22 minutes, the tank exploded. The fixed roof separated from the tank shell and was blown northward and folded over on itself, coming to rest on top of the collapsed north wall of the tank. (See figures 2 and 3.)

**Figure 2.** View of wreckage of tank 11 facing south. Note power lines and earthen dike at left and overpressure piping at right.

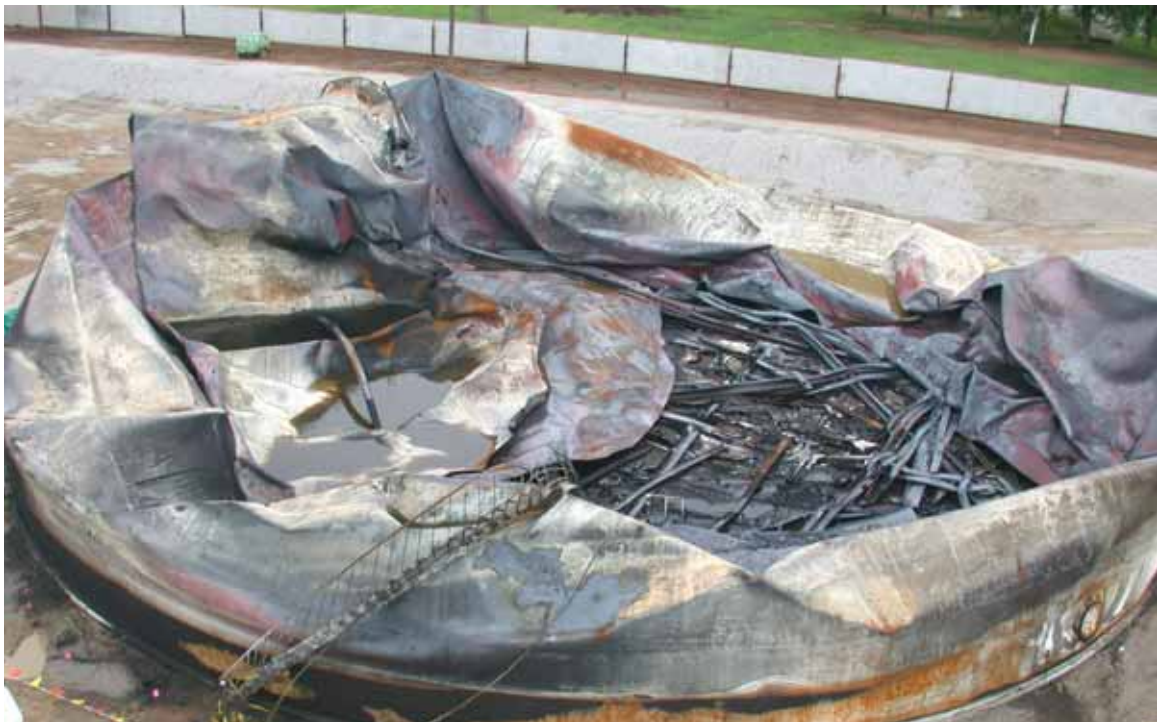
**Figure 3.** Wreckage of tank 11.

The floating roof and appurtenances had been severely damaged by the explosion, by heat from the fire, and by the collapse of the fixed roof and tank walls. Eleven floating roof legs were recovered from the debris of the burned tank. Pieces of four legs below the sleeves were recovered and reassembled. The recovered sleeves were observed to be

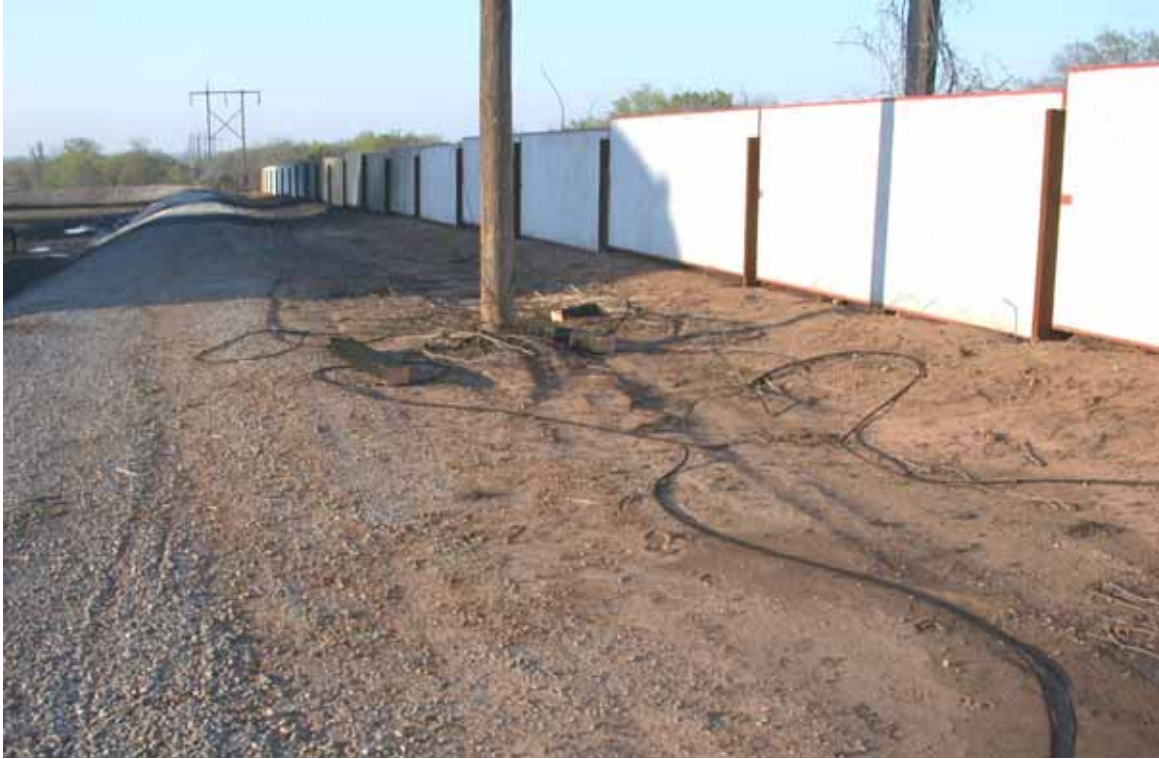
**Figure 4.** View of downed AEP power lines on east dike wall.

that AEP should recheck the lines. The servicer returned to the scene at about 5:30 a.m. and observed that the conductor closest to the fire now had a slight sag. This indicated that heat from the fire was affecting the power line. Incident command was notified that the servicer was on site, but the servicer did not check in or otherwise communicate with incident command. About 20 minutes later, one or more wires fell onto the diked area east of the tanks and the diesel that was contained inside that area of the dike ignited.

On April 10, 2003, investigators observed the power lines and shield wires on the ground on the east wall of the Glenpool South tank farm dike. The wooden power poles were standing.
