The Buncefield Investigation

Third progress report

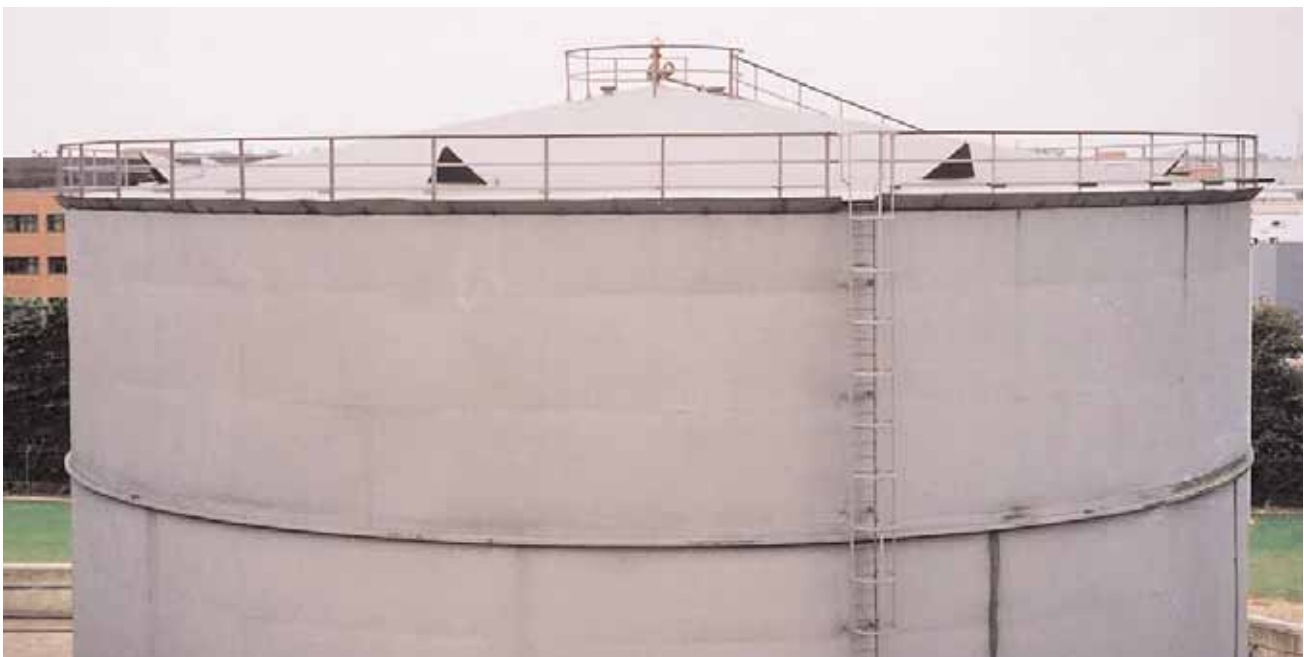
Figure 3 Tank top details before the incident

28 Therefore overfilling of Tank 912 would have resulted in flow from the breather holes at the top of the tank. There were eight of these, each triangular in section with an area of 0.07 m^2 , as can be seen in Figure 3 which is a photograph of one of the tanks in bund A taken shortly after construction.

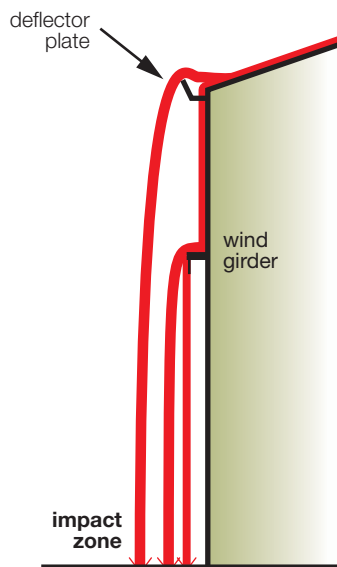
Figure 5 Liquid flow during overfilling of a tank with deflector plate and wind girder

36 The general features of these processes during an overflow are illustrated schematically in Figure 5.

37 The conclusion of this work is that the flow is likely to be very efficiently fragmented, and would create relatively small droplets falling freely through air around the tank. These conditions would promote the evaporation of the lighter chemical components of petrol, eg butanes, pentanes and hexanes.

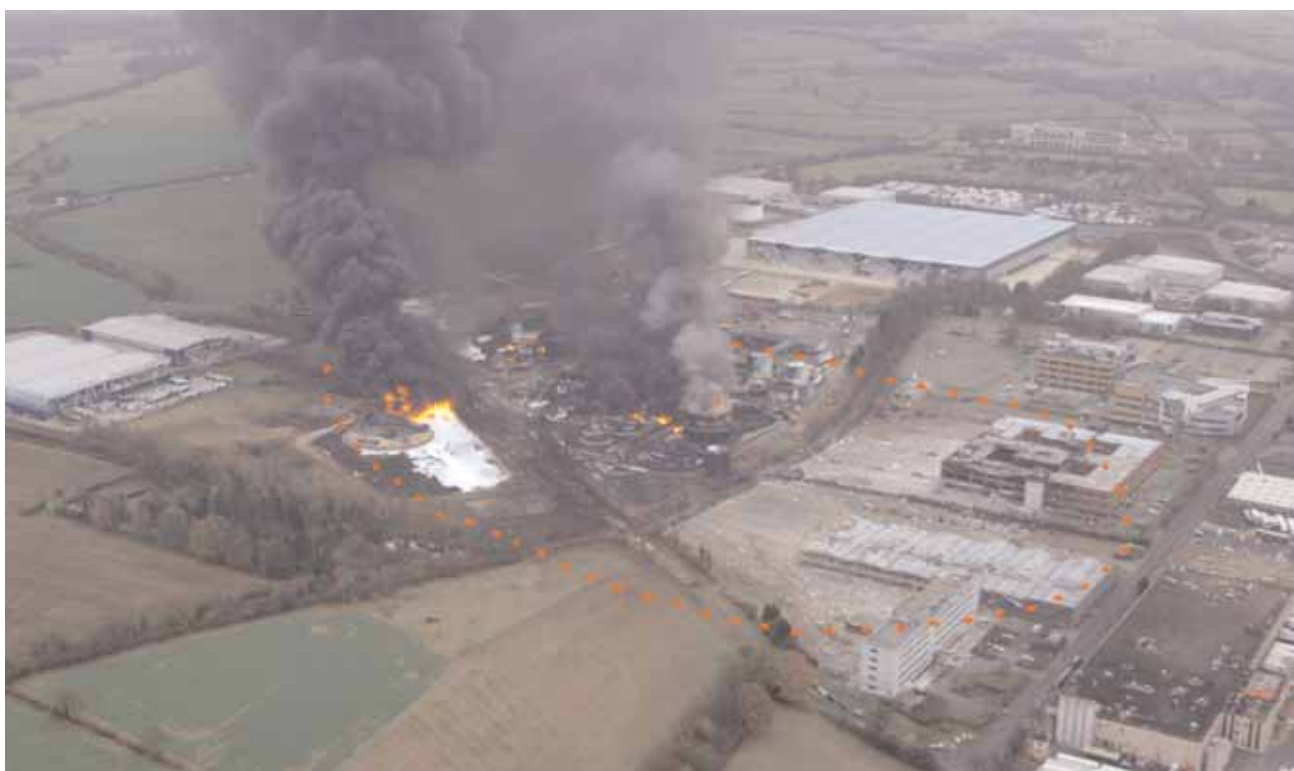
Figure 6 Extent of burn damage (indicated by dotted line)

39 Aerial pictures of the site have confirmed preliminary conclusions about the extent of the burn damage shown in Figure 5 of the first progress report. This is also shown by the dotted line in Figure 6. This is indicative of the extent of the flammable vapour cloud.

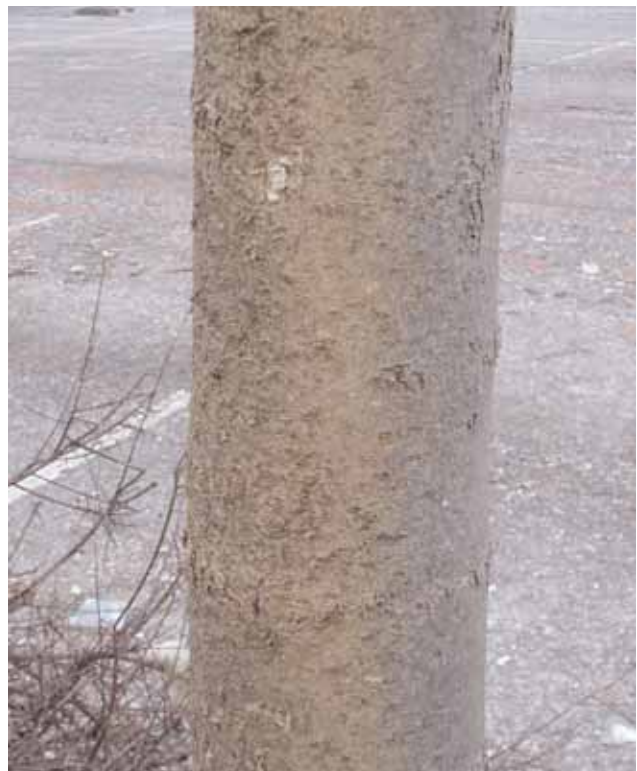
43 The tree trunk in the Northgate car park shown in Figure 8 is much further from the site and has been exposed to an explosion propagating in a more dilute vapour mixture with a composition close to the optimum for complete combustion. There is no soot on exposed surfaces but the left-hand side facing the camera has been deeply abraded by grit driven into it at high speed by the explosion. Examples of this kind of damage were found across most of the area covered by the Northgate and Fuji car parks.

Figure 8 Part of a tree trunk in the Northgate car park showing abrasion
