# BUNCEFIELD MAJOR INCIDENT INVESTIGATION

Initial Report to the Health and Safety Commission and the Environment Agency of the investigation into the explosions and fires at the Buncefield oil storage and transfer depot, Hemel Hempstead, on 11 December 2005

Buncefield Major Incident Investigation Board

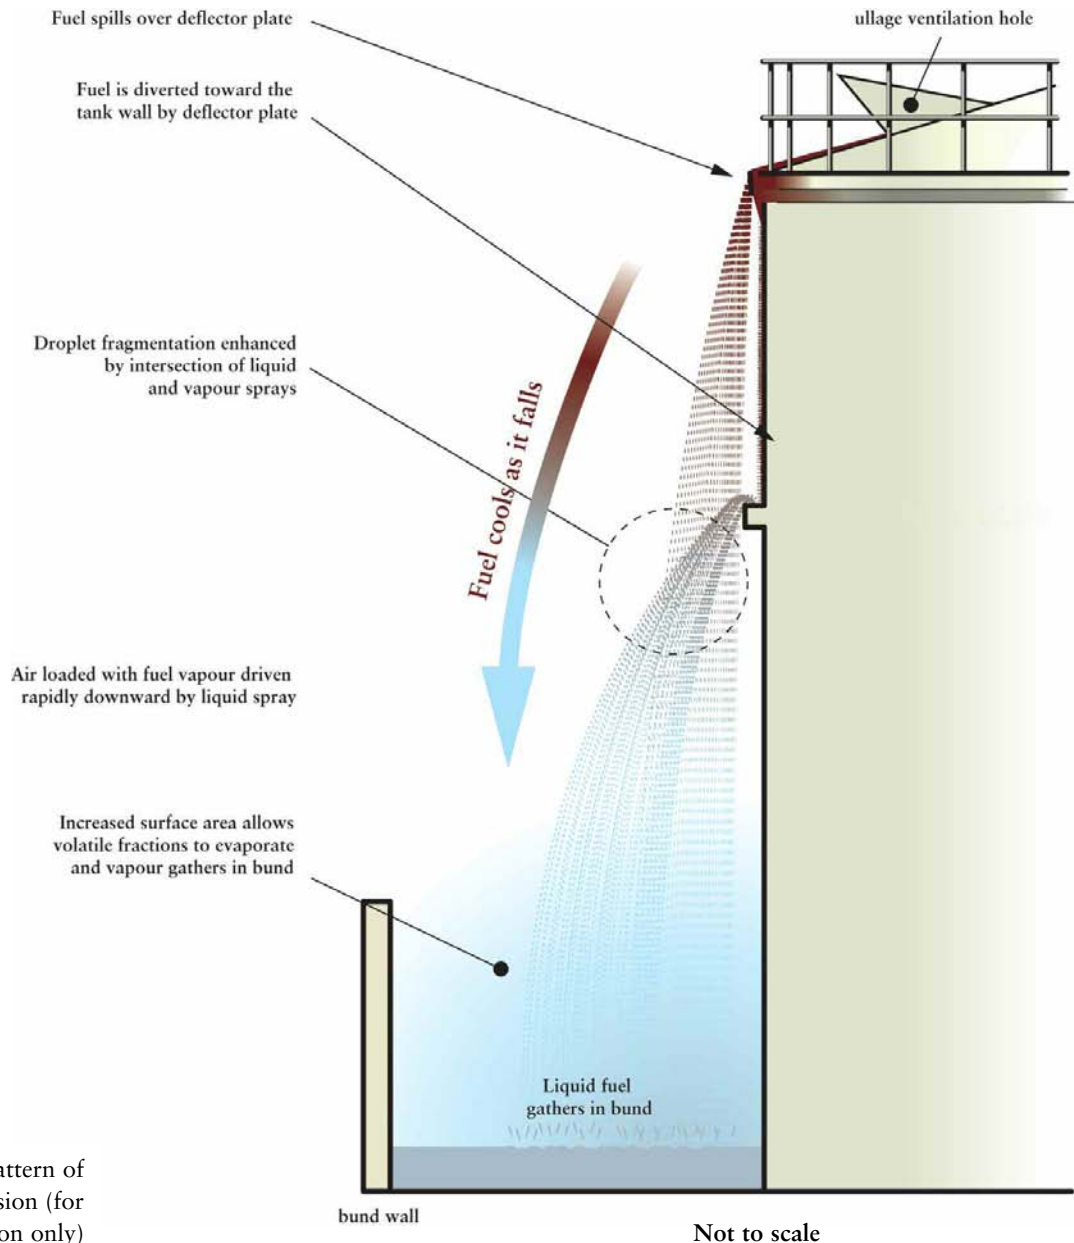
25 The Third Progress Report described extensive tests undertaken to model the behaviour of fuel escaping from Tank 912 during overfilling. Tank 912 was fitted with a deflector plate, installed to direct water from sprinklers on the tank's top to its sides to provide cooling in the event of fire. The tests demonstrated that the deflector plate channelled some of the escaped fuel onto the tank wall, but the rest ran over the top of the plate, fragmenting into droplets that cascaded through the air. Most of the fuel running down the wall hit a wind girder (a structural stiffening ring) and detached from the tank wall, creating a second cascade of droplets.

26 These conditions would promote the evaporation of the lighter components of petrol, eg butanes, pentanes and hexanes. The free-fall of droplets leads to entrainment of air and mixing between the air and fuel vapour, and the formation of a rich fuel/air mixture. Cooling of the surrounding air, already saturated with water vapour by the evaporation, would cause some of the water content to precipitate as an ice mist, which is consistent with the cloud of mist visible on

Figure 2 The pattern of fuel dispersion (for illustration only)

CCTV. The fuel/air mixture and its accompanying ice mist were heavier than air and so were initially contained within the bund. As the volume of the mixture grew from the continuing overflowing of the tank, it flowed out of the bund, dispersing and flowing off site. Further mixing with the air would have reduced the vapour concentration to the point where significant volumes of the mixture could support an explosion.<sup>12</sup>
