Explosion Mechanism Advisory Group report

Buncefield Major Incident Investigation Board

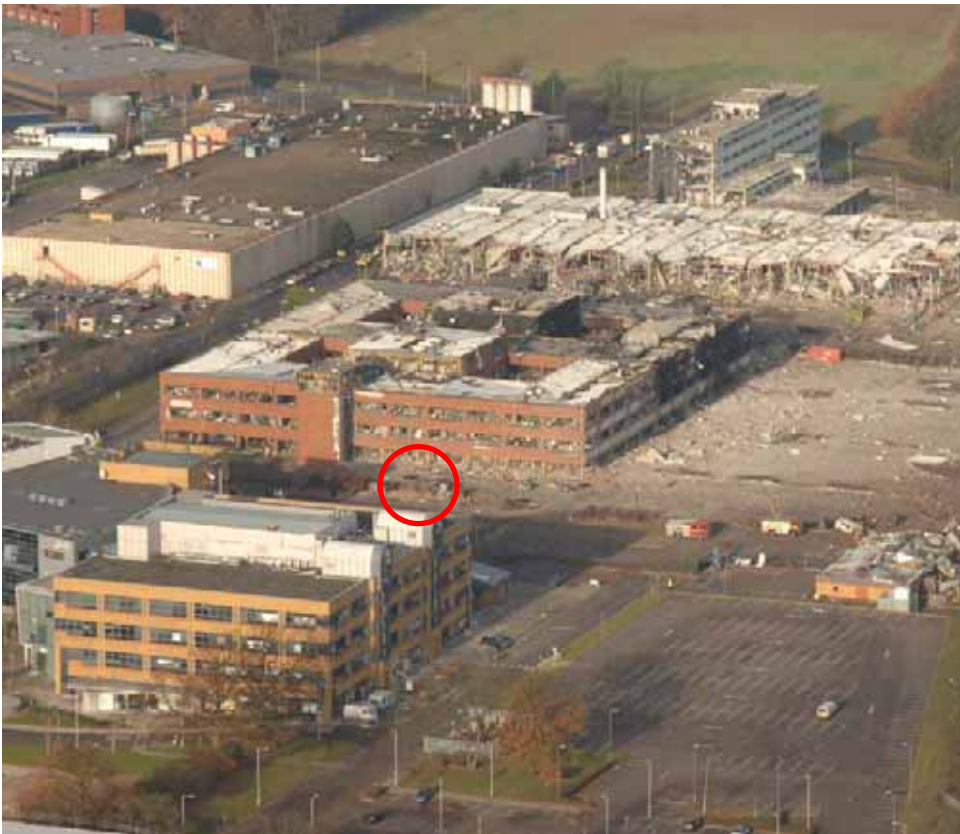
Figure 12 View looking north towards the Northgate and Fuji buildings, with the Buncefield depot just off picture on the right. The emergency generator cabin is highlighted
