**Report on technical aspects of HSE's
investigation into the collapse of a luffing tower
crane at a Liverpool construction site on 15th
January 2007**

Date of Issue: 16 July 2008

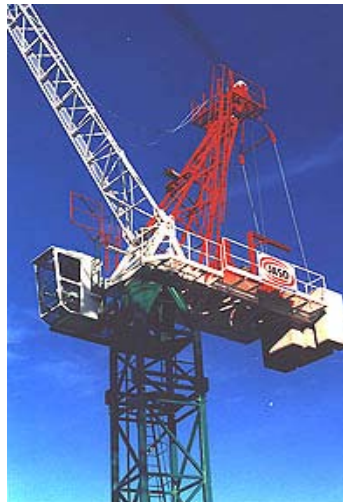
Photograph 1: Luffing jib tower crane similar to that involved in the accident

5. The crane was a luffing tower crane (see *Photograph 1, Appendix 1*) consisting of a slewing unit, operator's cab, counterweights, luffing hoist and winch drums and jib attached via a slewing ring to the top of a tower comprised of a number of sections. The tower sections were pinned together and secured to a specially constructed foundation pad (see *Illustration 1, Appendix 1*).

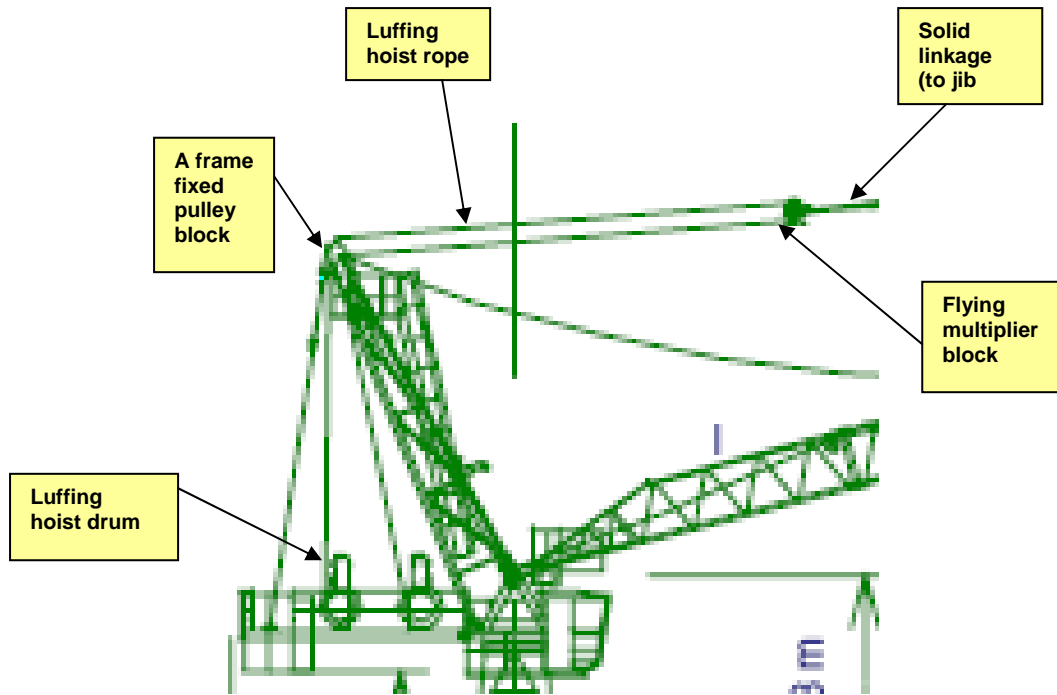
Illustration 2: Schematic of luffing hoist configuration

8. The luffing rope was reeved around a fixed pulley block which was secured to the A frame and a flying multiplier block which was connected in turn to the end of the jib via a solid linkage (see *Illustration 2, Appendix 1*).

37. Witness marks on the luffing limit buffers indicated that they had been partially compressed.
38. Several pulleys on the luffing hoist fixed block and the flying multiplier block had failed and witness marks on remaining pulleys indicated that the luffing hoist rope had come off the pulleys.

39. Examination of the fixed pulley block showed it was fitted with a single retaining bar designed to prevent the ropes coming off the pulleys whereas the flying pulley block was fitted with 4 such retaining bars.

52. The design of the protective device on the fixed block – the single bar – was not adequate to prevent the rope from coming off the pulleys and jump into the gaps between them.

53. As the wind gust subsided, the jib, under gravity, restored tension on the luffing rope causing it to jam between the pulleys and the casings of the blocks. This resulted in the jib hanging in a position near to minimum radius.

65. From our investigation, it would appear that better protective devices to prevent luffing ropes from coming off their pulleys would significantly reduce the potential for further events, particularly where wind and operating conditions provide potential for slack rope conditions to arise. And alternative or additional precautions may also be required.
66. HSE recognises these are complex issues to address necessitating engagement with the crane hire community, crane manufacturers and suppliers, inspection bodies, national and international standards bodies and others.
