The Specialist – “sharing through experience”

Ageing Plant Issues

Catastrophic fin fan failure and major implications on safety

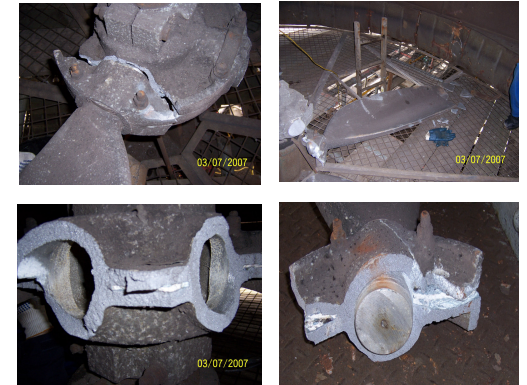
- Standard fin fan cooler assembly with solid aluminium blades mounted in split design hub
- All 4 blades catastrophically failed
- Guards and fan ring failed to contain components - they are not designed to do this.
- Initial failure caused by corroded lifting bracket bolts
- Initial failure unearthed an underlying deterioration mechanism in the hub causing hub integrity to be severely compromised.

- Lifting bracket dropped into path of rotating blades – first blade failure caused rest to be removed
- Blade failure showed hub assembly cracking due to stresses from corrosion product build up
- Both mechanisms were corrosion related time dependent.

1. Design: Crevices allow corrosion products to create stresses weakening key components
2. Safety: Fan ring/guard breached: potential for damage to surrounding plant/people
3. Installation: Plenum installation lifting brackets left in place. Should they have been removed?
4. Inspection: none on the hub, deterioration mechanism was unexpected
5. A simple message,
 “Expect the unexpected”.
