Naphtha Hydrotreater E-6600E Failure

Anacortes Refinery, Washington

TOP Investigation Team Report

Incident Tracking # 100402OPR038

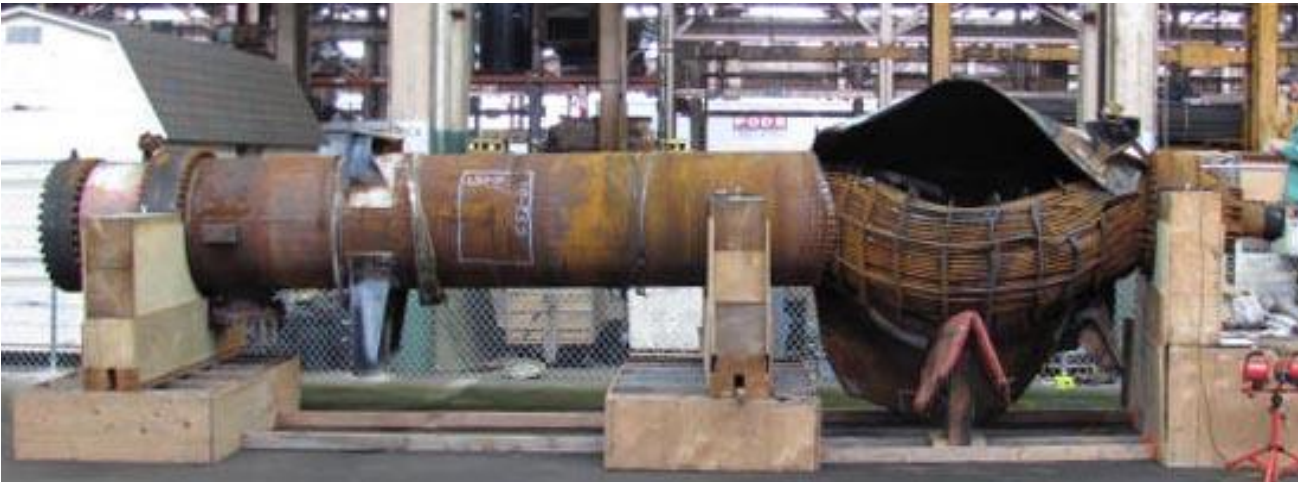
Photo 1: Sections 1-3 [from left] showing failure locations

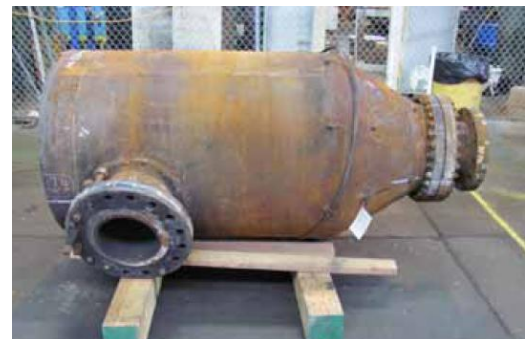
Photo 2: Section 4, shown separated from shell sections 1-3

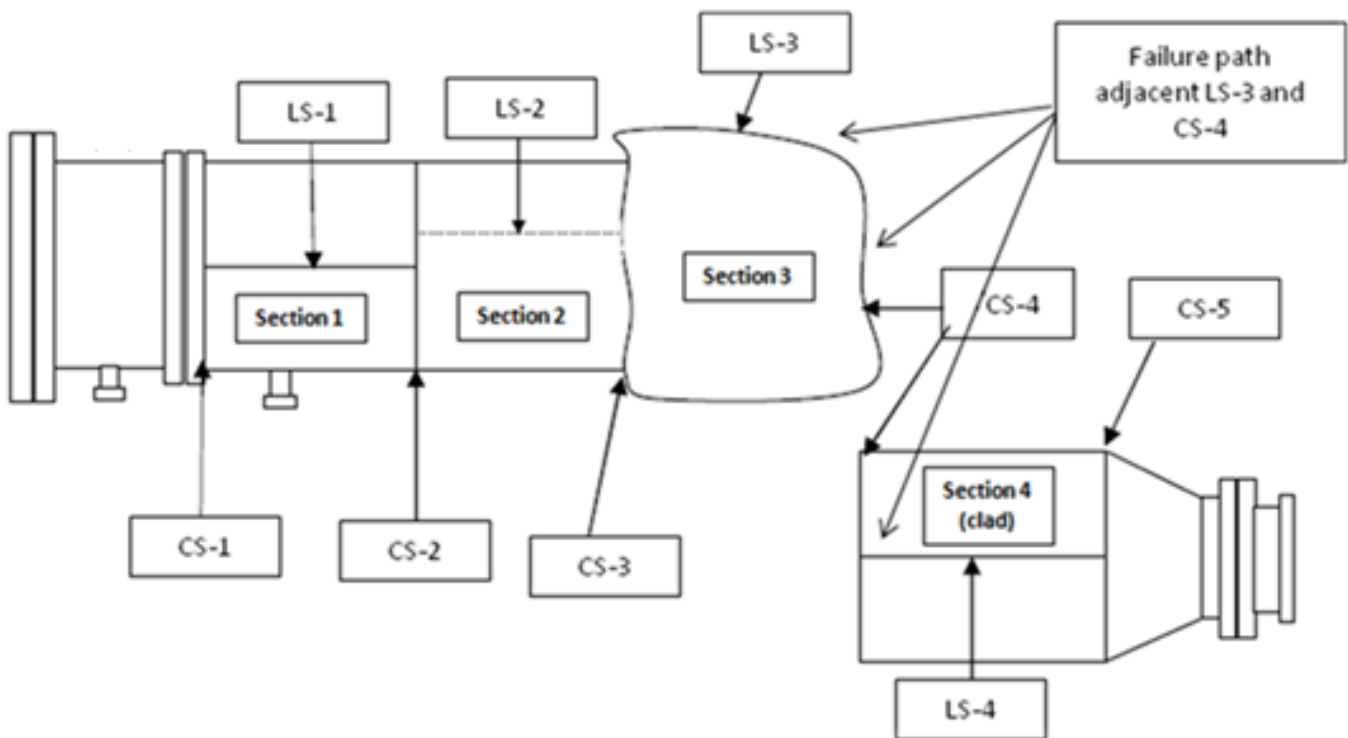
Figure 5: E-6600E Weld Seams and Failure Locations

The exchanger ruptured adjacent to longitudinal weld seam LS-3 and circumferential weld seam CS-4 due to damage from advanced high temperature hydrogen attack (HTHA).

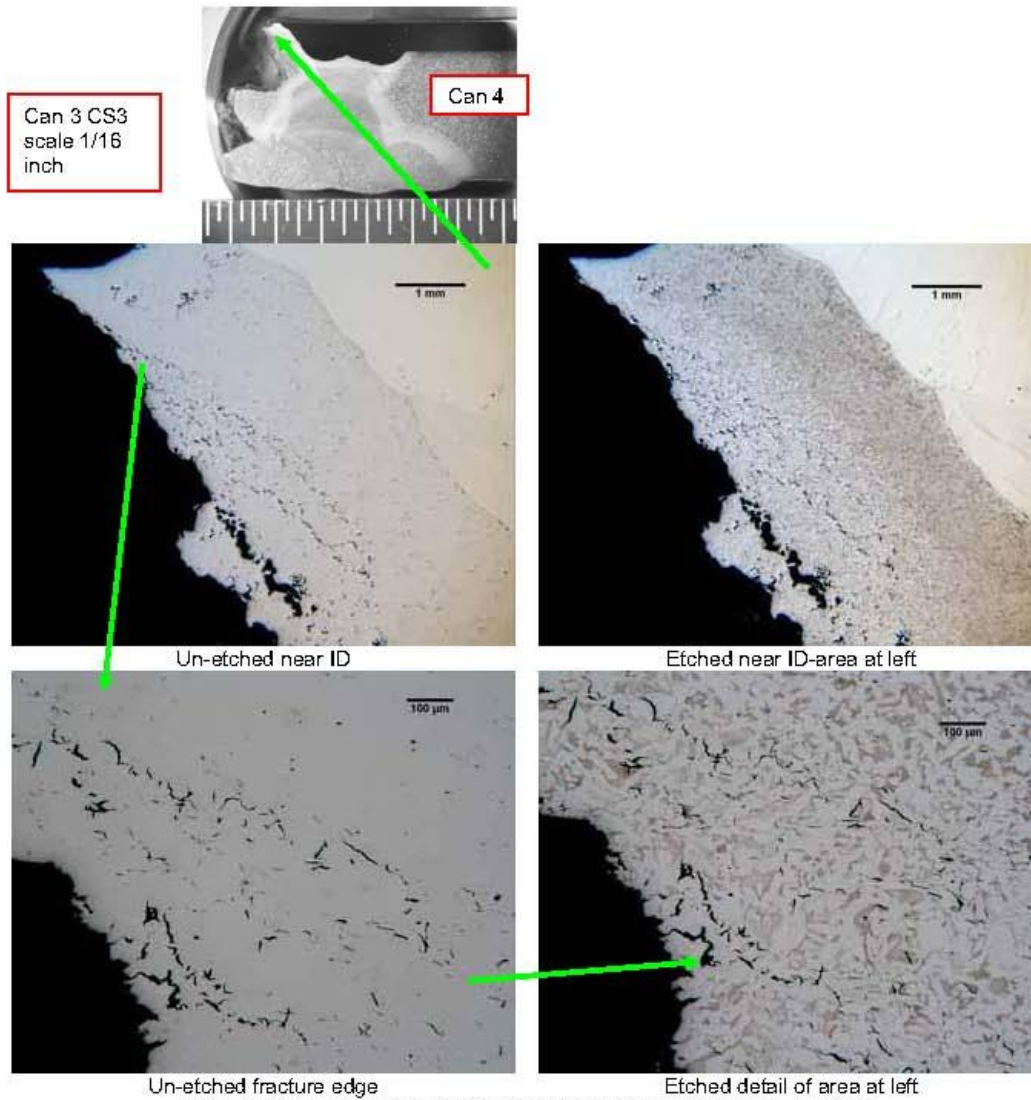
FIGURE 17 Un-etched and etched fracture edge near ID for mount M1

HTHA micro-fissures and decarburization were observed adjacent to the fracture surface in the heat affected zone (HAZ) of weld seam CS-4 of E-6600E (reference 7).

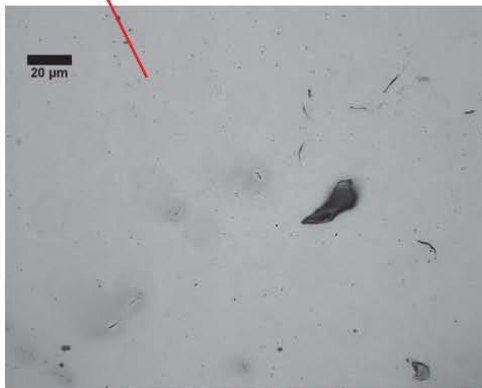
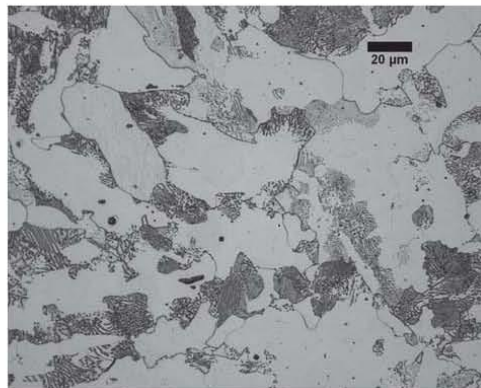
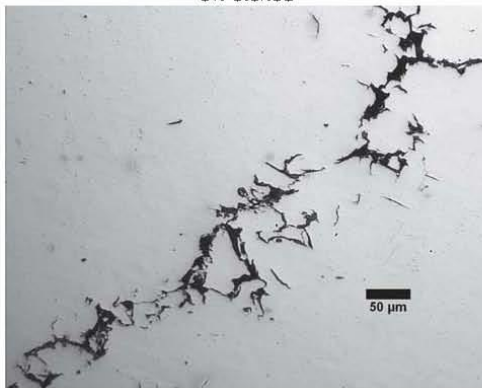
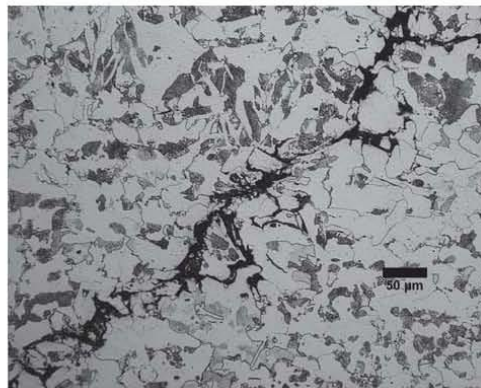
Figure 25

Area 4 mm from the crack to the left of the crack.
Un-etched

Same as at left. Etched

Area near the tip of the crack. Un-etched

HTHA micro-fissures and decarburization were observed within the heat affected zone (HAZ) of weld seam CS-4 (referenced as CW-4 above) of E-6600B (reference 7).
