If you go through the attached Incident Investigation (all references related to vessel and its company is intentionally omitted) you will see that the fire caused by shore fault.

M/T [REDACTED] before the Incident at Huelva Spain.

INVESTIGATION REPORT

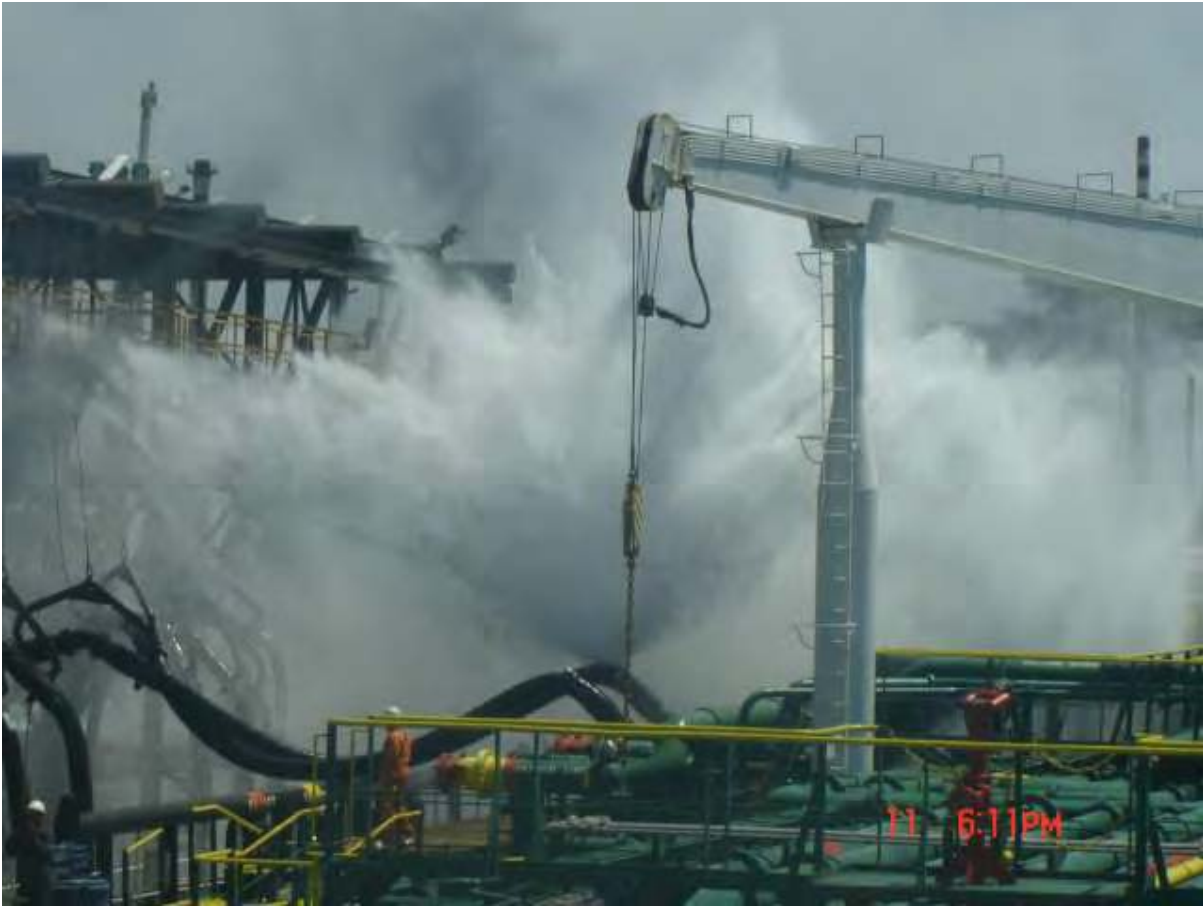
Phot

ograph 1 Leak from hose prior to fire.

Upon hearing of the leak over the radio, [REDACTED] went to the port side of the accommodation and saw a large spray coming from the transfer hose. (See Photo above) [REDACTED] initially saw what he classified as a small leak in the hose as he looked from the Cargo Control Room Window. He went to the deck, opened the valve to the slop tank and attempted to start the Wilden pump before the subsequent fire forced him to retreat.

From the photos above, it is quite clear that the cargo leak occurred in the flexible portion of the transfer hose, adjacent to its connection with Cargo Line no.1 of the vessel's manifold

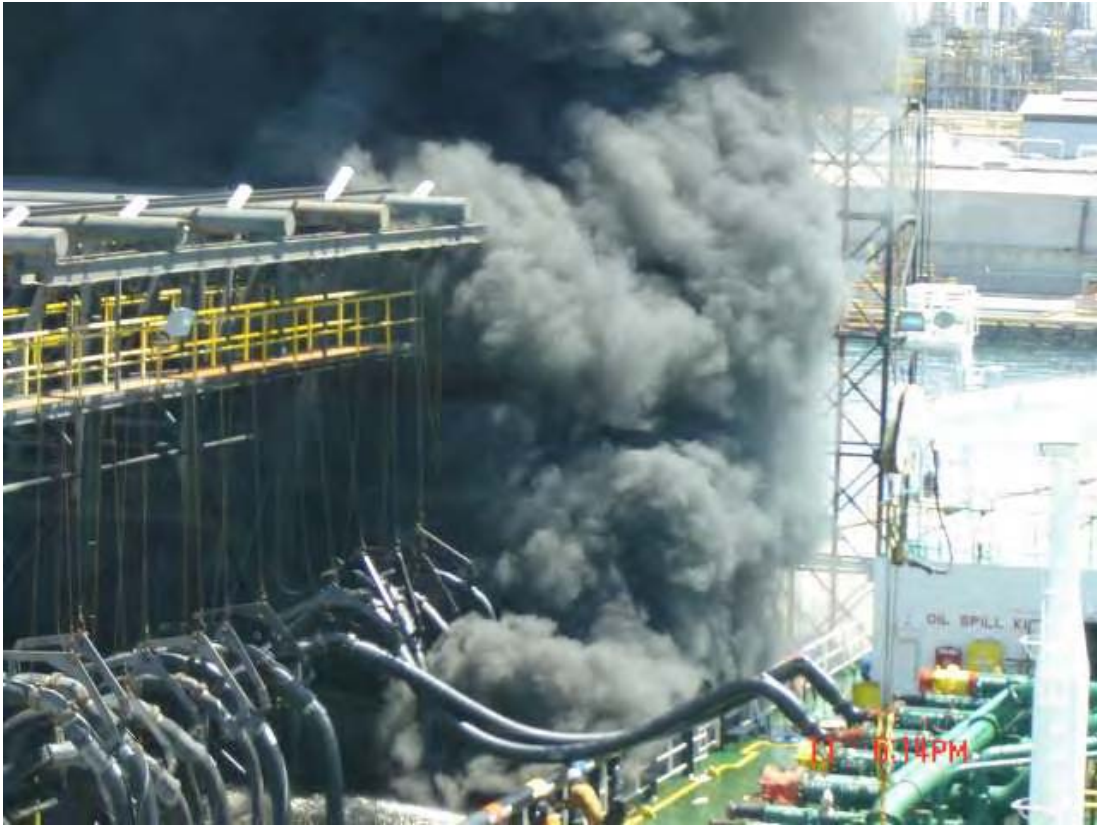
Fire burning on jetty. Note vessel's fire stream directed upon jetty in bottom of photograph

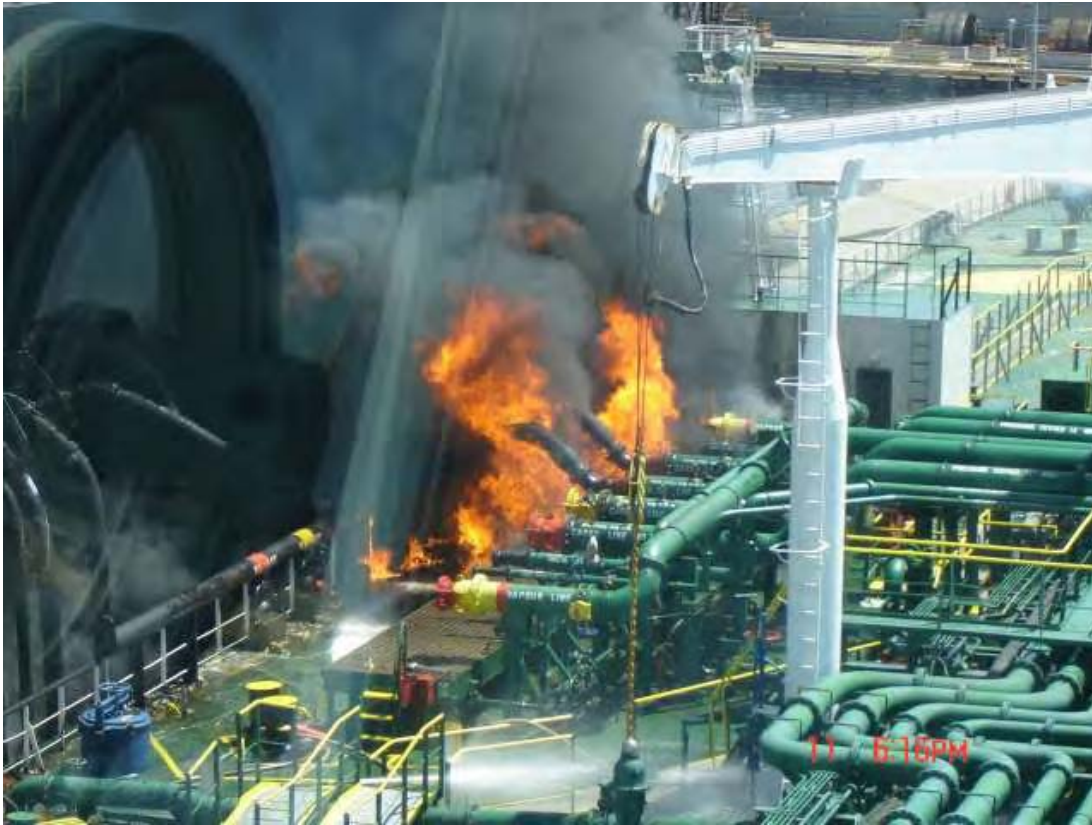
Fire burning on jetty and vessel

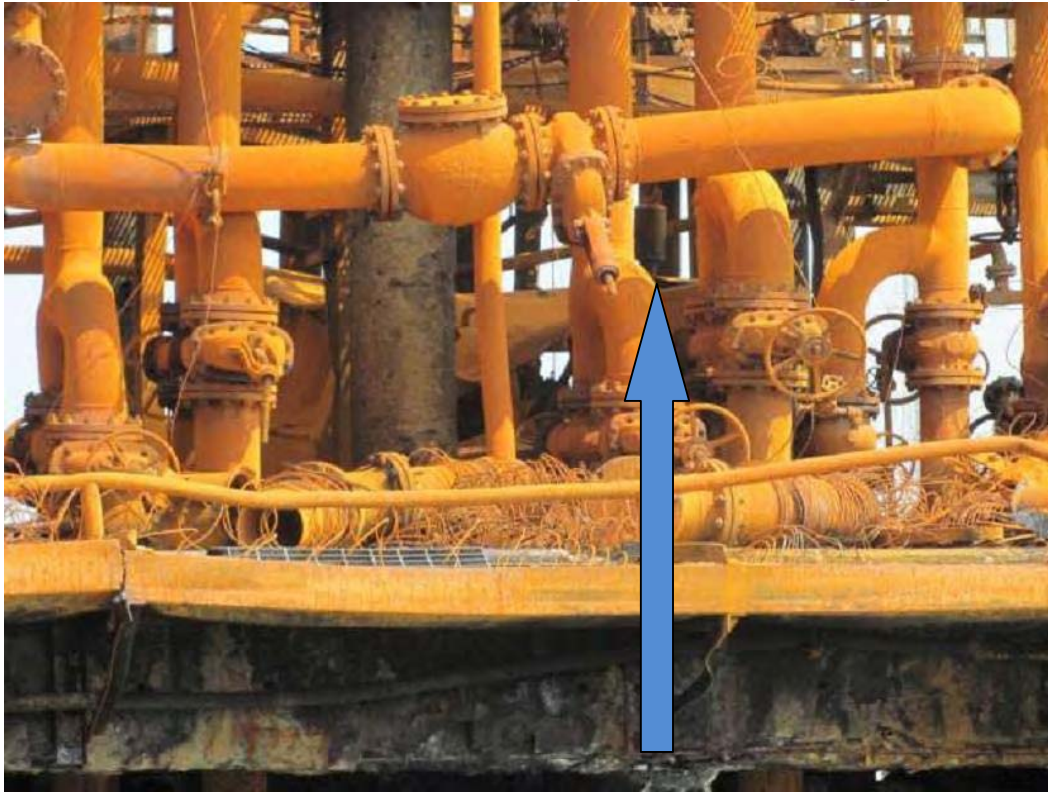
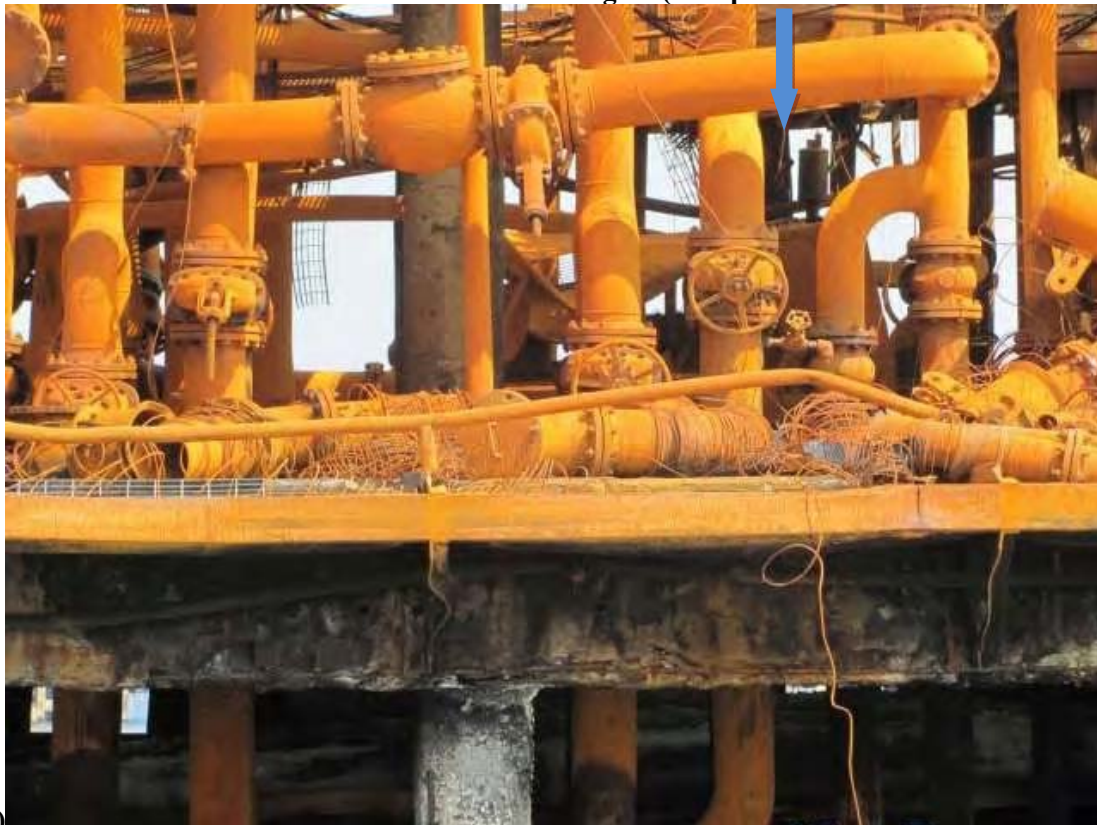
Several individuals stated that [REDACTED] had installed a temporary diesel powered air compressor on the jetty. This could not be ascertained from the view I was permitted. (See Photographs below)

Preccence of Internal Combustion Engine (Compressor at the

pier)

While the available evidence does not permit a conclusion as to the source of ignition, hearsay evidence suggests that the fire may have been started by an operating Diesel powered air compressor.

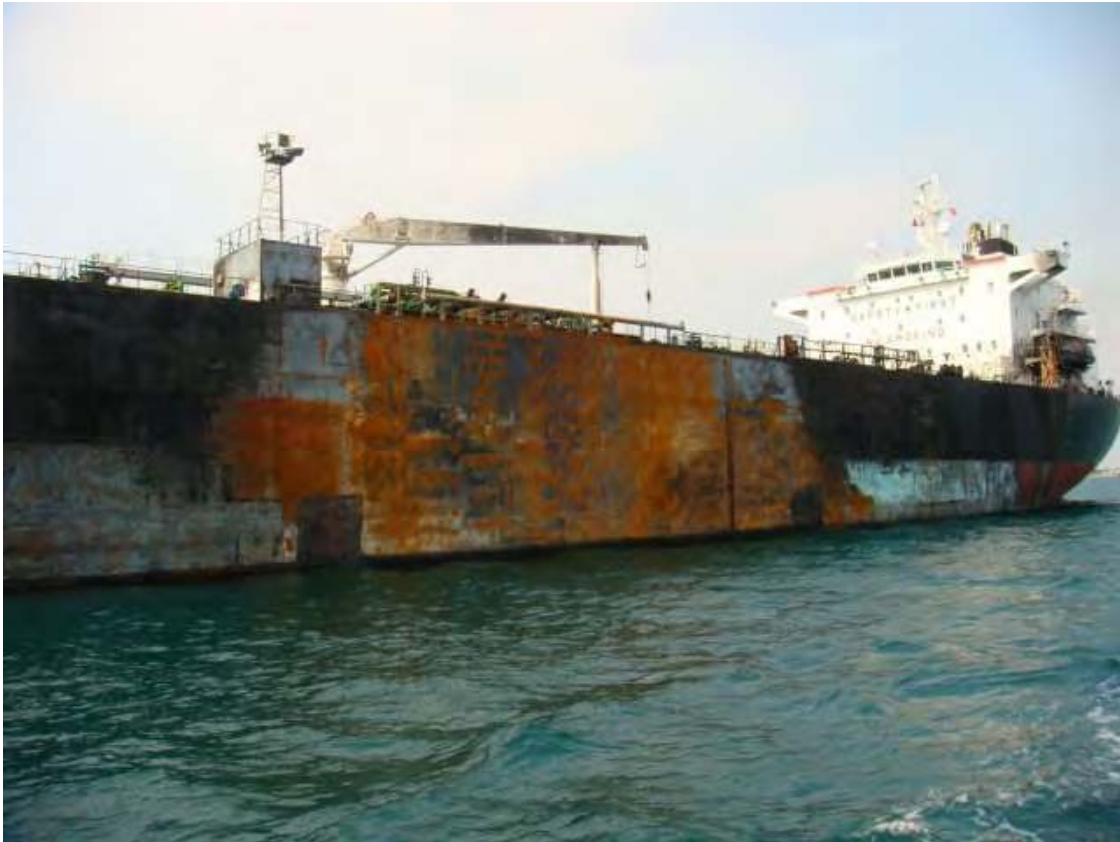
Damage to side shell of vessel

The vessel suffered external fire attack to its starboard side shell and deck. Scorching of the deck coating was evident from the front of the deck house to just aft of the midpoint of the manifold. From the exterior, there was no obvious distortion of the deck. The port side deck house, which contained cargo samples, and crane were also seriously affected by the blaze. Fire affects to the accommodation were minor, although the

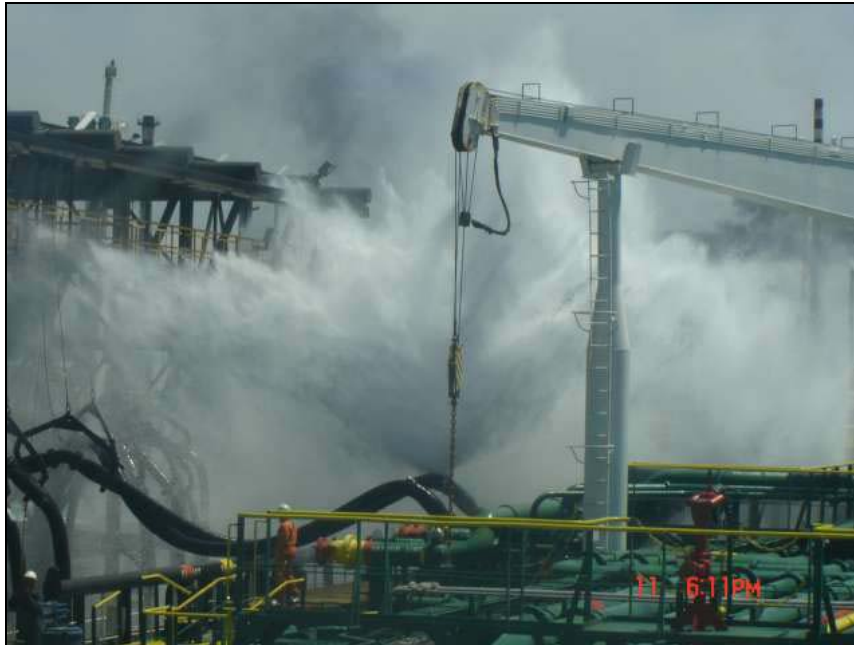
Ship's oil pollution team was activated and pumpman opened immediately the main deck dump valve to the slop (P) tank in order to collect the cargo of JET A1 which was already spilled on deck port side. Besides, he also attempted to start the wilden pump in order to prevent overboard pollution.

Photograph 1 :Burst of cargo hose before fire.

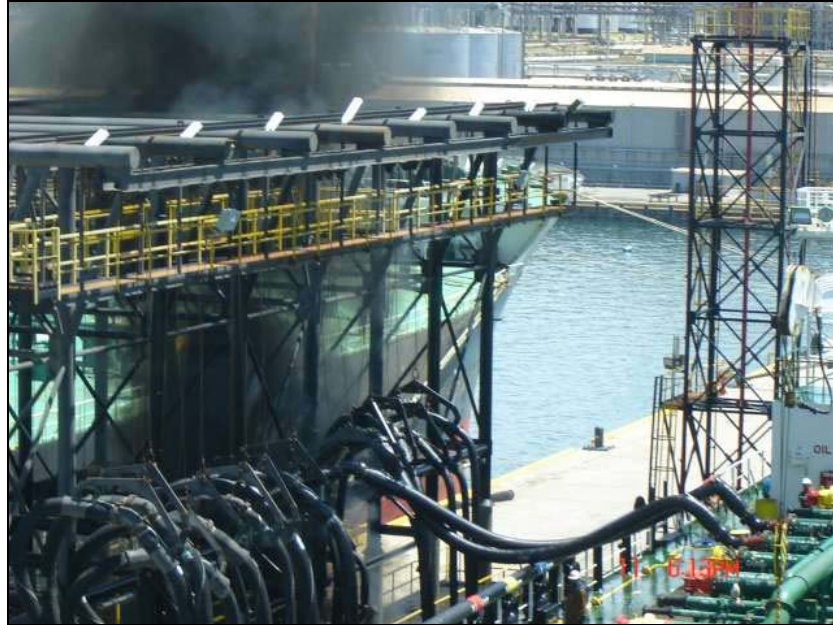
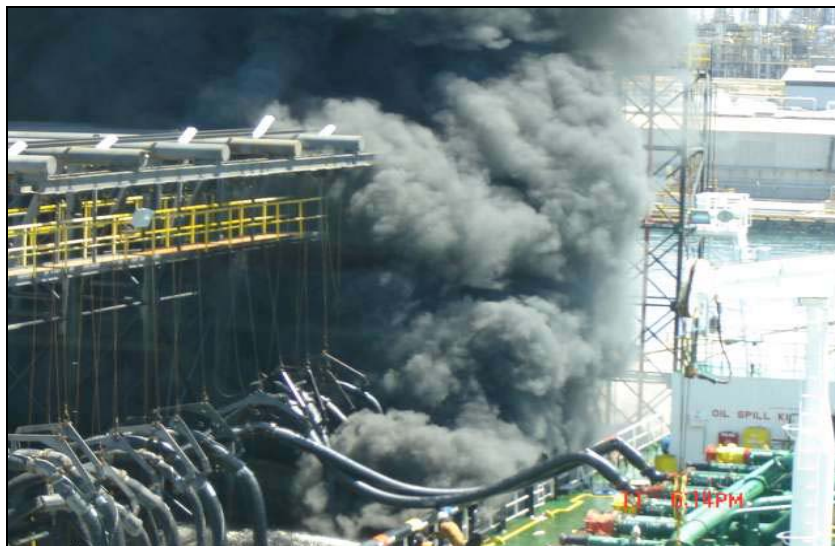
Fire burning on jetty. Note vessel's fire stream directed upon jetty in bottom of photograph

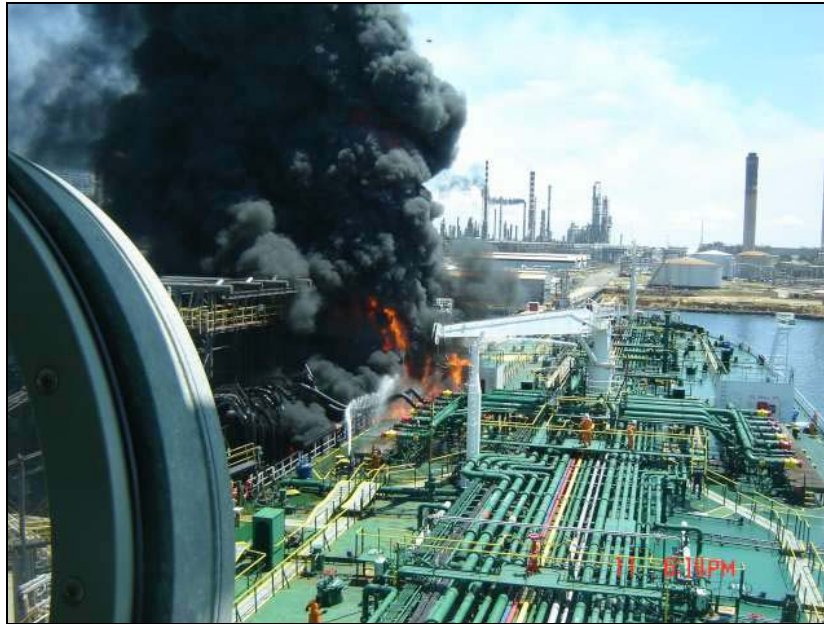
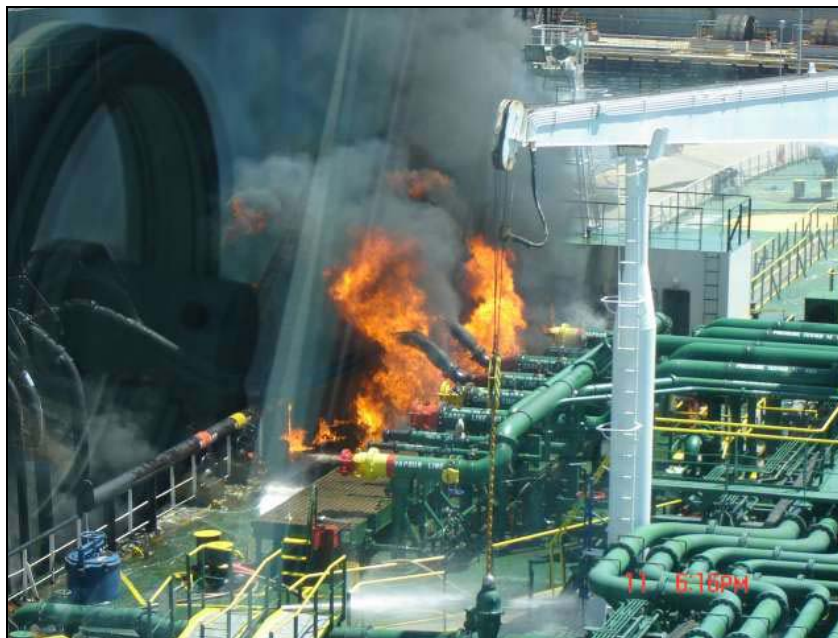
Fire burning on jetty and vessel

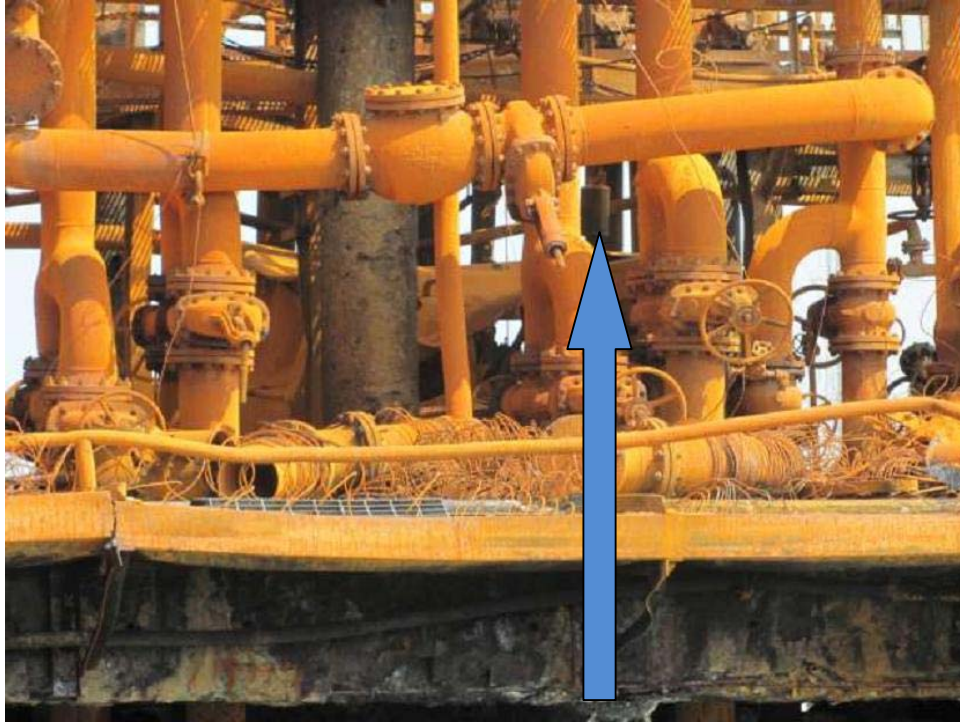
Presence of Internal Combustion Engine Compressor behind the pipes on the jetty

Indeed a diesel powered air compressor has been found in the pier after the incident.

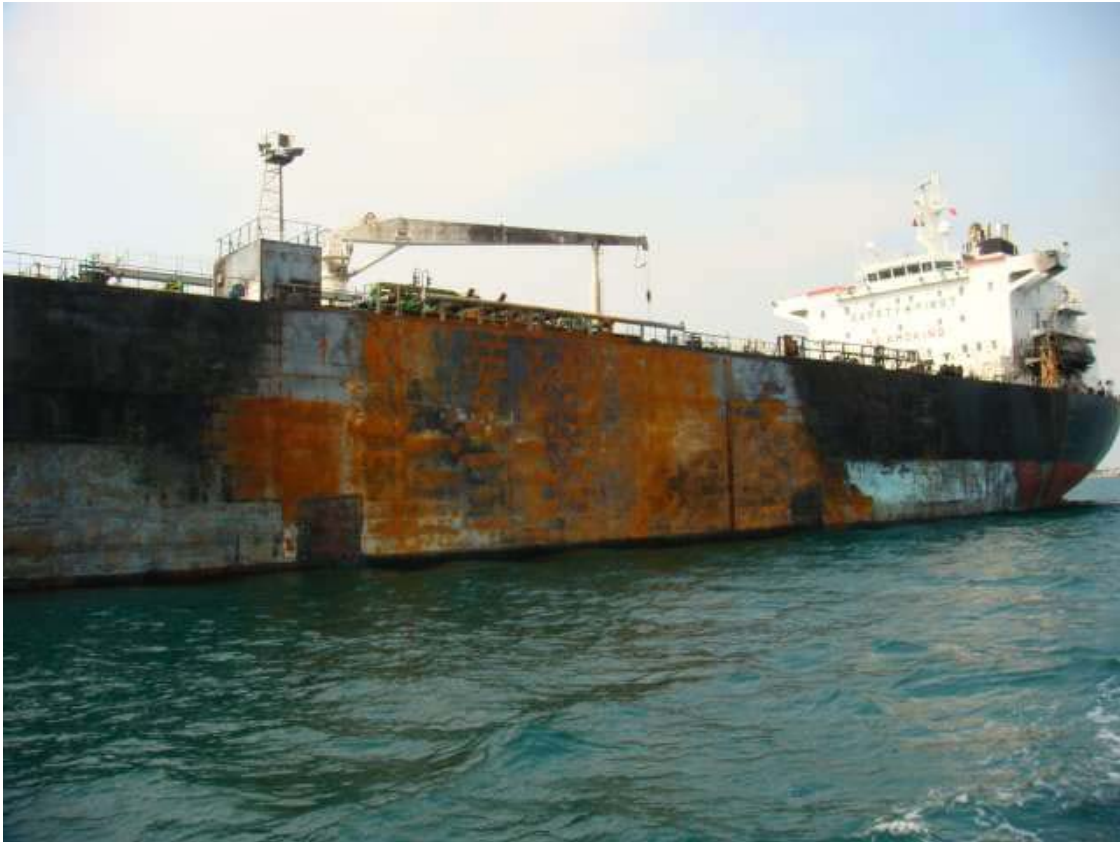
Damage to side shell of vessel

The vessel suffered from the fire to her port side shell and main deck. Scorching of the deck coating was evident from the front of the deck house to just aft of the midpoint of the manifold. From the exterior, there was no obvious distortion of the deck. The port side deck house and ship's crane were also seriously affected by the fire blaze. All that remained from the terminal cargo hoses was the flanges and the
