Investigation report

Report	
Report title Loss of well barriers in connection with wireline operation on the Draugen facility.	Activity number 005093016

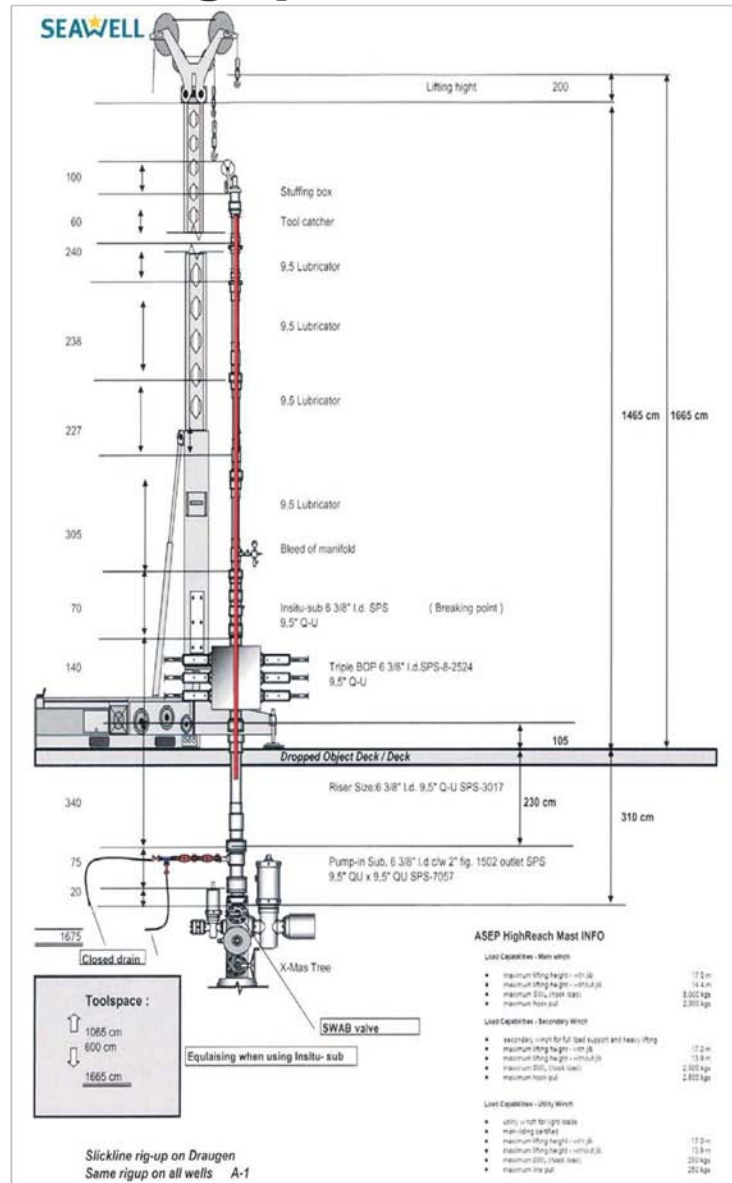
W/L rig-up on well 6407/9-A-01

Length of
W/L-
toolstring:

13,83 meter

Available length
from stuffing-box to
top of BOP:

11,40 meter

- risk factors were not sufficiently highlighted in the company's well intervention programme
- the plan was to use a toolstring which was longer than the available lubricator length, which led to the toolstring blocking the BOP
