Investigation report

Report title Gas leak on Gullfaks B 4 December 2010	Activity number 001050014
--	------------------------------

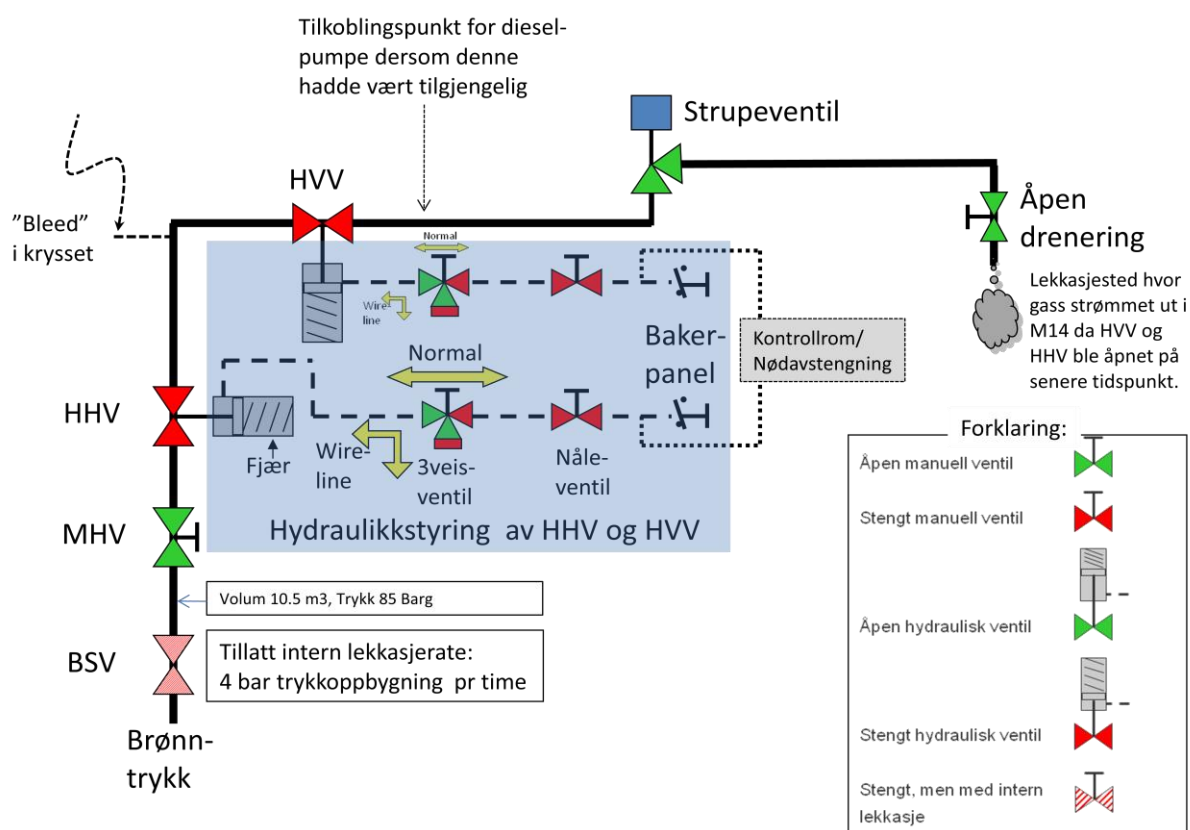
Figure 1 shows the valve positions before resetting and readying for operation. The three-way valves on the hydraulic system for both the HMV and HWV were placed at that time in wireline mode¹. The needle valves on the hydraulic system were also closed. This ensured that the HMV and HWV were locked in the closed position during the maintenance work. As mentioned above, the process technicians had to open the HWV in order to conduct the leak test. The HMV did not need to be opened, but the Baker panel supplying hydraulics for opening HMV and HWV has a built-in interlock which means that the opening signal for the HWV cannot be given until an opening signal has been given for the HMV. Two methods are available for ensuring that the HMV does not actually open at the signal from the Baker panel. One is to keep the three-way valve on the HMV in wireline mode, and the other is to keep the needle valves closed. (These can also be combined.)

Figure 1 Valve positions for resetting and preparing for operation (figure based on Statoil's figure)

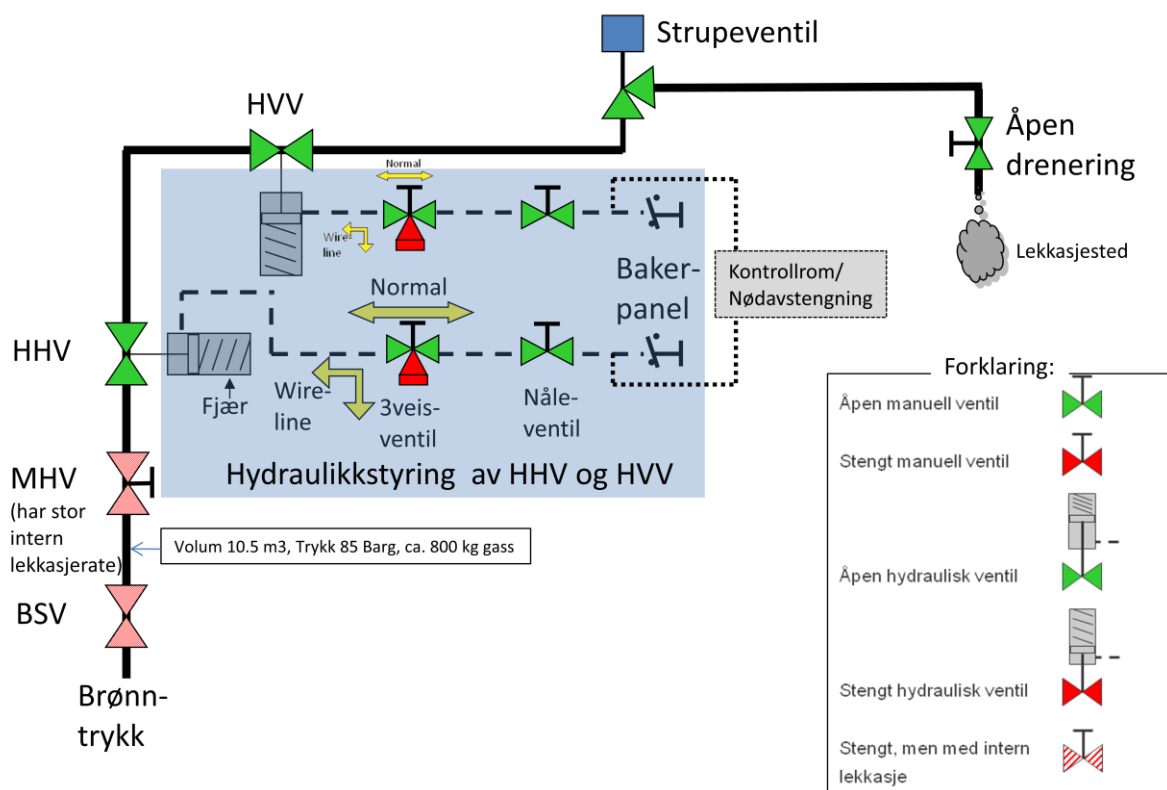
Hydraulic pressure from the Baker panel was released up to the closed needle valves. To open the HMV and HWV, both three-way valves were placed in normal mode. The process technician then opened the needle valves for both the HMV and the HWV, which resulted in these two ESD valves going from closed to open position. The sequence of events and timing for opening the needle valves for the HMV and the HWV is somewhat unclear. Opening both the HMV and the HWV allowed gas to flow through the leaky MMV and past the Xmas tree. That caused gas to leak from an open drainage point. The time was then about 14.00. Figure 2 shows valve positions when the leak started.

Figure 2 Valve positions when the leak started

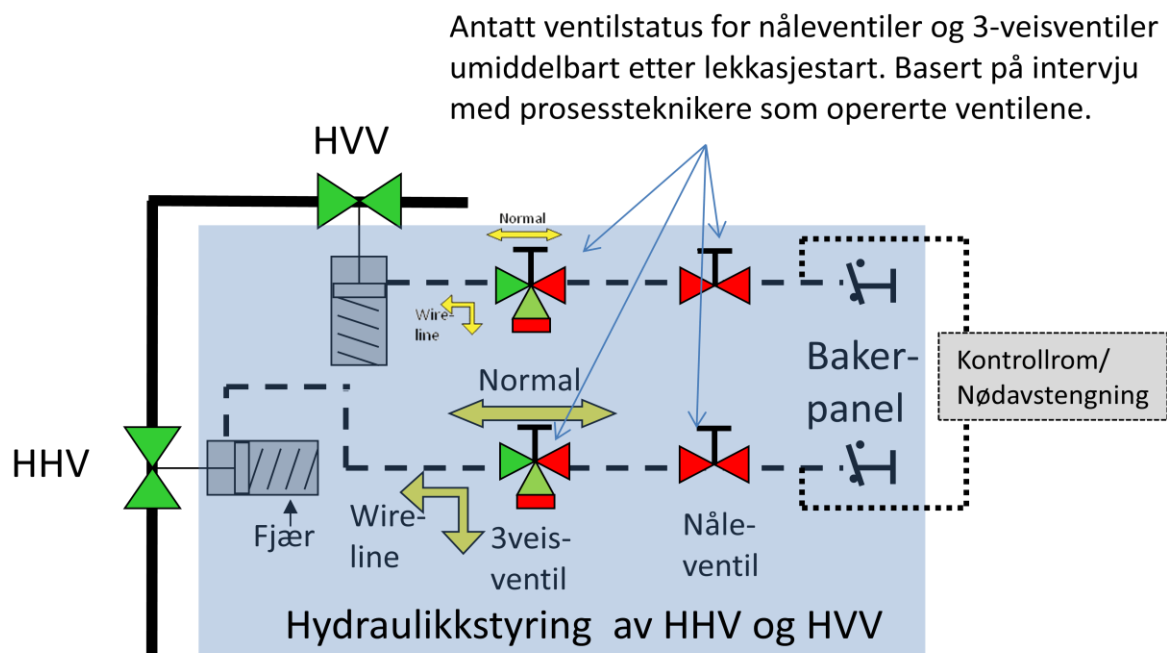
The area technician realised immediately that a leak had occurred somewhere, but did not know whether it involved injection water or hydrocarbons. In an attempt to stop the leak, the needle valves were closed. This meant that the HWV and the HMV were locked in the open position because the hydraulic pressure keeping the valves open could not be bled off from the control room or through automatic ESD. As a result, the leak lasted about an hour. If the needle valves had not been closed, the HMV and the HMV would have responded to the ESD signal and the leak halted within one-two minutes. One explanation for shutting the needle valves could be the level of stress experienced by the process technician in the circumstances, and the fact that the leak had begun precisely after the needle valves were opened. He sought to reverse this by re-closing the valves. It is uncertain whether the three-way valve was operated at this time. The status of the three-way valve is of no significance as long as the needle valves are closed and the end piece of the hydraulic connector was plugged.

Figure 3 Estimated status of the needle valves and three-way valves immediately after the leak began

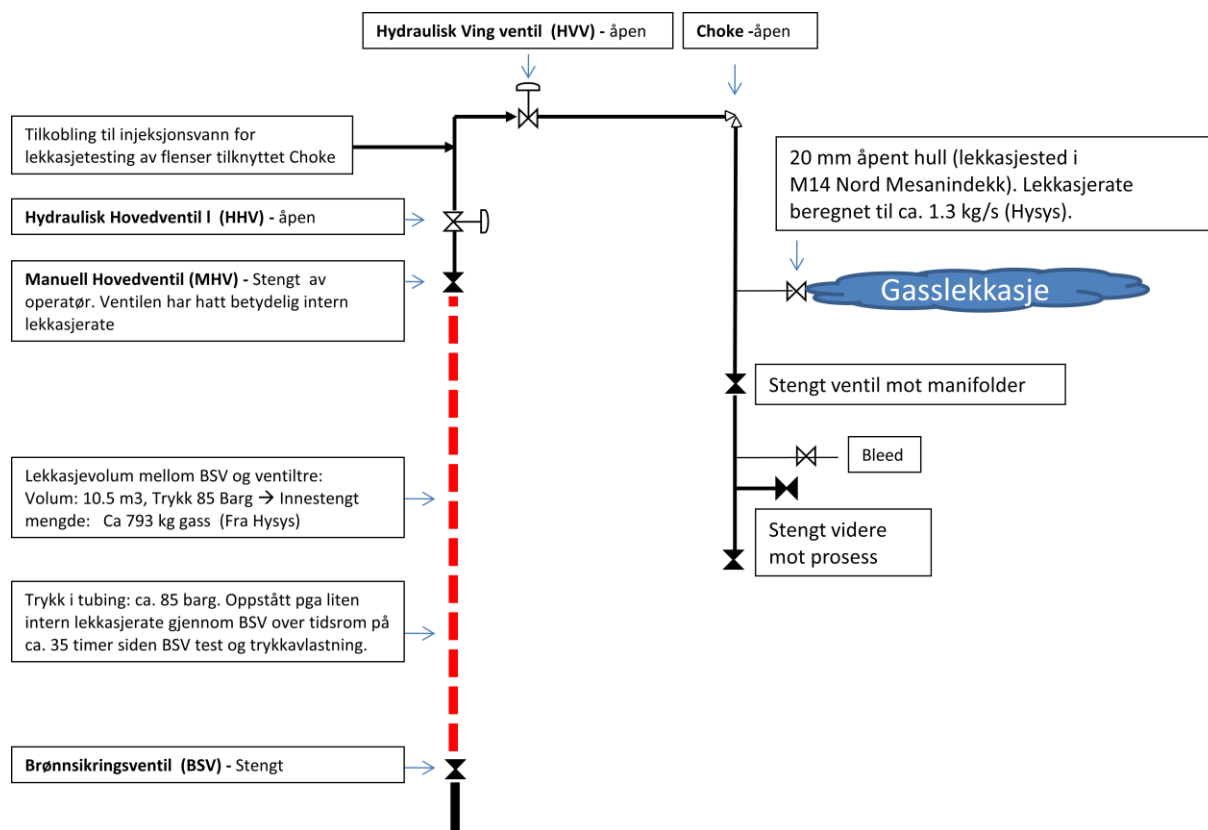
Figure 4 below illustrates valve positions at the start of the leak, the available leak volume (dotted line) and leak site.

Figure 4 Valve positions at the start of the leak, the available leak volume (dotted line) and leak site

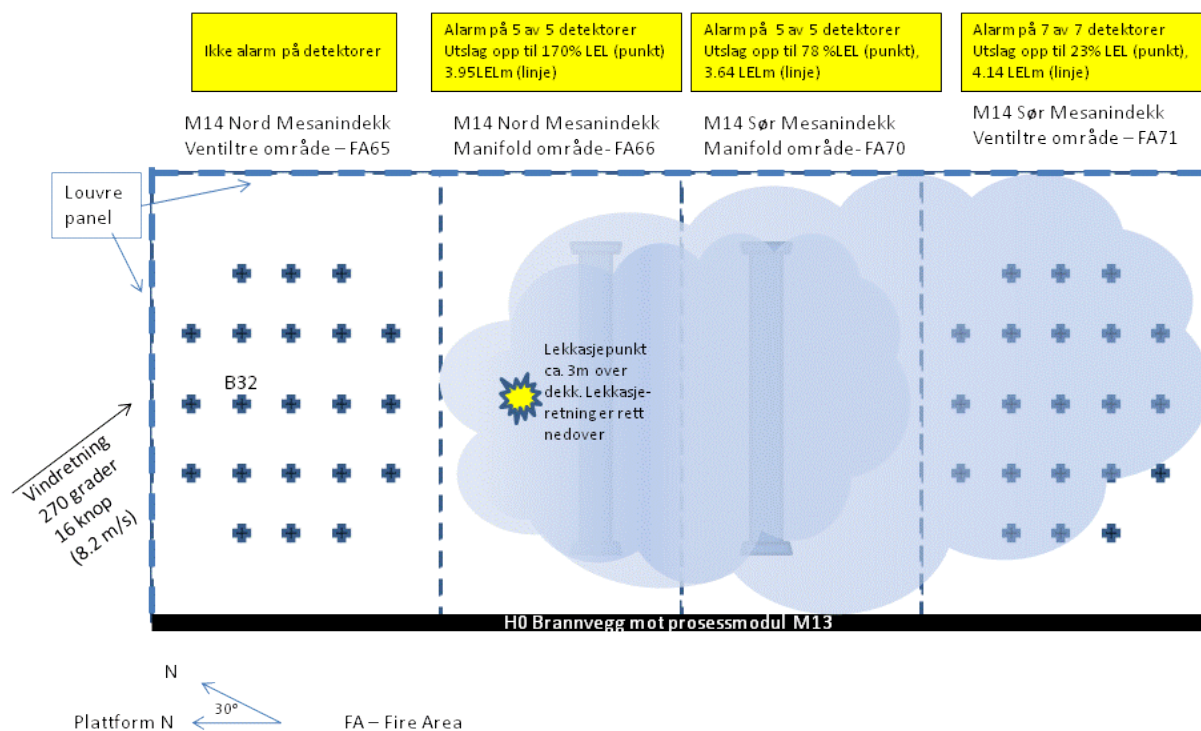
Figure 5 and Figure 6 below show the fire and gas detection areas in M14 mezzanine deck and M14 main deck (seen from above) and include a rough illustration of the gas cloud based on gas detector readings. The highest gas concentration was in area FA66, which includes the leak site. The illustrated gas cloud does not show detailed information about concentrations and form/spreading. The mezzanine deck comprises gratings at its northern and southern ends and solid flooring in the central third.

Figure 5 M14 mezzanine deck

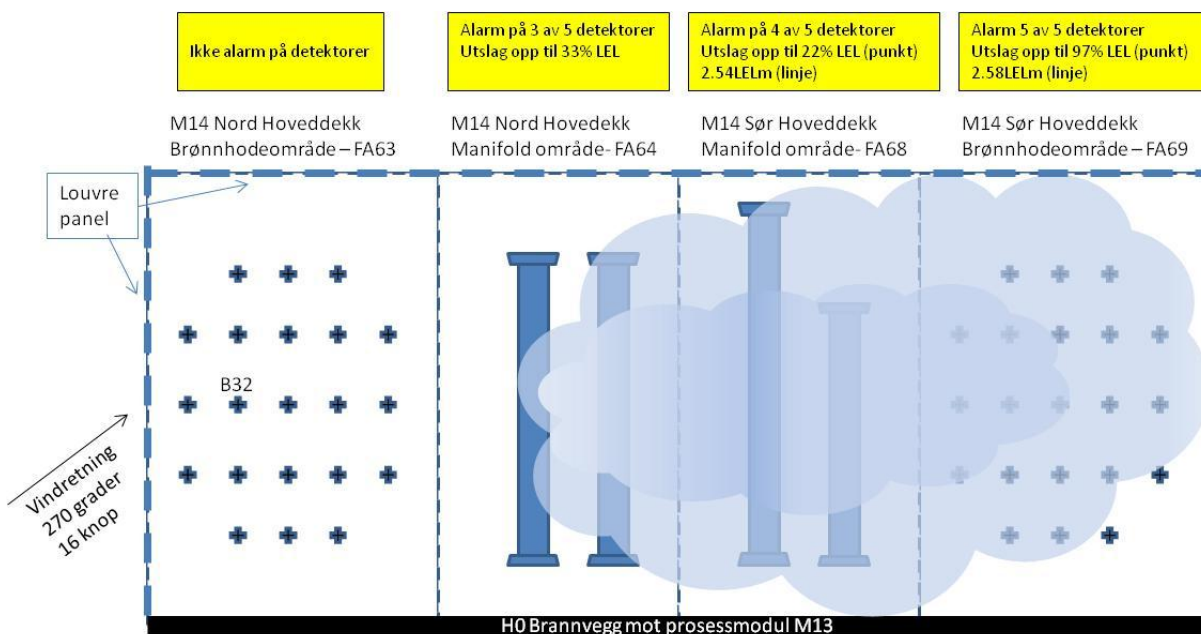
Figure 6 M14 Main deck

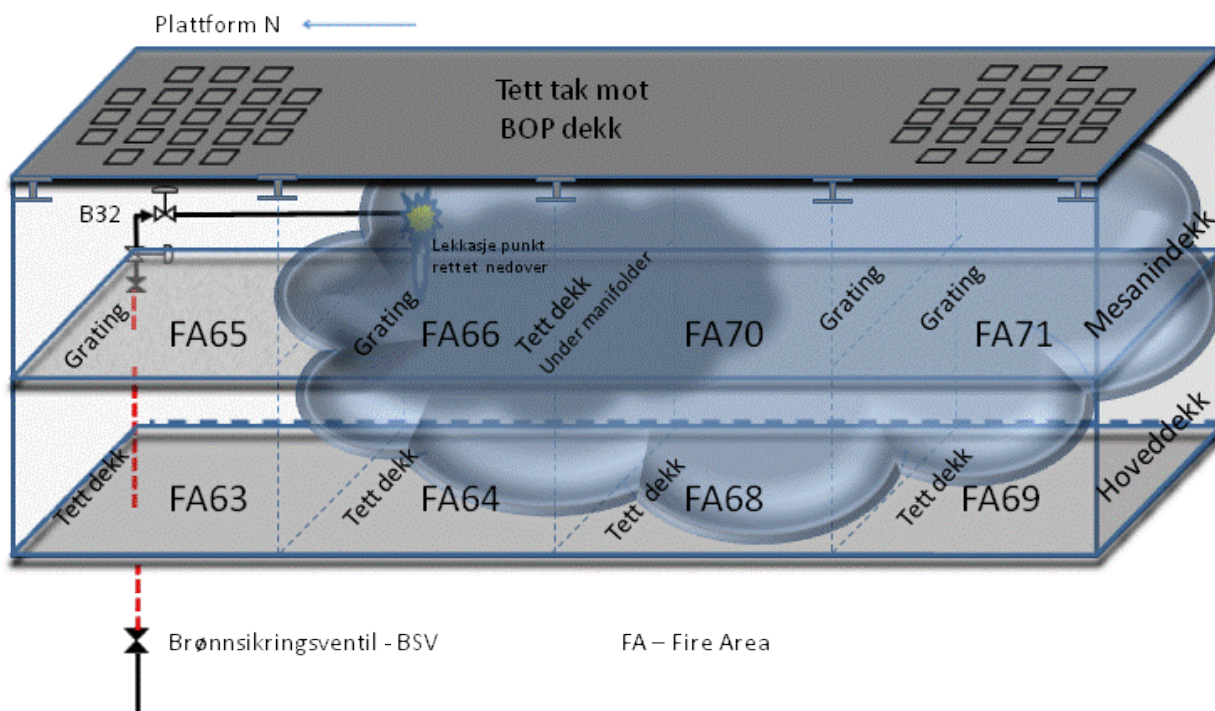
Figure 7 below shows the fire and gas detection areas in M14 (seen through the firewall from M13) and includes a rough illustration of the leak site, leak direction and the gas cloud in the module, based on gas detector readings. The highest gas concentration was in the FA66 area, which includes the leak site. As mentioned above, the mezzanine deck comprises gratings at the northern and southern ends and solid flooring in the central third. The main and BOP decks (the roof of M14) have solid flooring

Figure 7 shows fire and gas detection areas in M14 (seen through the firewall from M13)

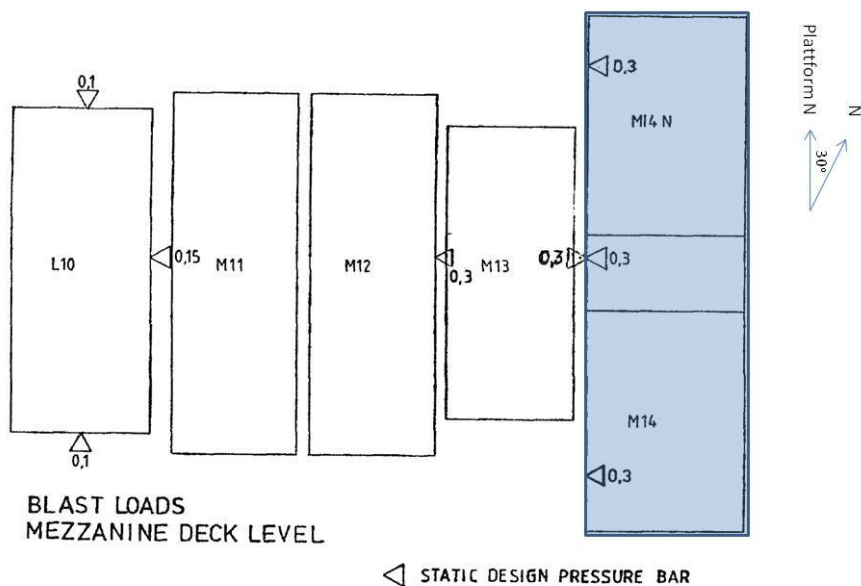
Figure 8 below shows the static blast loads which the wall between M14 and M13 is designed to withstand. The figure is for the mezzanine deck, but is similar for the main deck.

Figure 8 Static blast load which the wall between M14 and M14 is designed to withstand

According to the design accidental load (DAL) specification for GFB, the H0 firewall between M14 and M13 is designed to withstand an average blast pressure of 0.3 barg for a duration of 0.5 seconds. To prevent damage to the passive fire protection on the wall, the specification states that bending/deflection as a result of an explosion must be within the required tolerances for the fire protection material. The loads in the GFB DAL specification state dimensioning loads in the form of static overpressure. An explosion involves a dynamic pressure development with a short-lived maximum overpressure. The GFB TRA, appendix D – explosion analysis suggests that fire/explosion walls will probably cope with a dynamic pressure considerably higher than the specified static design pressure.

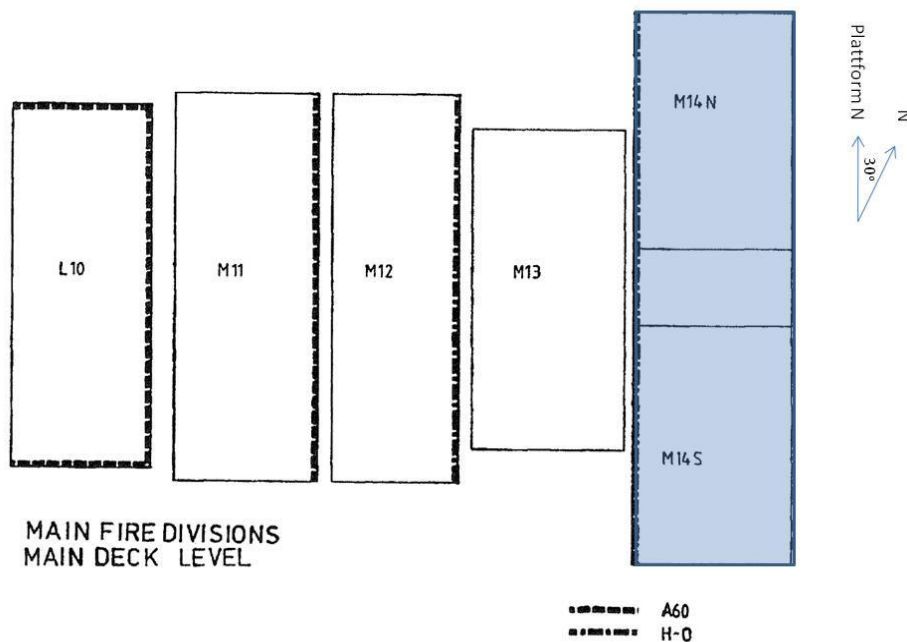
Figure 9 below shows the fire divisions at main deck level. An H0 division separates M14 and M13. The same applies on the mezzanine deck.

Figure 9 Fire divisions at the main deck level

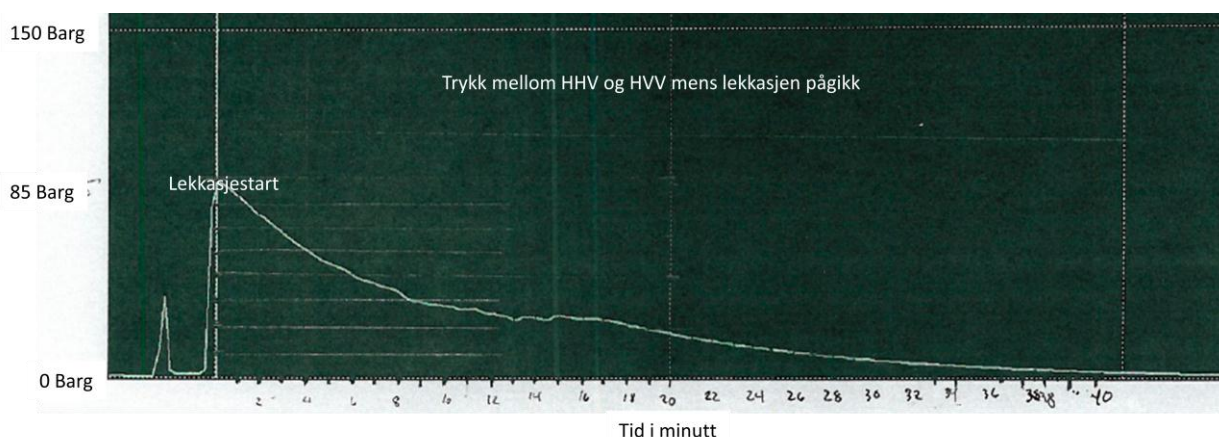
The pressure history of the incident is shown in Figure 11 below. This shows that the pressure between the HMV and the HWV halved in about seven minutes. The form of the pressure reduction curve is rather unusual, but that could be because the leak opening in the MMV was not uniform throughout the course of events, or because of special flow conditions. Based on the detected gas concentrations in FA66, where the leak occurred, the investigation team has assumed that the leak rate had declined considerably from its initial condition after seven to 10 minutes.

Figure 11 Pressure between the HMV and the HMV during the leak period

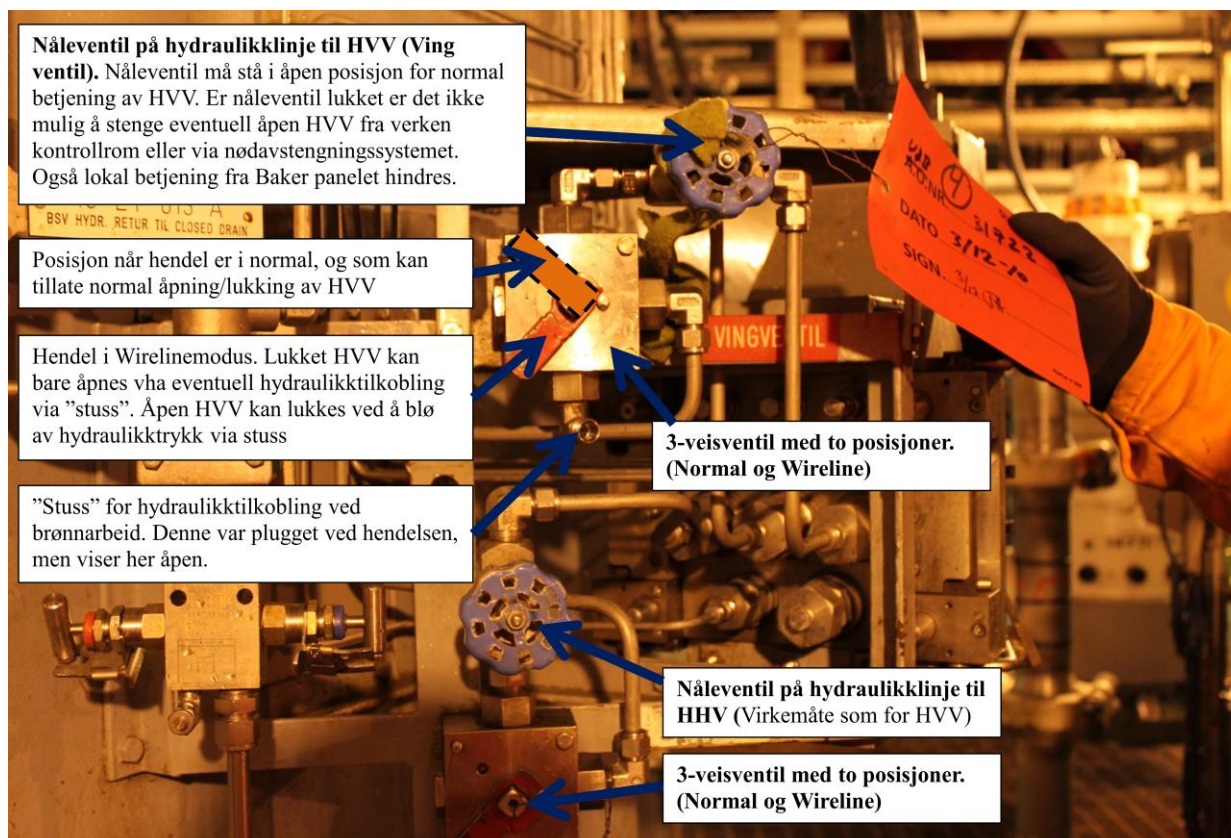
- Needle valves installed on hydraulic lines to well valves are not entered in the P&IDs and are not tagged. The investigation team has not verified whether preventive maintenance programmes exist for these valves.

- No text or labelling in the field provides information that these needle valves can prevent ESD valves closing on signal.

Figure 12 The hydraulic system for the HWV and the HMV on well B-32
