Steam Turbine Failure During Overspeed Test

Eskom Duvha Unit No. 4
9 February 2011

Updated Presentation Rev 2

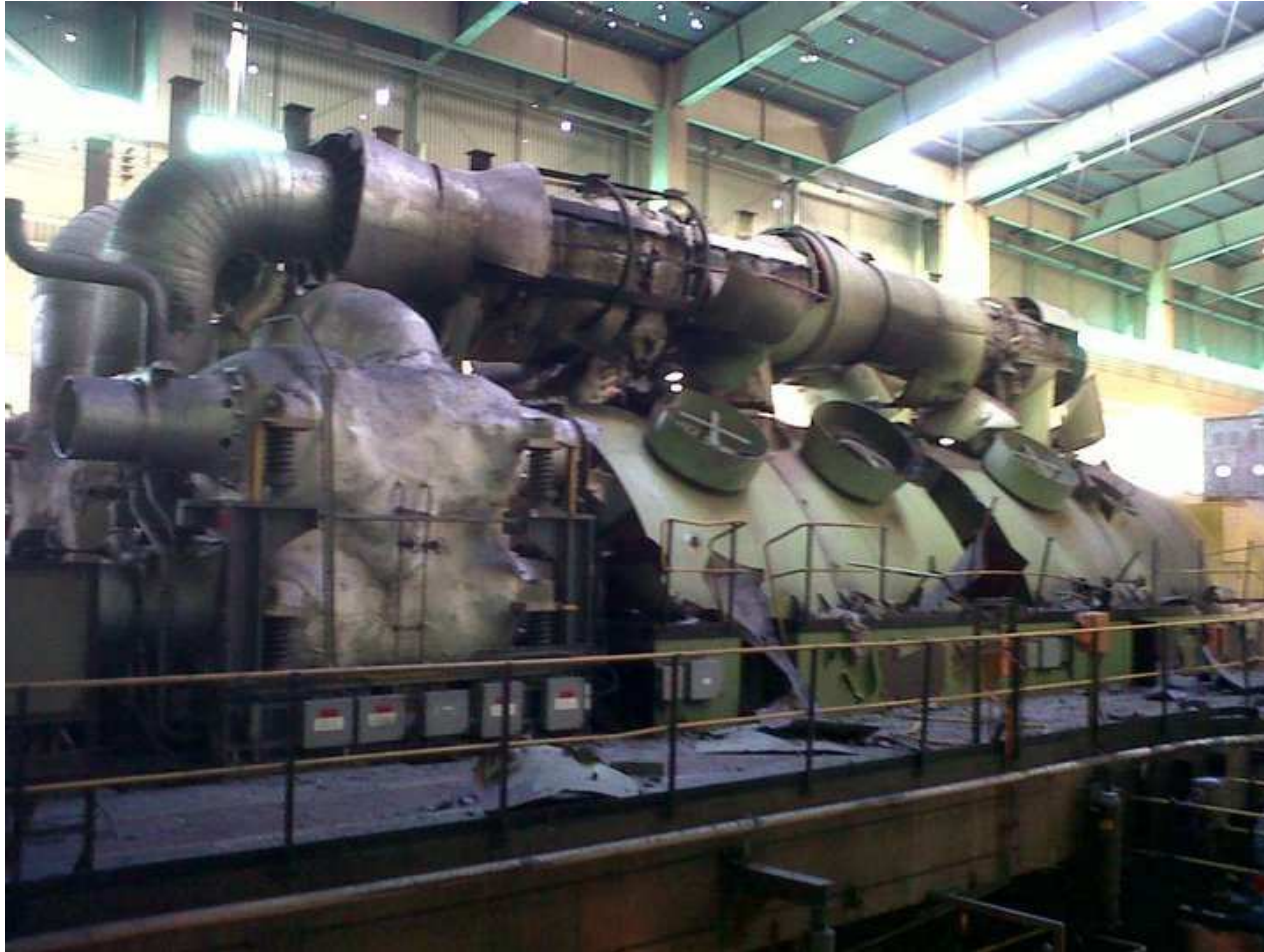
Severe damage to Unit No. 4 after failed overspeed test

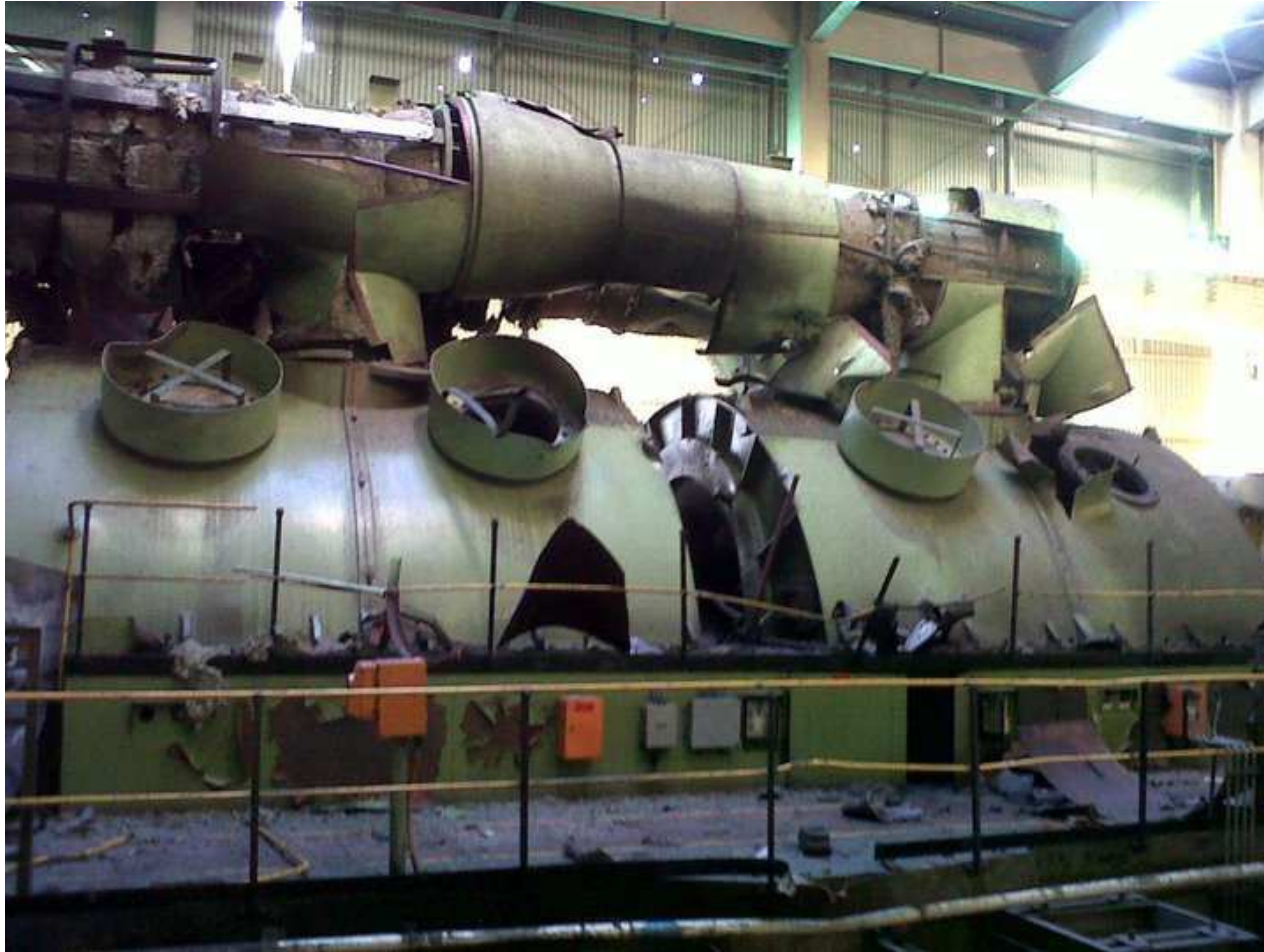
Damage to Low Pressure (LP) Casings and Cross Over Piping

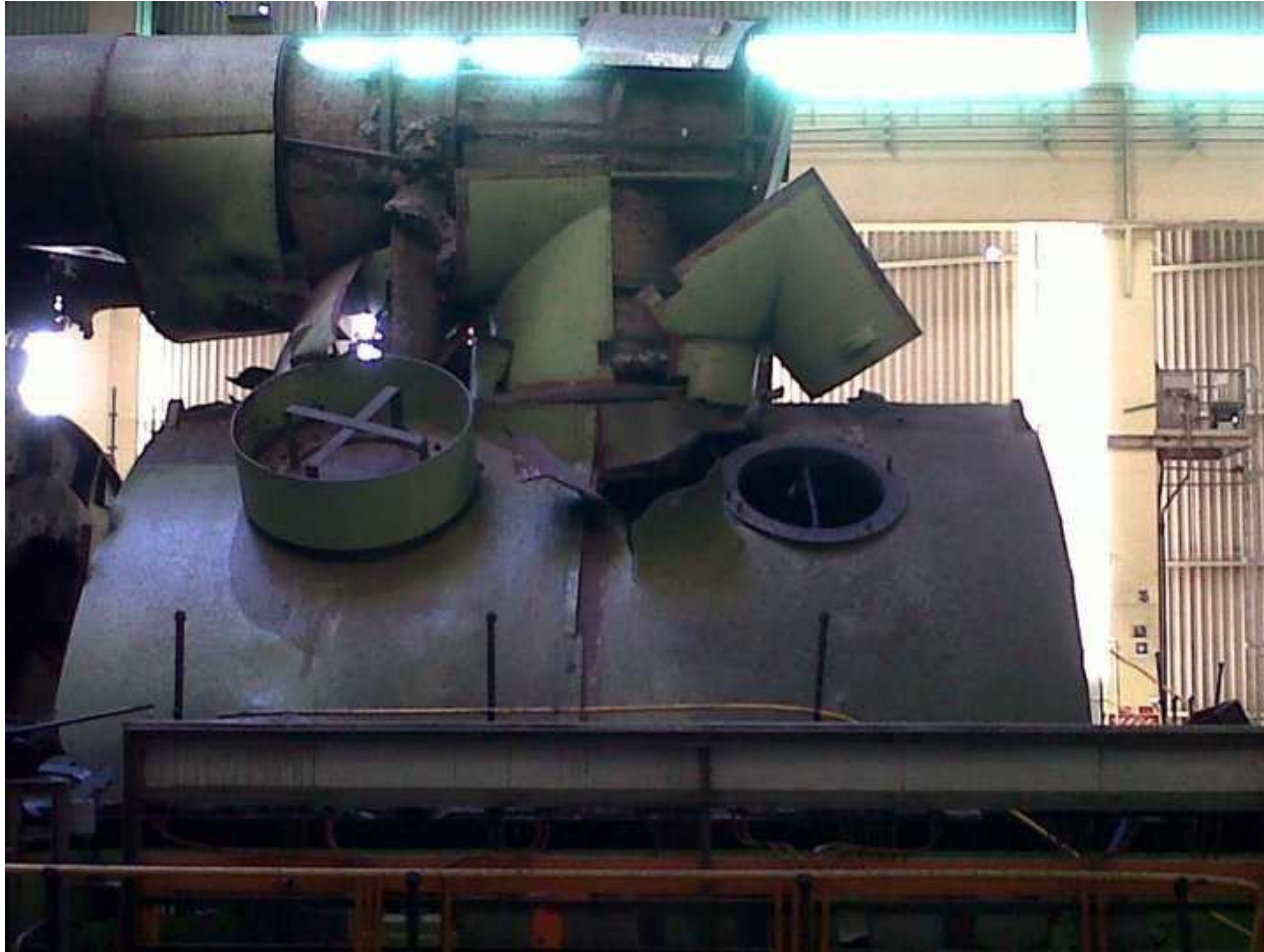
Severe outer casing rupture LP2

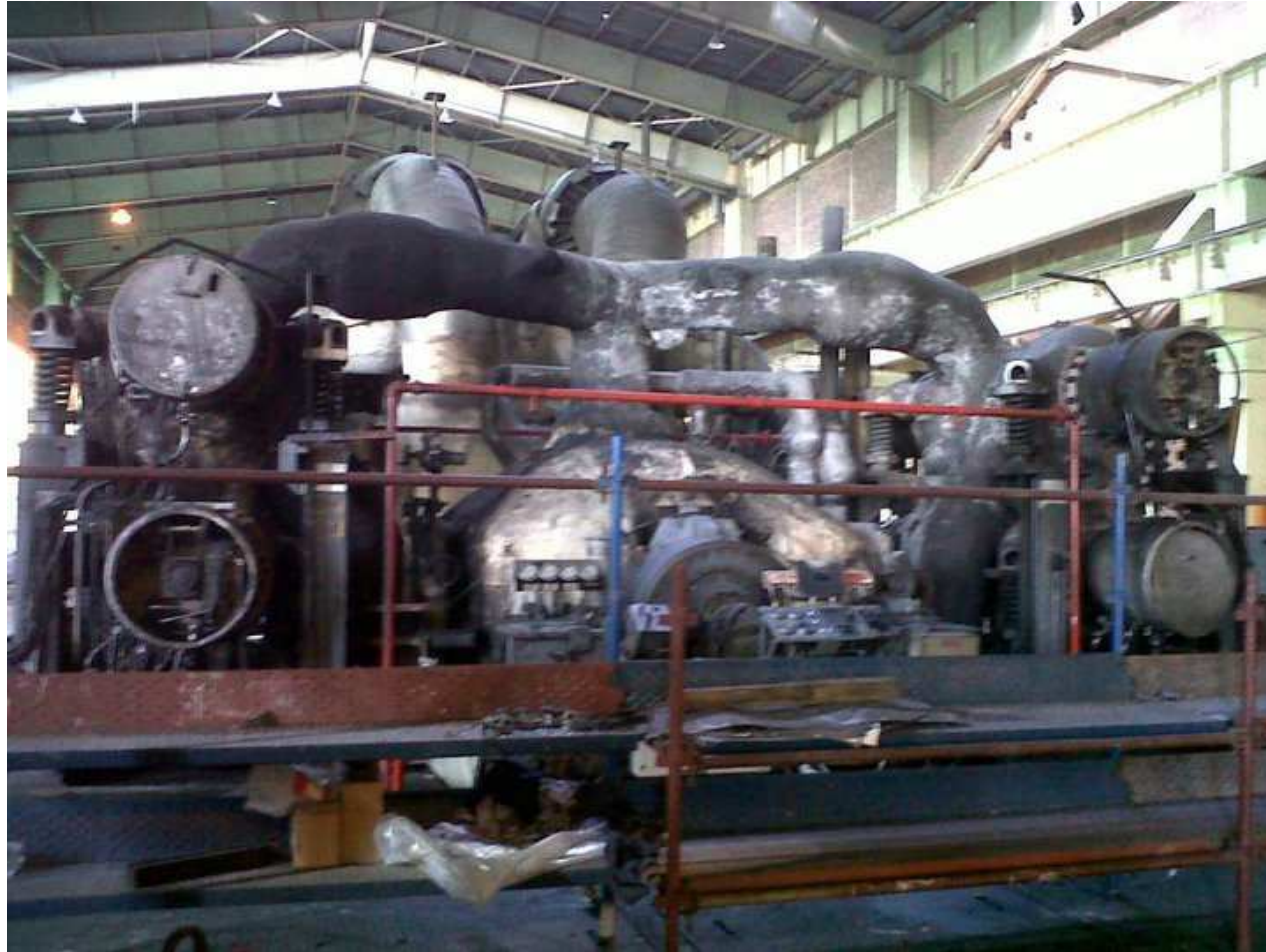
Fire damage at High Pressure (HP) Turbine

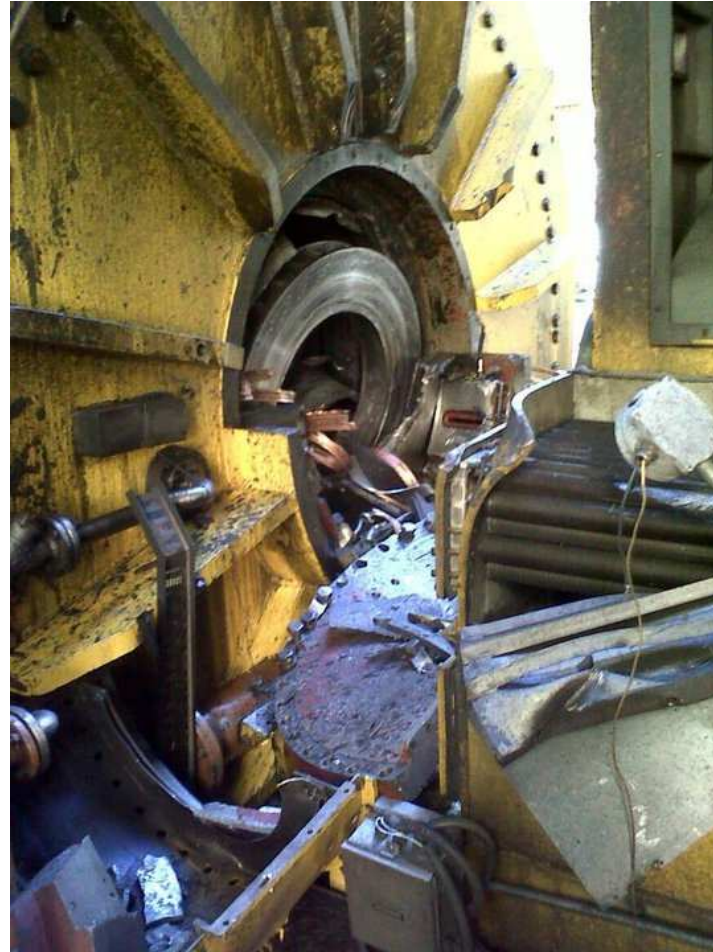
Damage at Generator (left) to Exciter (right) Coupling

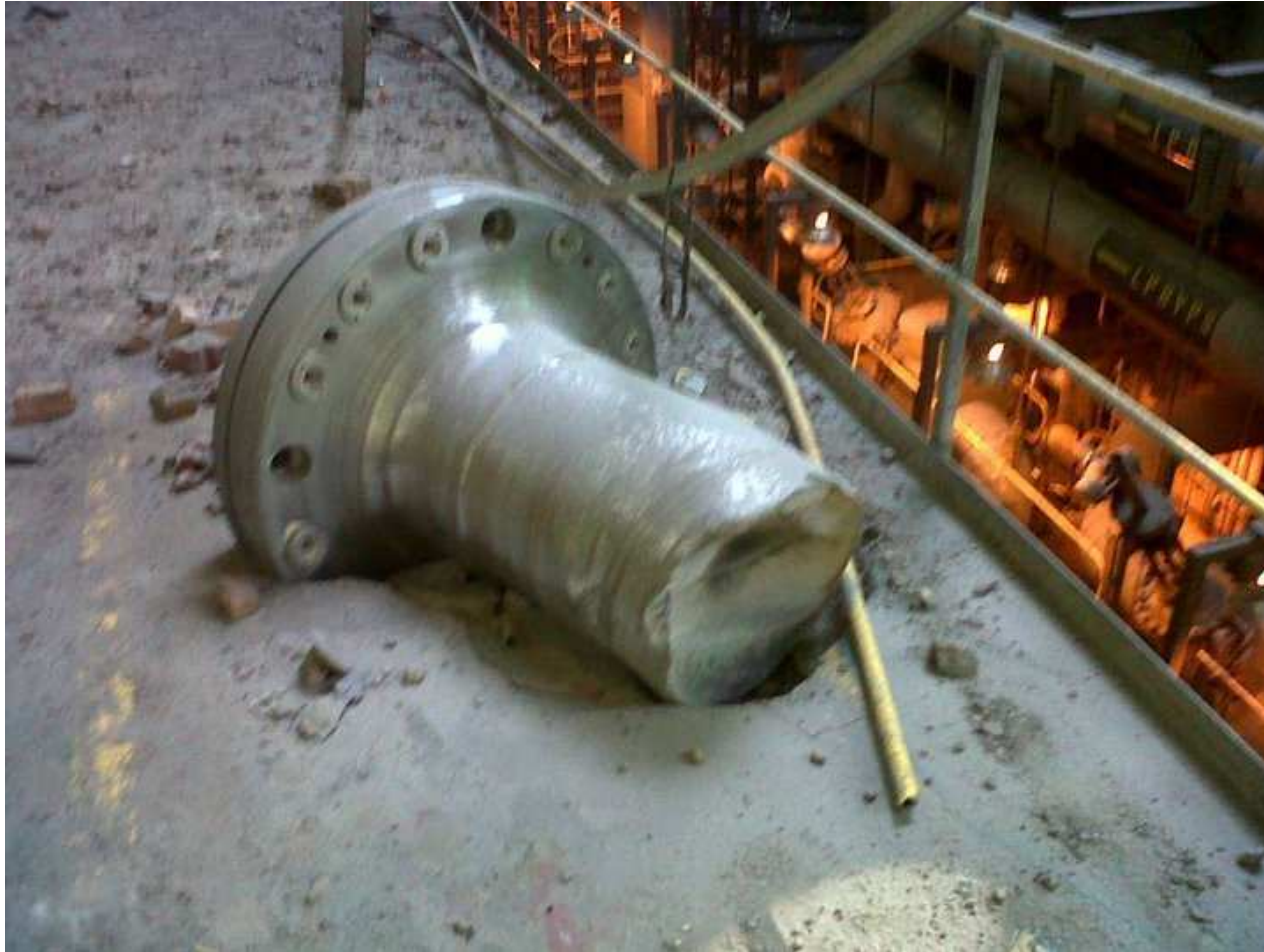
Coupling Shaft thrown from unit

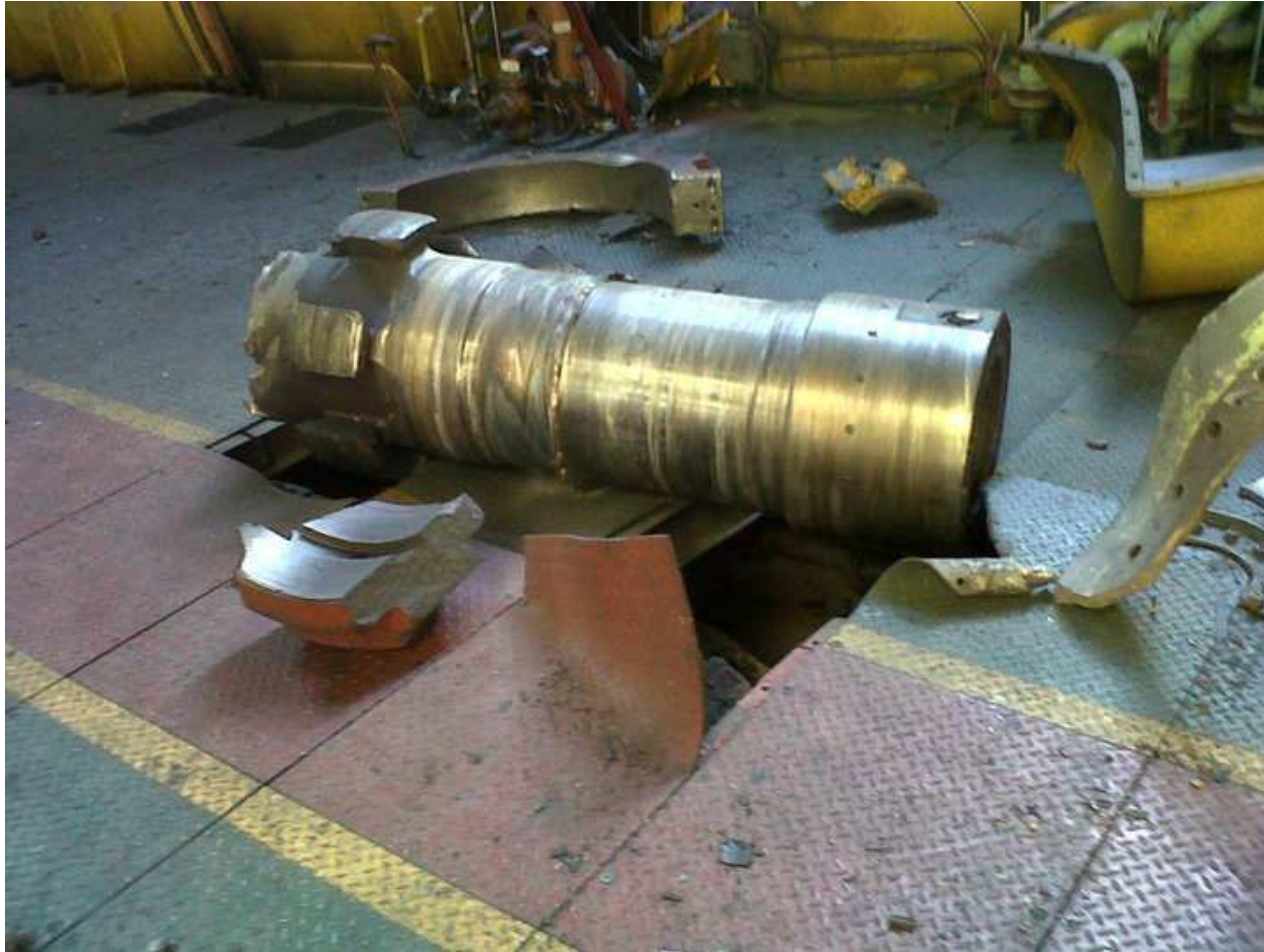
Shaft thrown from unit

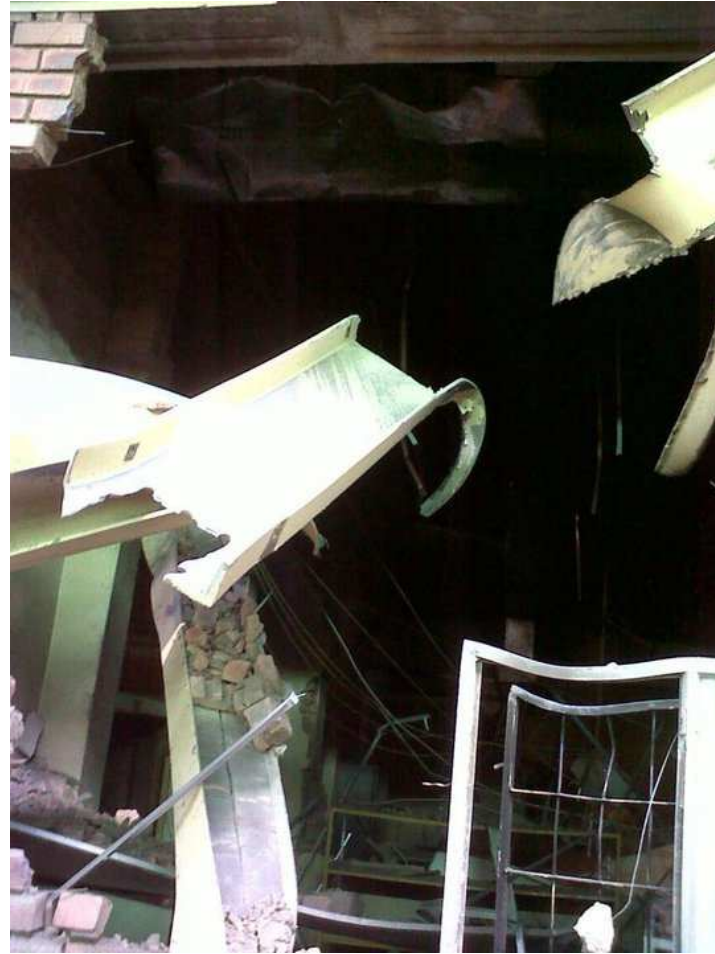
Structural Damage

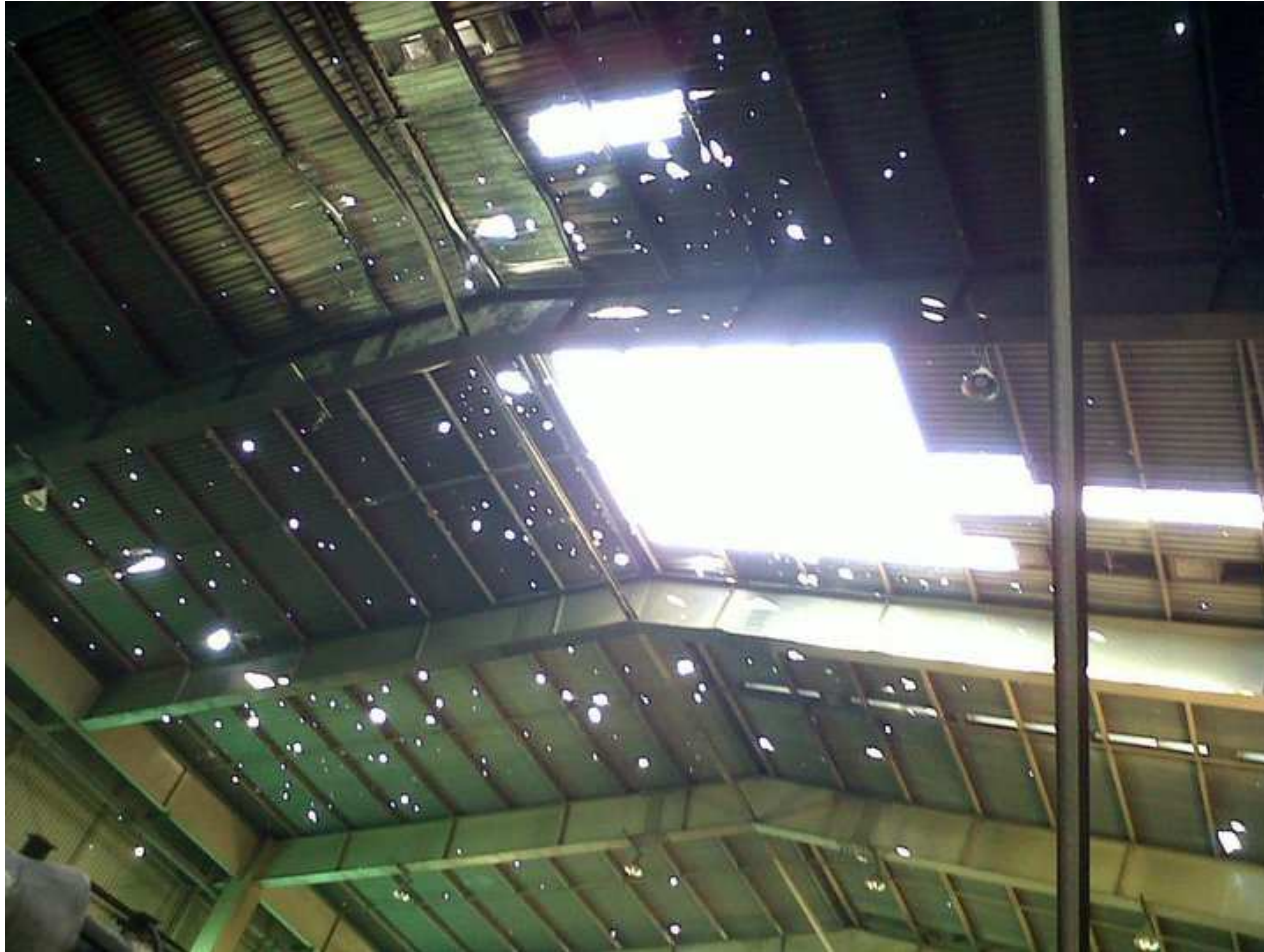
Damage to roof

(20 m above the turbine deck)

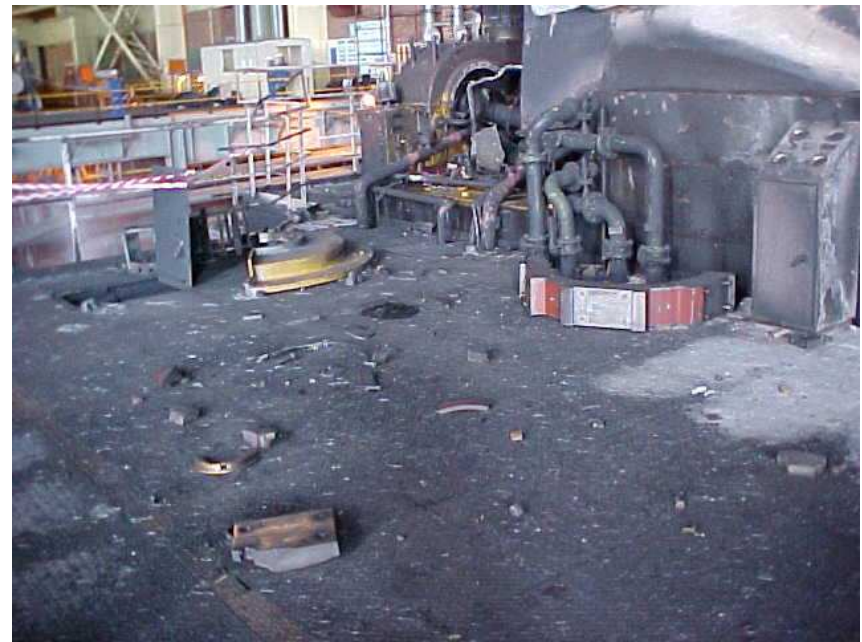
Duvha LSB Failure 2003

- Sister Unit No. 2 suffered a last stage blade (LSB) failure on 8 January 2003.
- Similar damage as seen on Unit No. 4 with a fire, ruptured shafts & components leaving the building
- Minimal visible damage to outside of LP casings

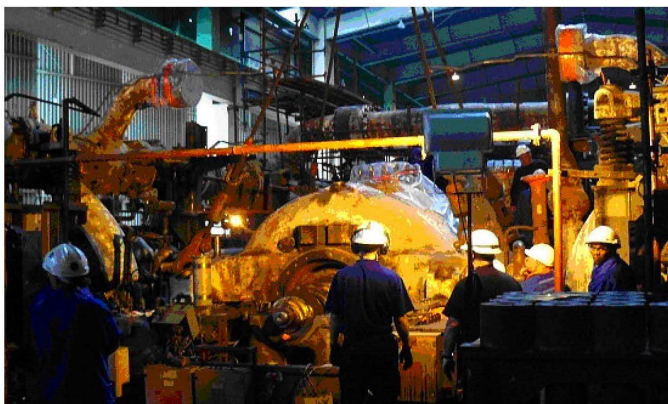
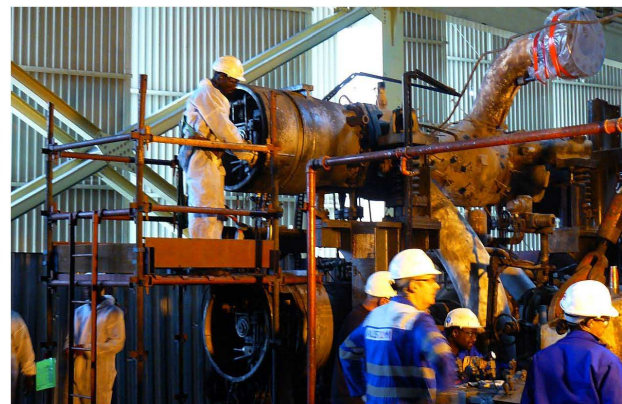
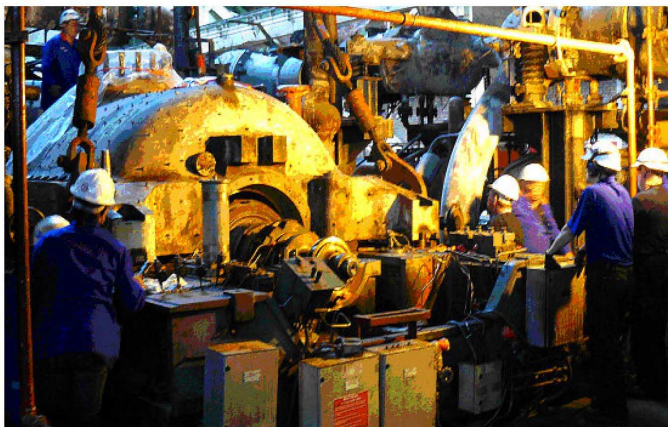
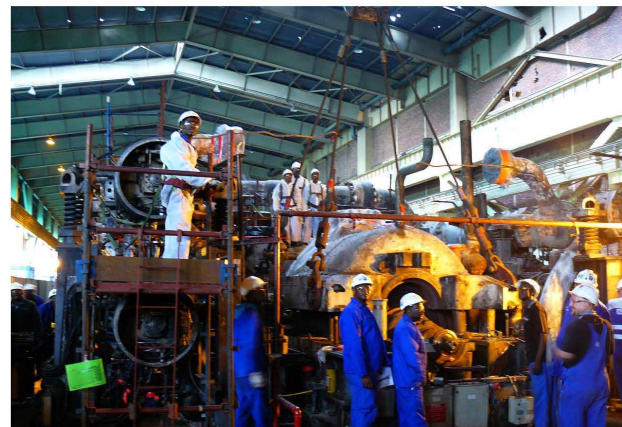
Update on mechanical damage to Duvha Unit

- As we announced before 08h00 on 10 February, unit 4 of the Duvha power station was damaged during statutory turbine overspeed protection test. The damage is extensive and will take more than a year to repair
- No-one was injured, for which we are thankful
- Independent investigation into the cause of the incident is under way. The Duvha recovery team has the go-ahead from investigators to proceed with the first phase of returning the 600 MW unit to service
- Eskom has consistently declined to speculate about the findings of the investigation. Once complete, a statement will be released and shared with stakeholders
- Recovery time depends on the availability of spare components and their level of serviceability. The cost to repair and timing of repairs are still being established
