Steam Turbine Failure During Overspeed Test

Eskom Duvha Unit No. 4
9 February 2011

Updated Presentation Rev 2

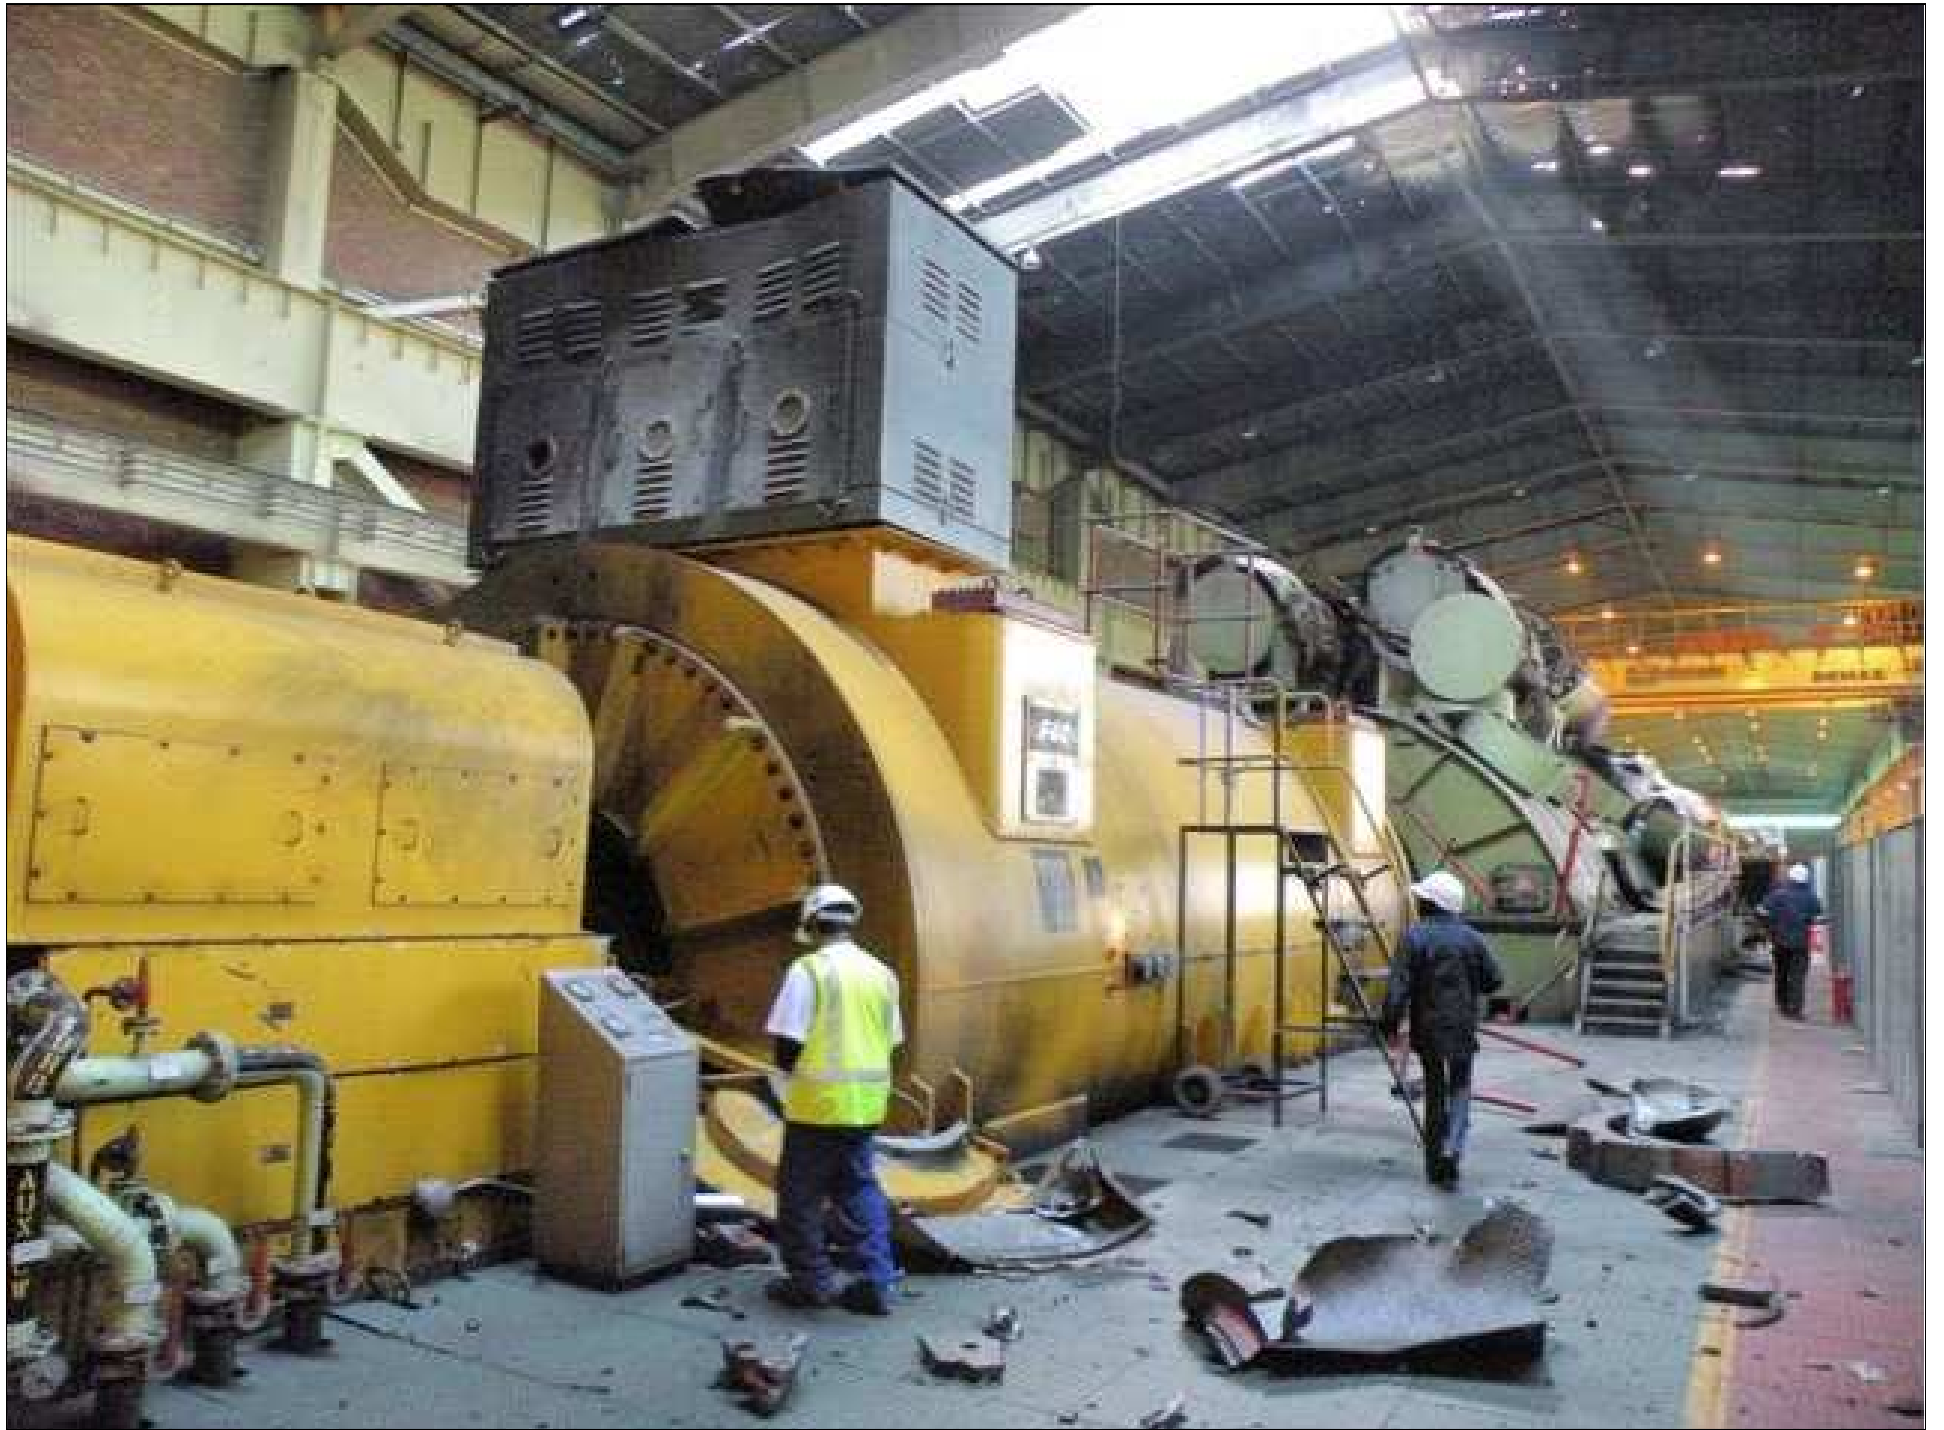
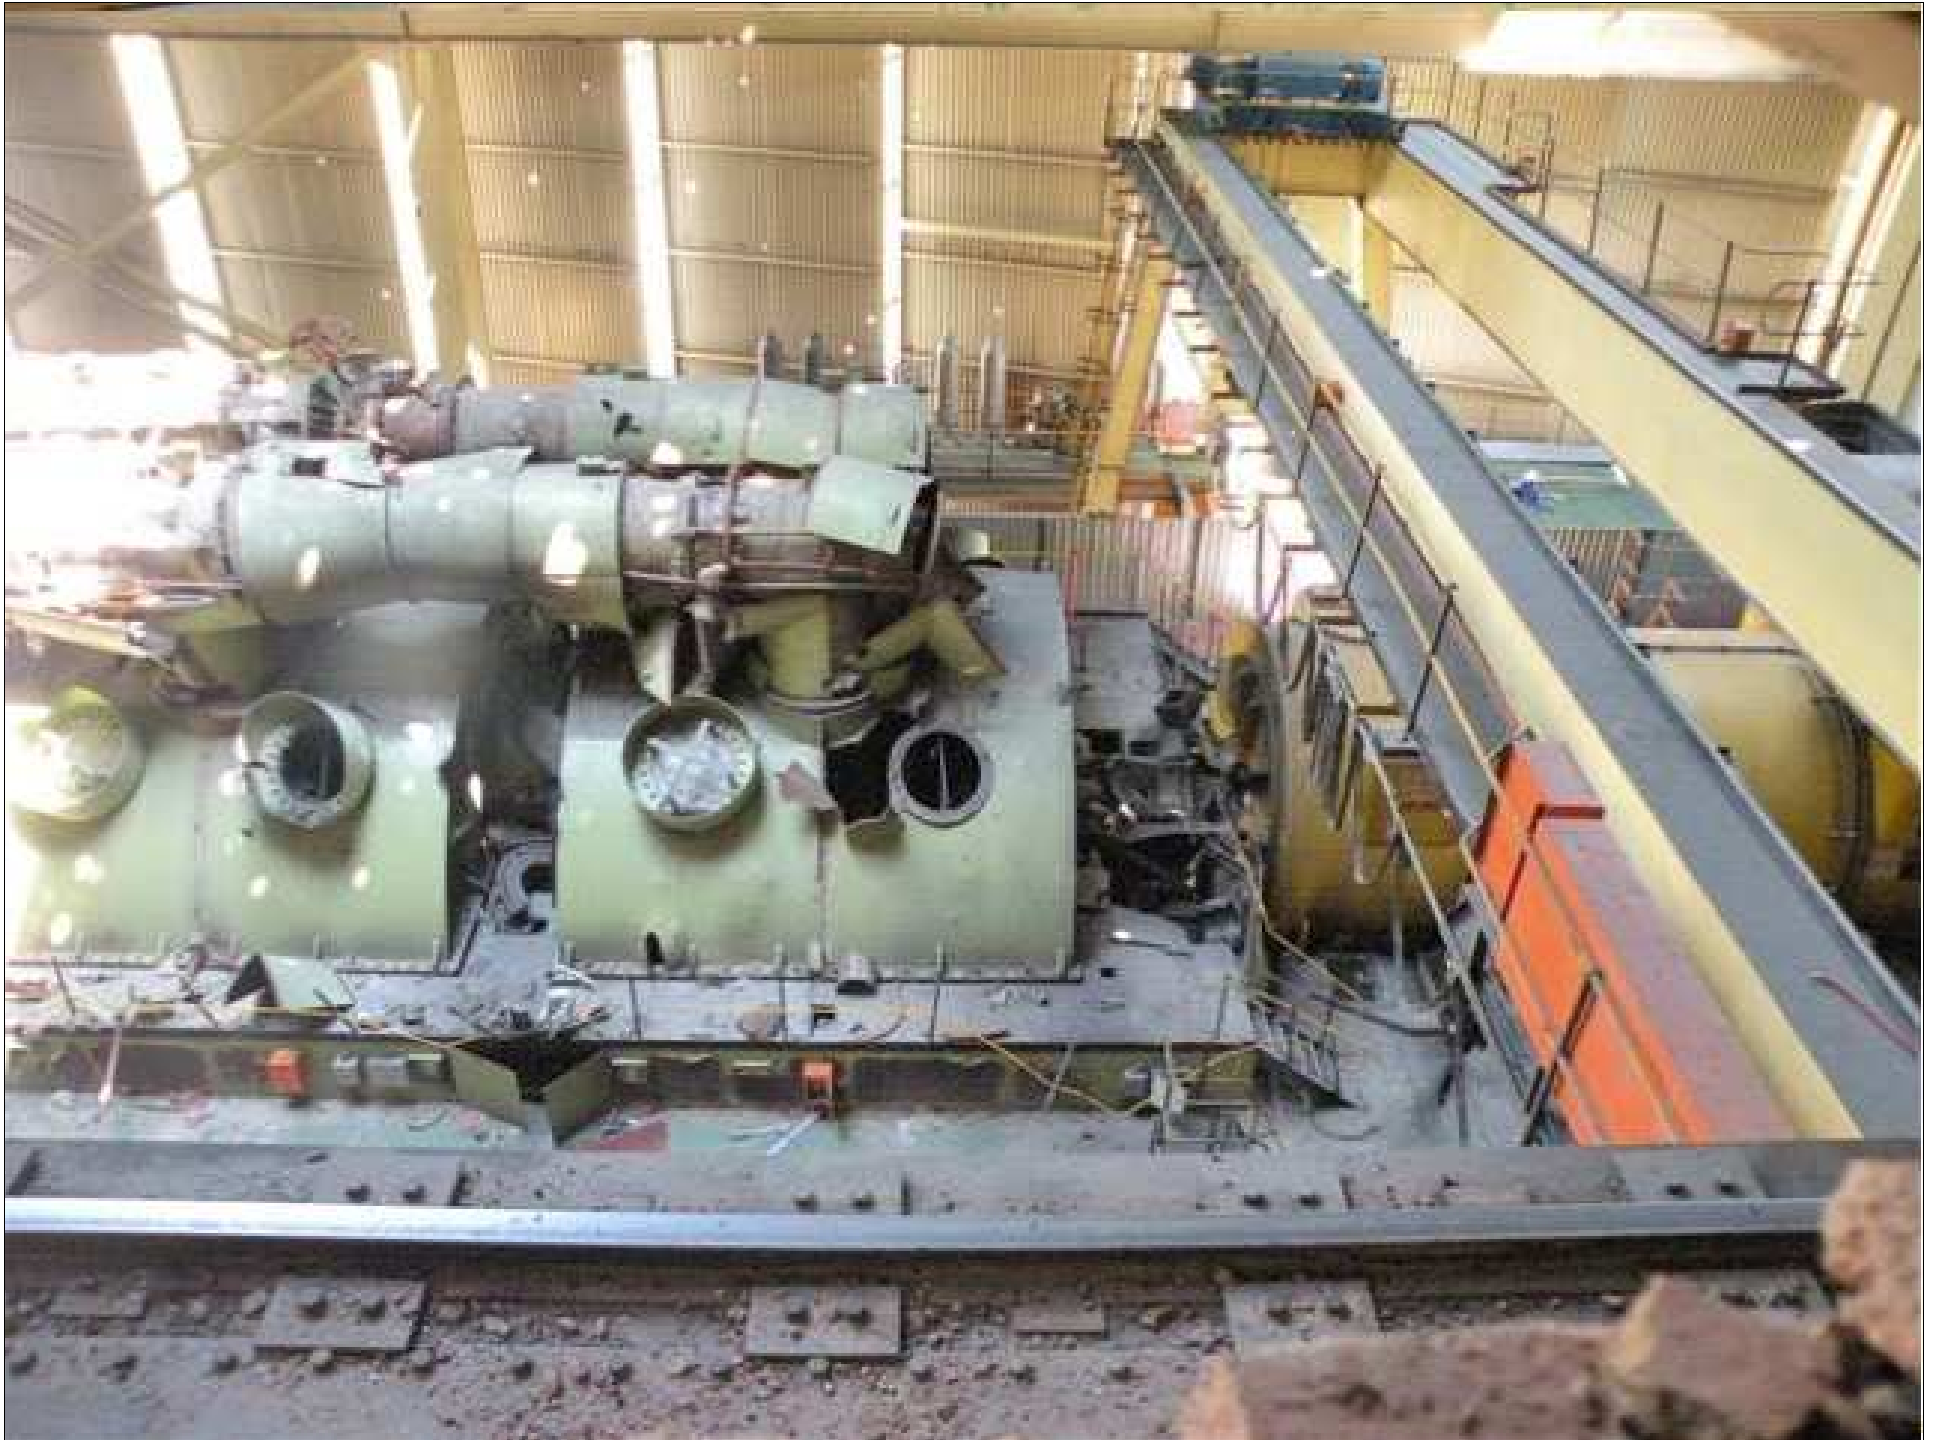
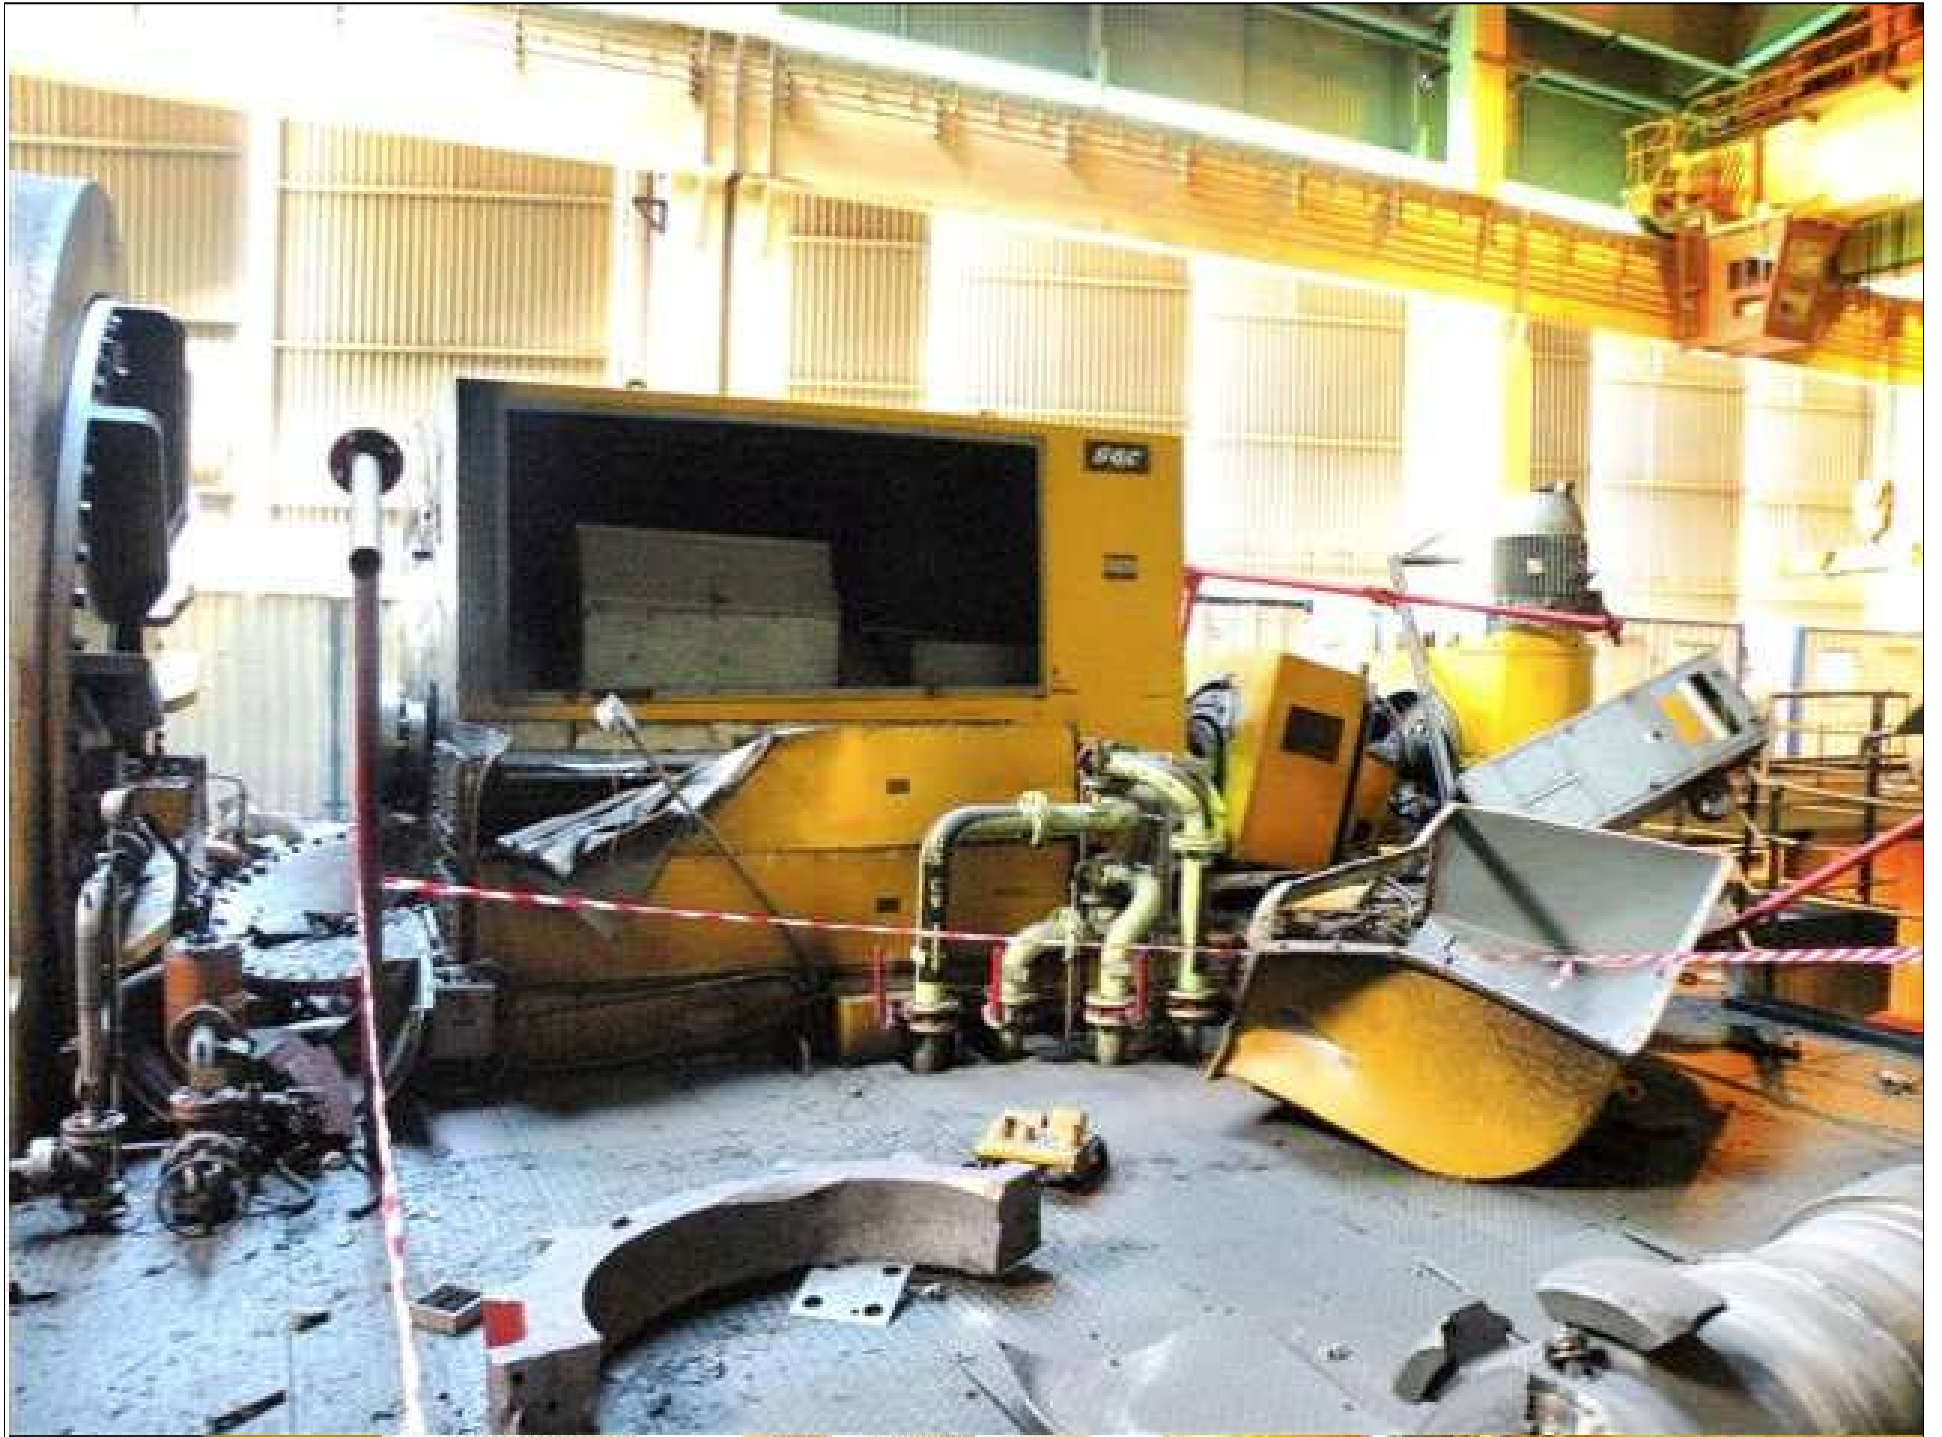
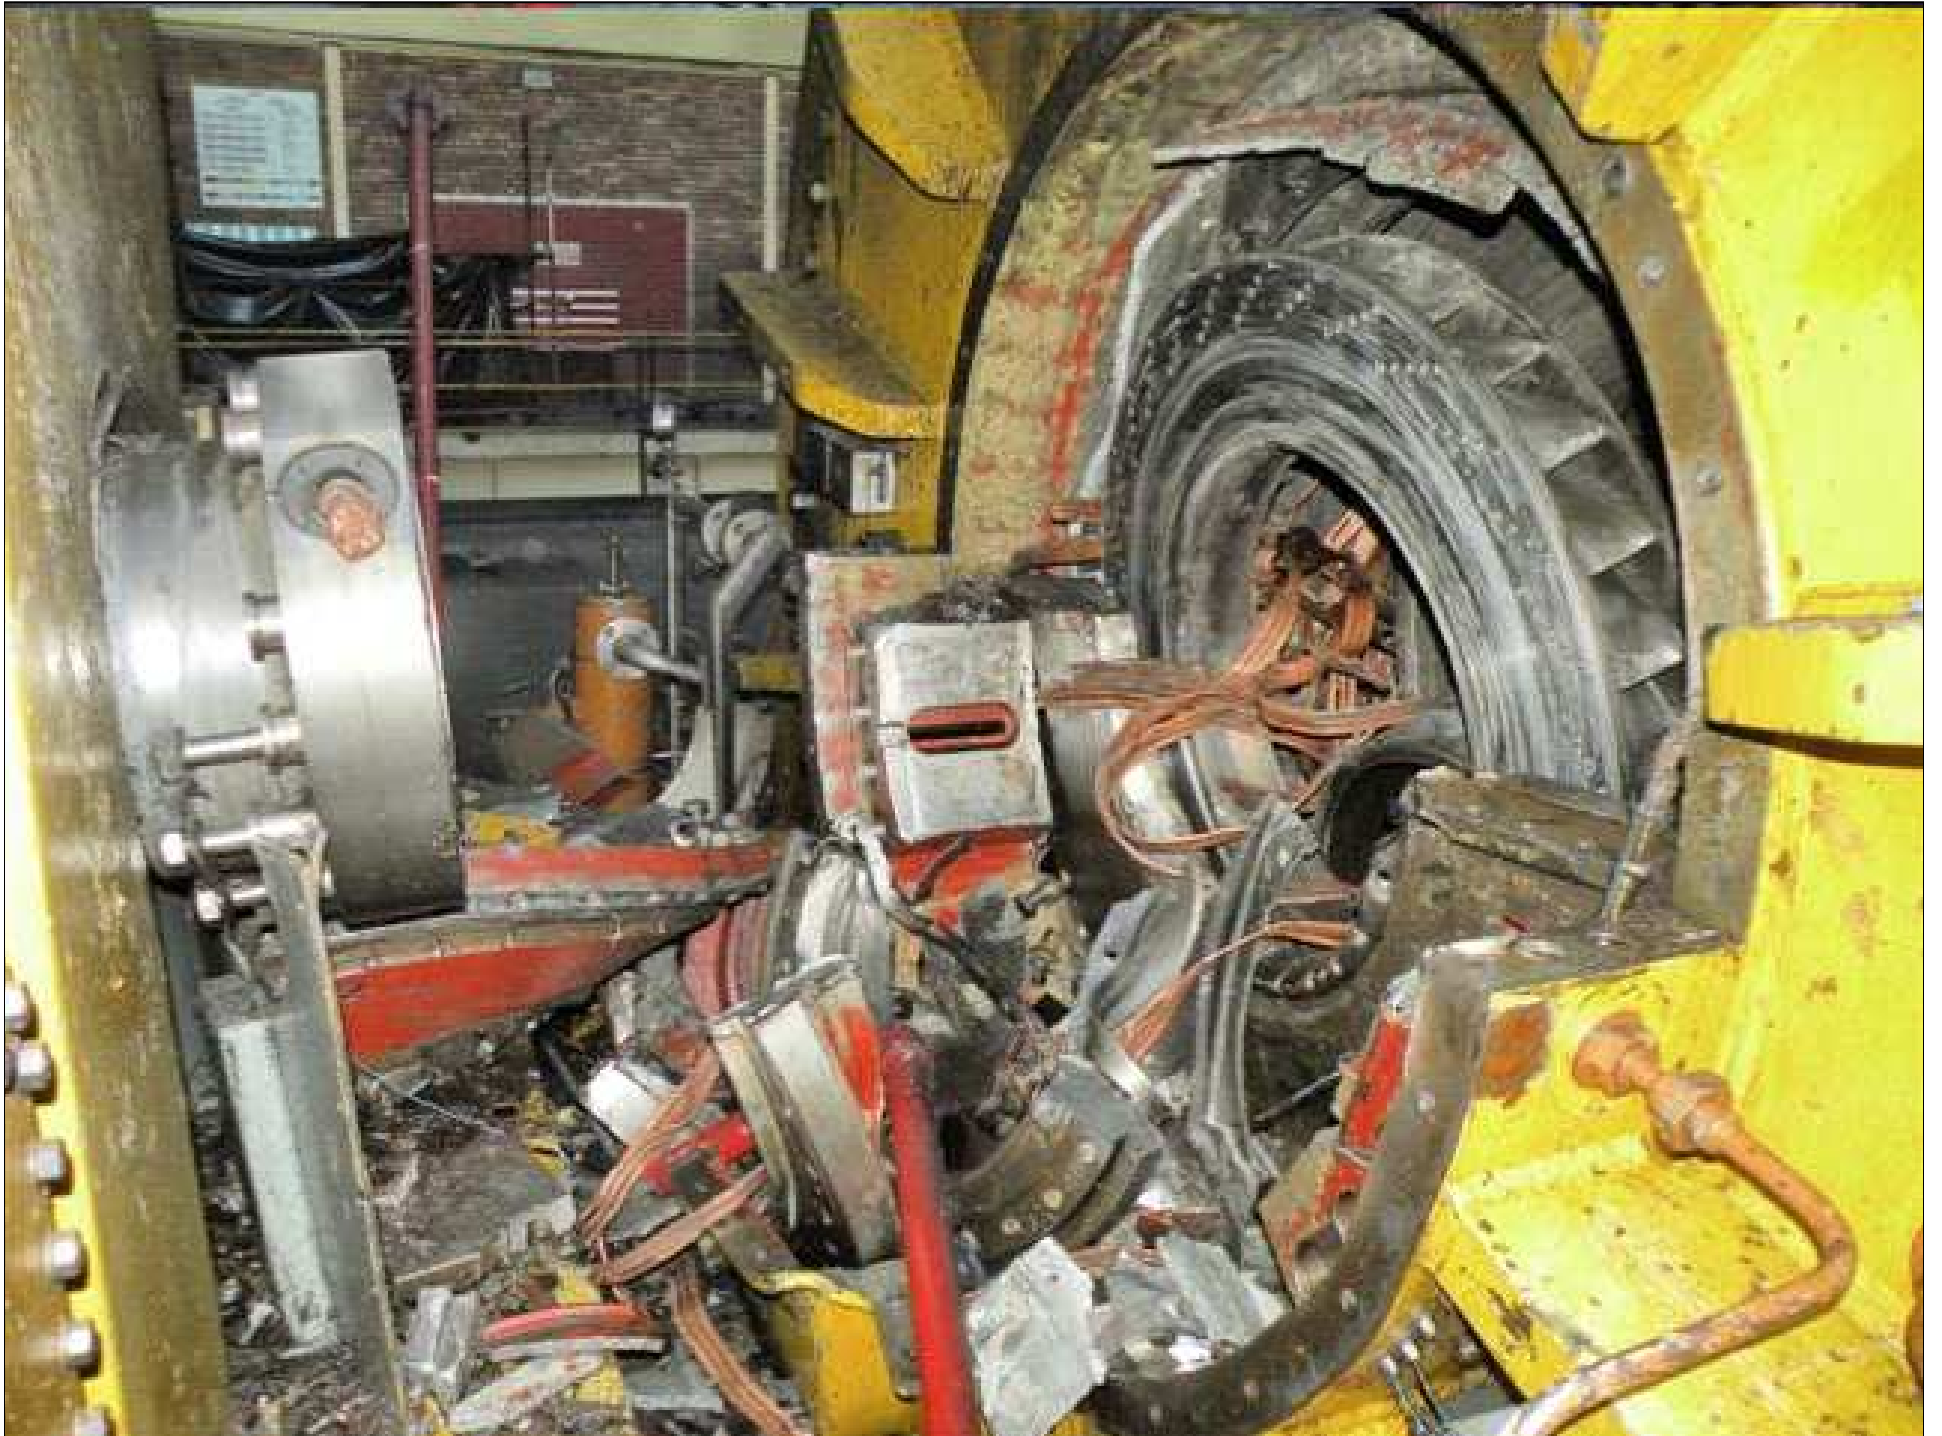
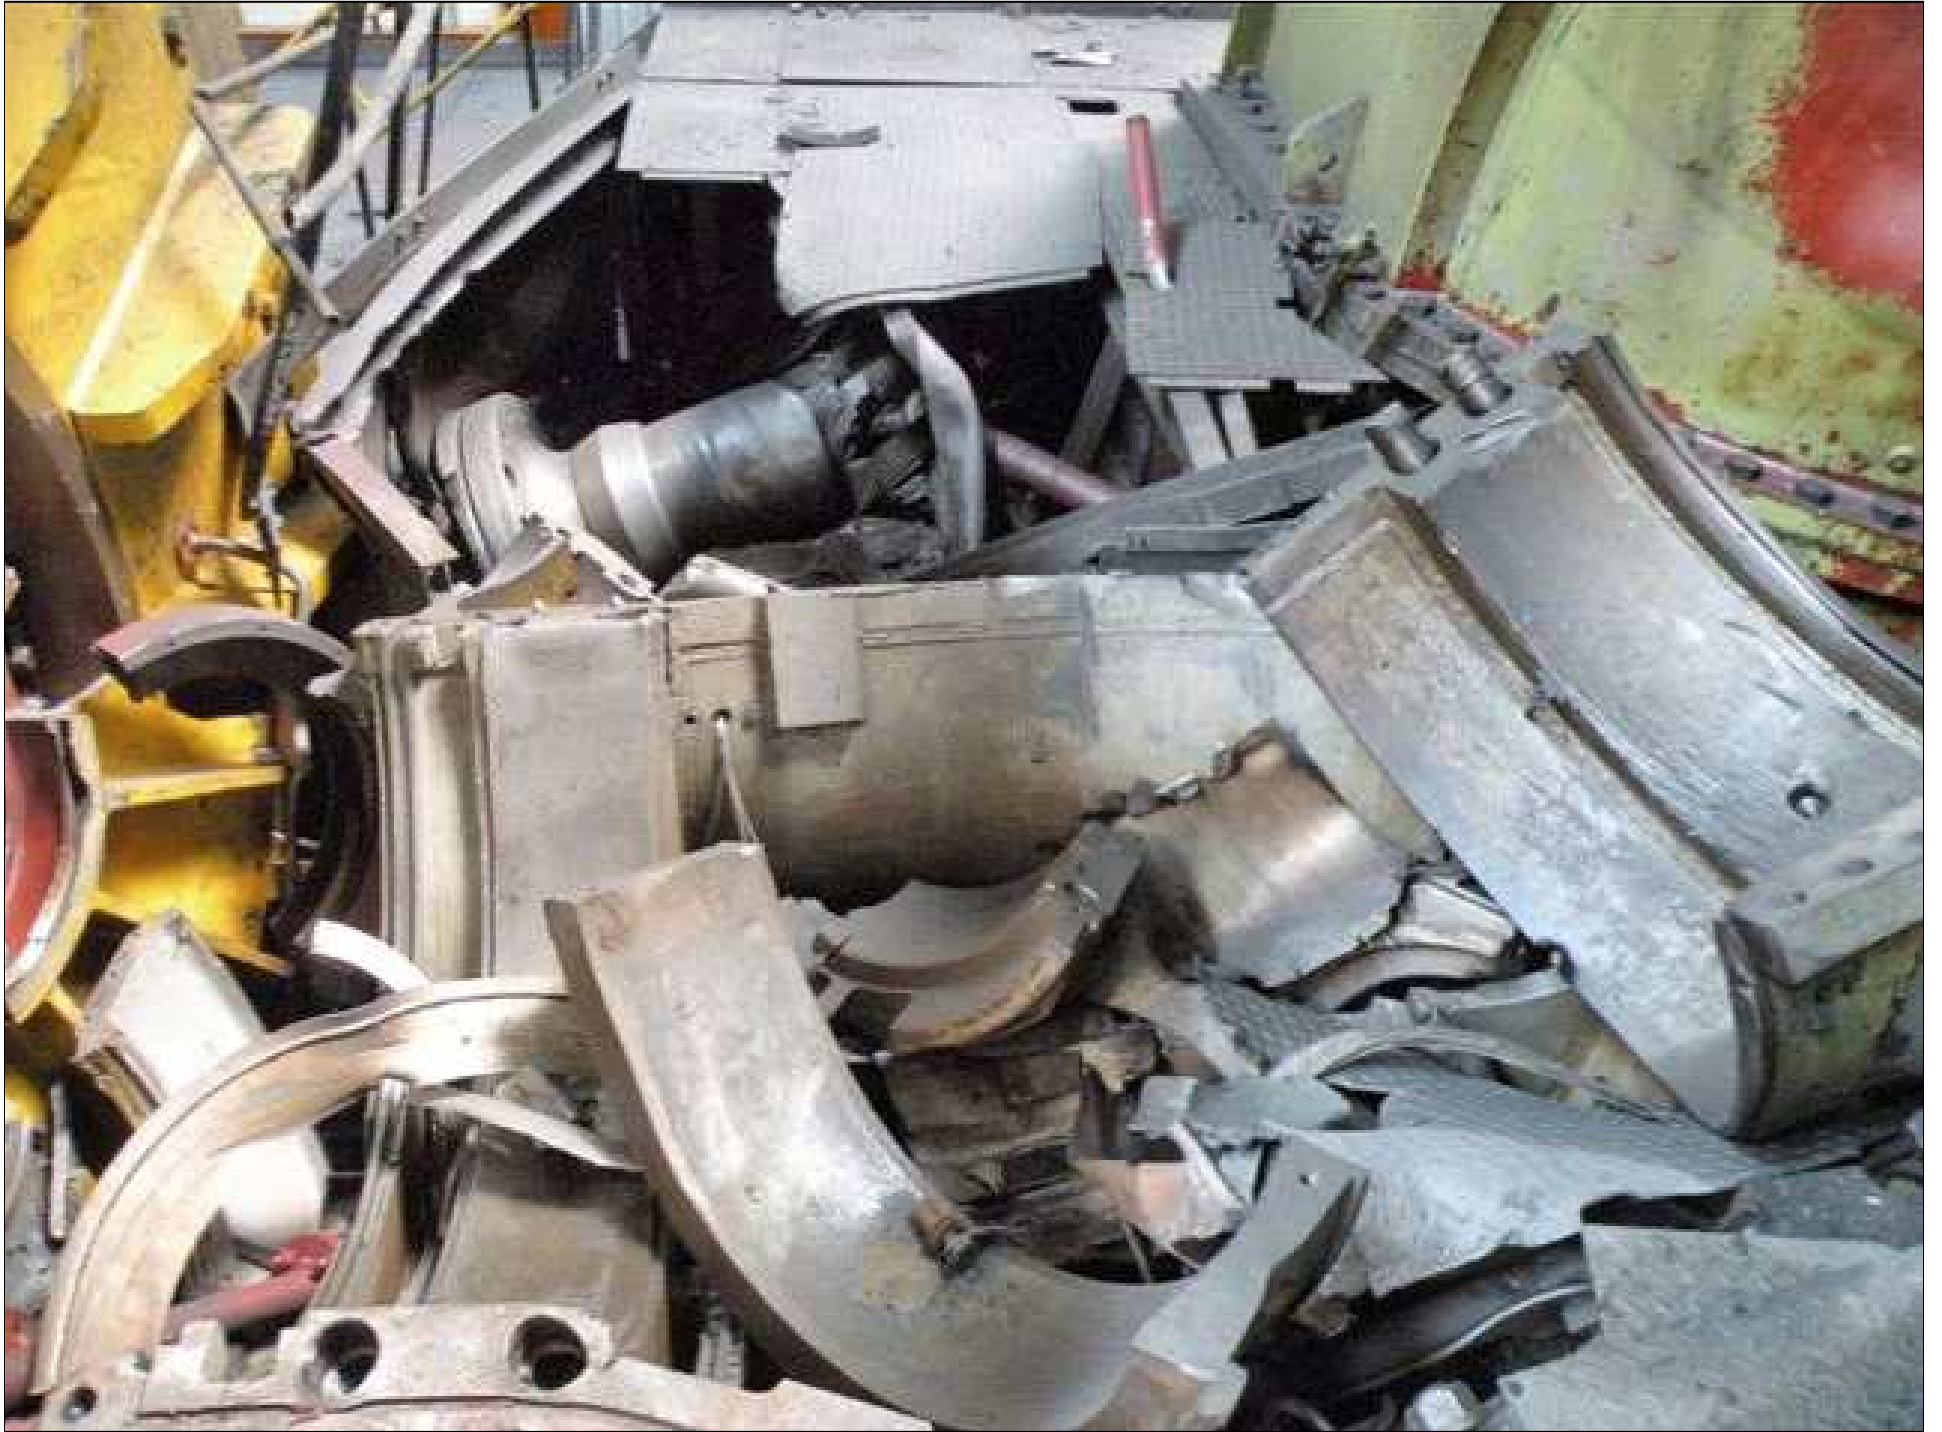
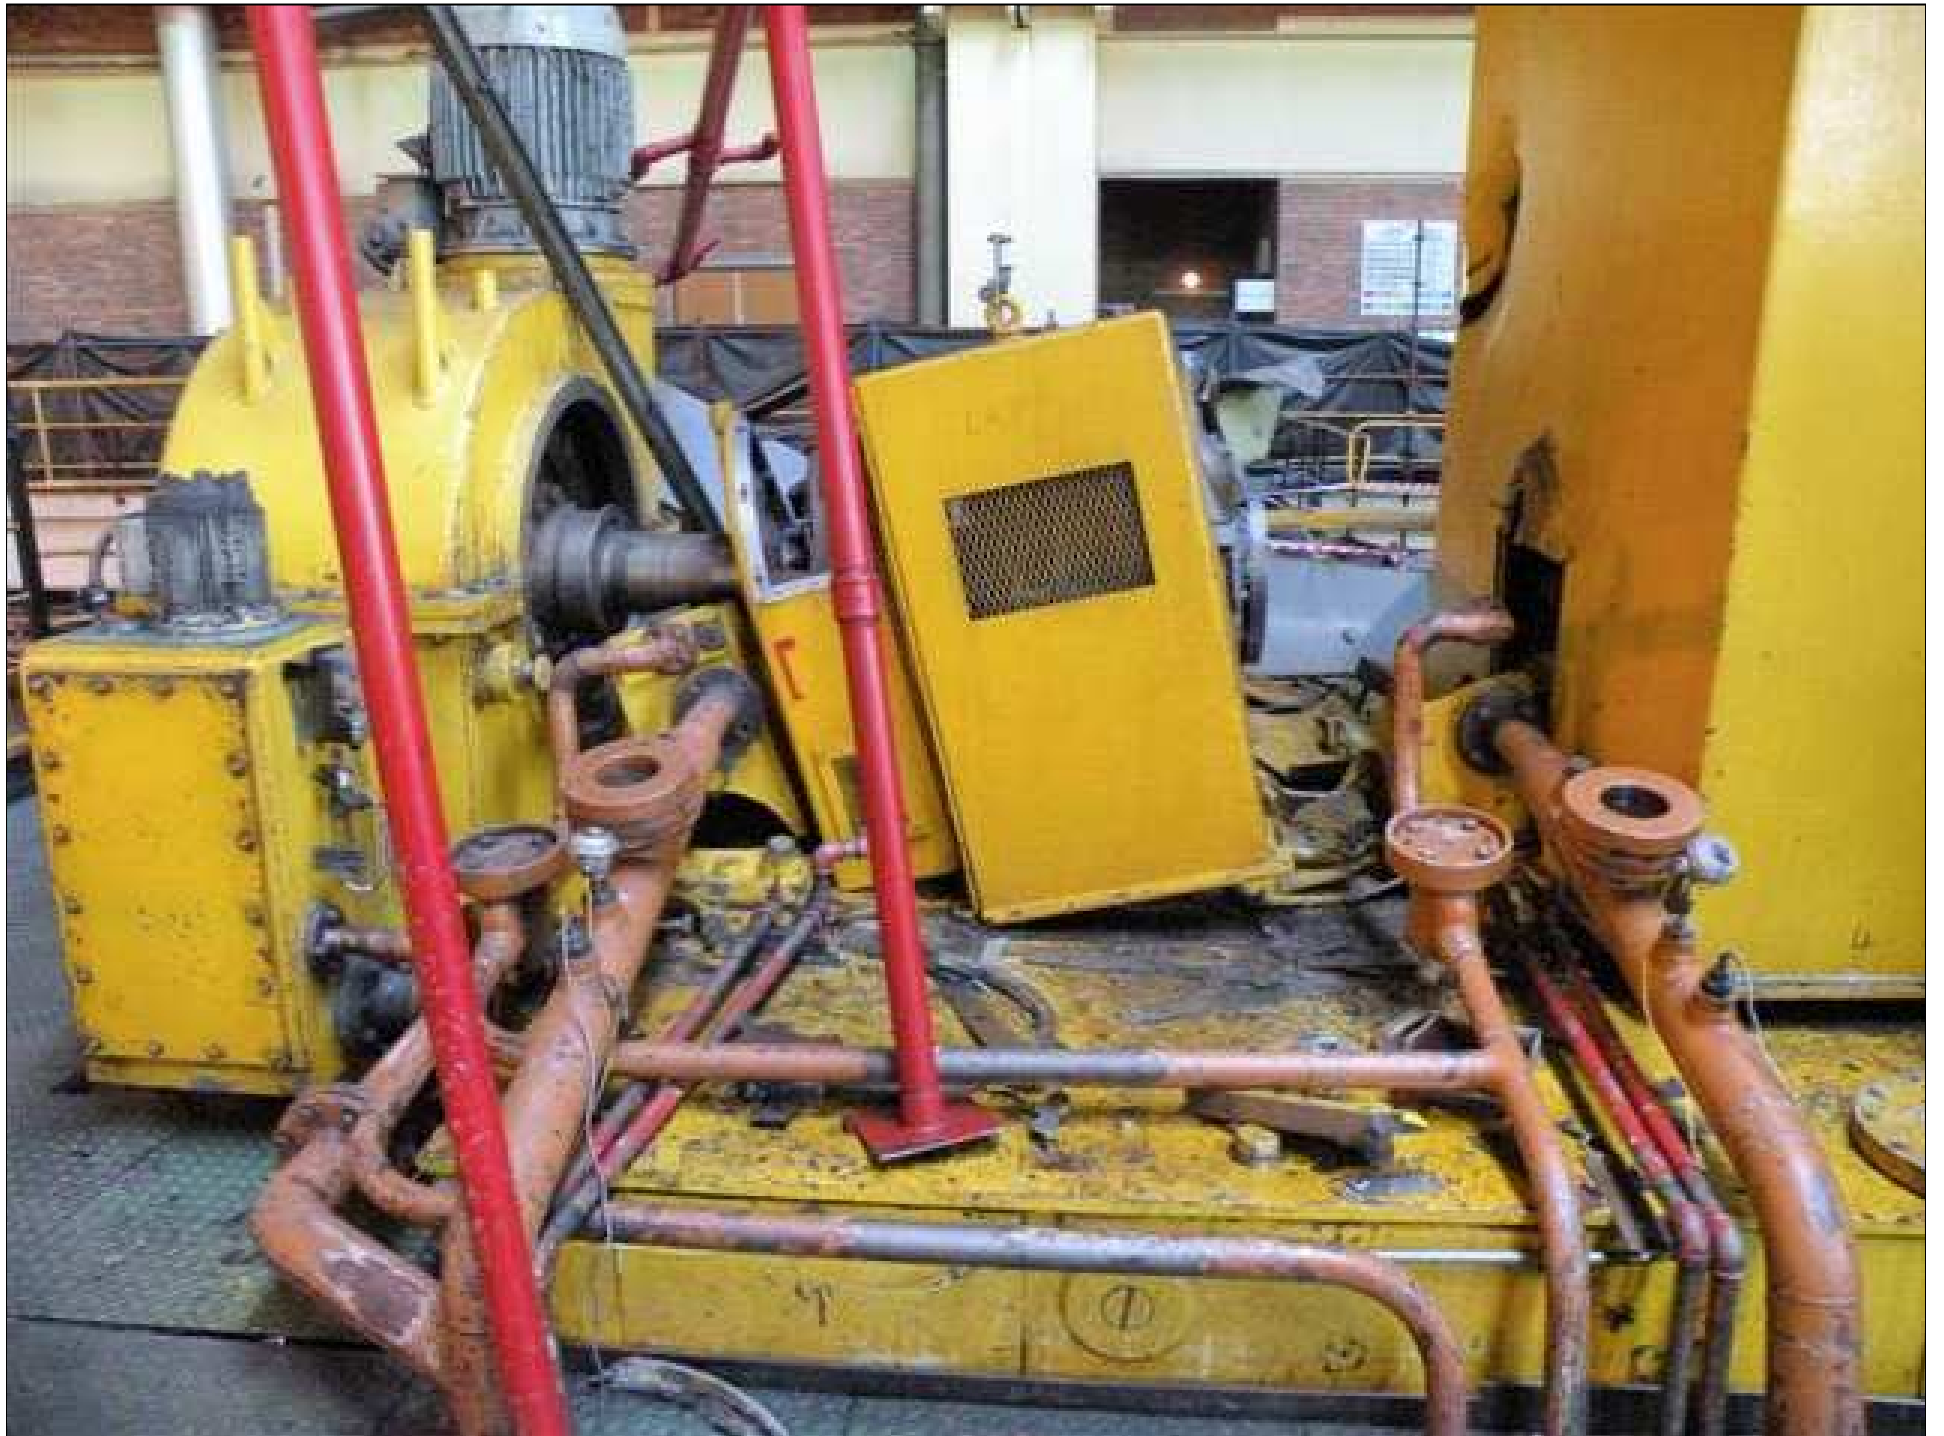
Additional Pictures

- The following pictures were received in April 2011, after the initial batch, and continue to show the damage to the turbine generator set.
- The pictures also show extensive damage done to the plant by 'missiles' created by thrown machine components.
