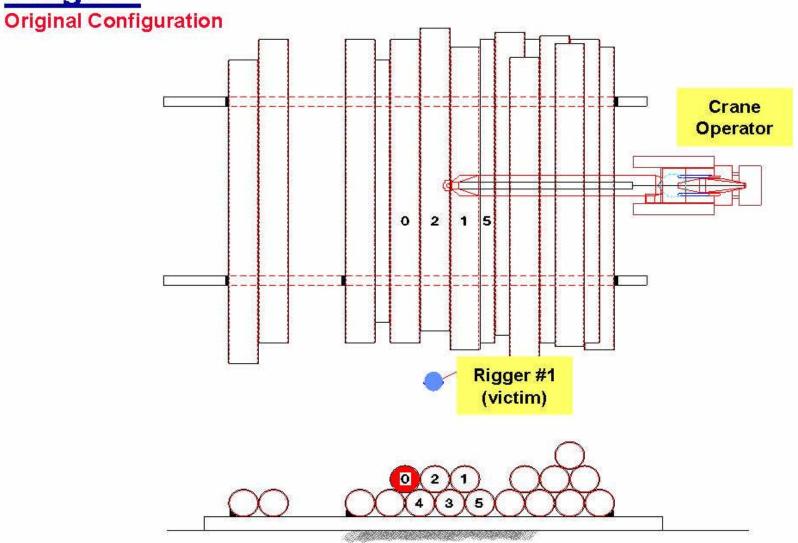
Stage B

Tubular no. 1 was repositioned to the end of the stack

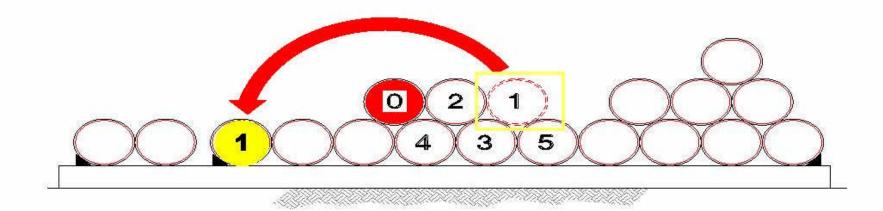
Stage C

Tubular no. 2 was repositioned to expose tubular no. 3

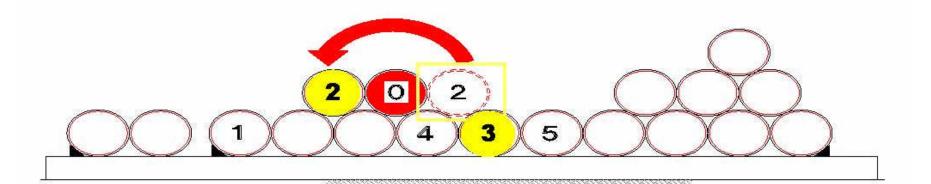
Stage D

Tubular no. 3 was removed from the bottom tier and placed clear of the stack

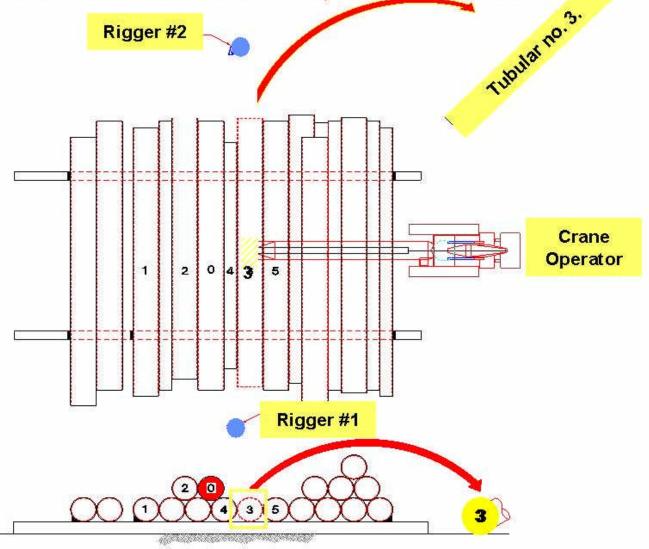
Stage E

Rigger #1 enters the space created by the removal of tubular no. 3. The reason for his action is uncertain - but believed to be to position a stabilising chock, or to follow a tag line which was attached to tubular no. 3.
