U.S. CHEMICAL SAFETY AND HAZARD INVESTIGATION BOARD

CATASTROPHIC VESSEL FAILURE

D. D. WILLIAMSON & CO., INC.

REPORT No. 2003-11-I-KY

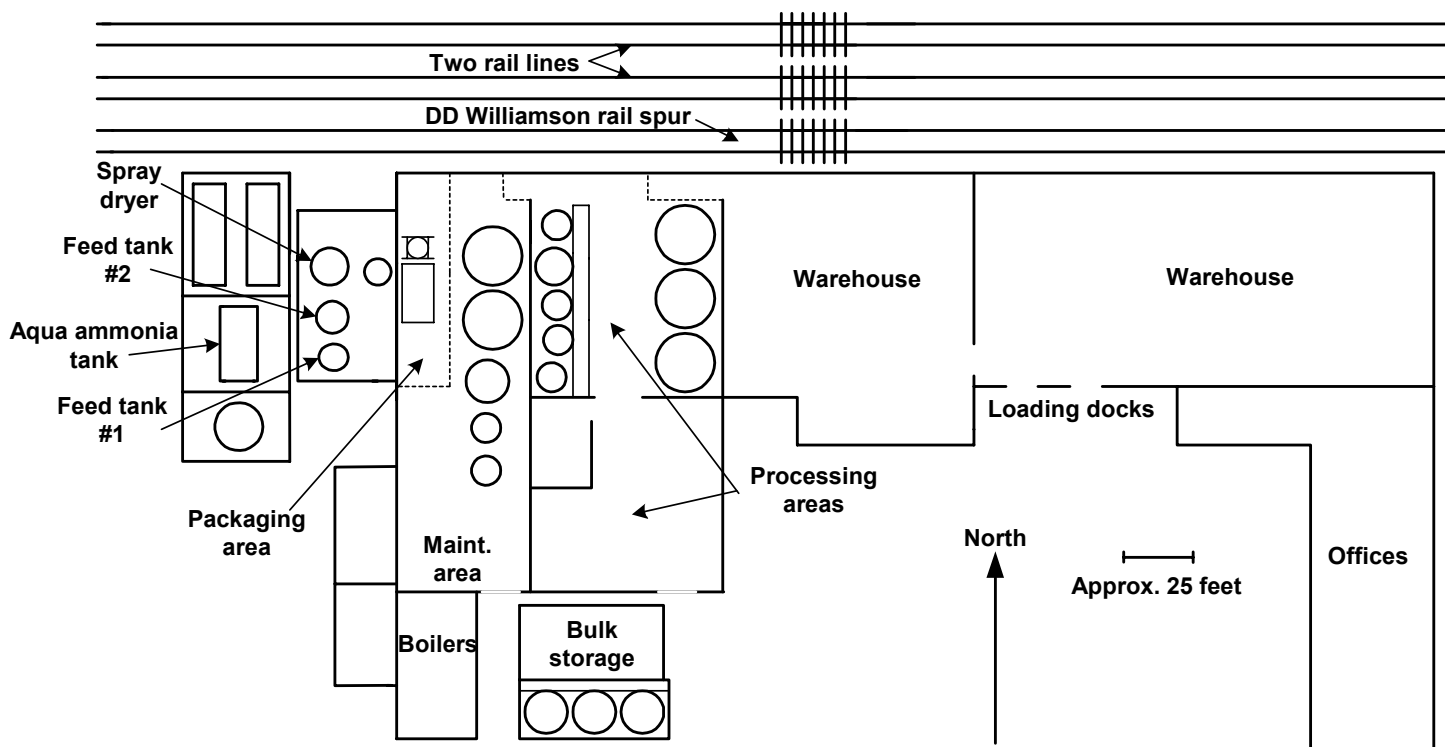
Figure 1. DDW plant layout.

The April 11 incident occurred in the spray dryer area at the west end of the plant (Figure 1). The spray dryer was located 6 feet north of feed tank #2 (Section 1.5), the tank that exploded.

Corrugated aluminum walls enclosed the spray dryer area, and a concrete block wall to the east separated it from other processing areas of the facility. The aqua ammonia storage tank was one of four tanks located just outside and to the west of the spray dryer area; of the other three tanks, one was empty, one was a 12,000-gallon horizontal tank of 50 percent caustic soda, and one was a 20,000-gallon vertical tank of ammonium bisulfite.

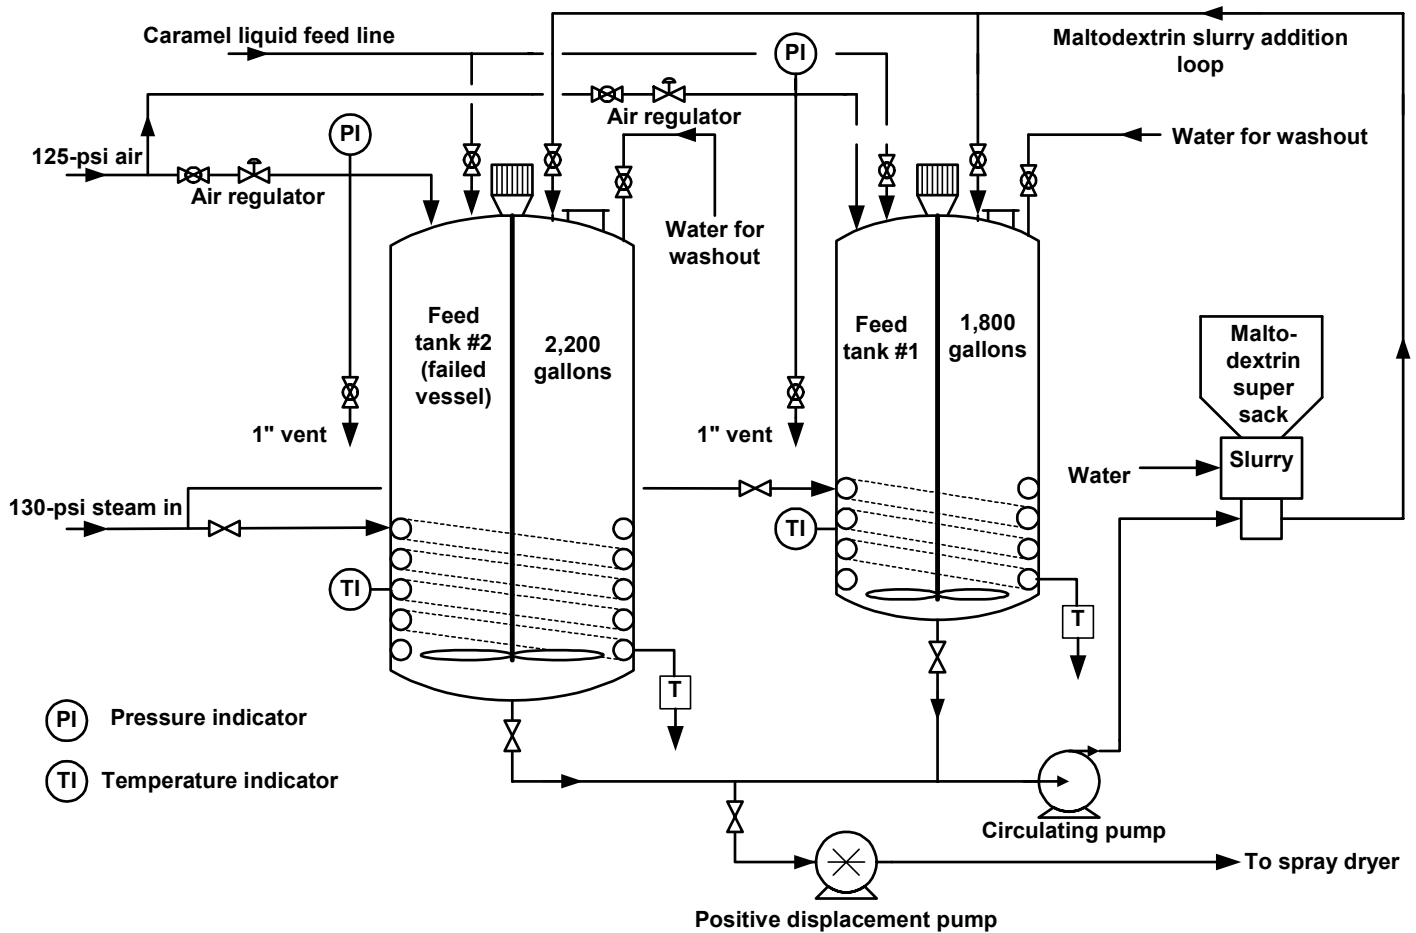
Figure 2. Feed tank flow schematic.

One 1,800-gallon tank (feed tank #1) and one 2,200-gallon tank (feed tank #2) fed the DDW spray dryer (Figure 2). These stainless-steel pressure vessels were equipped with internal stainless-steel coils for heating with steam or cooling with water and with agitators for mixing.

As installed in Louisville, the feed tanks had no safety valves or rupture disks. Each tank was equipped with a 1-inch vent line, terminating in a manual valve, which operators used to relieve pressure (Section 1.4). The tanks were placed on weigh cells to measure batch quantities; there was no other automatic instrumentation. A temperature gauge located midway up the tank shell and a pressure gauge on the air feed manifold were the only instruments associated with the tanks.

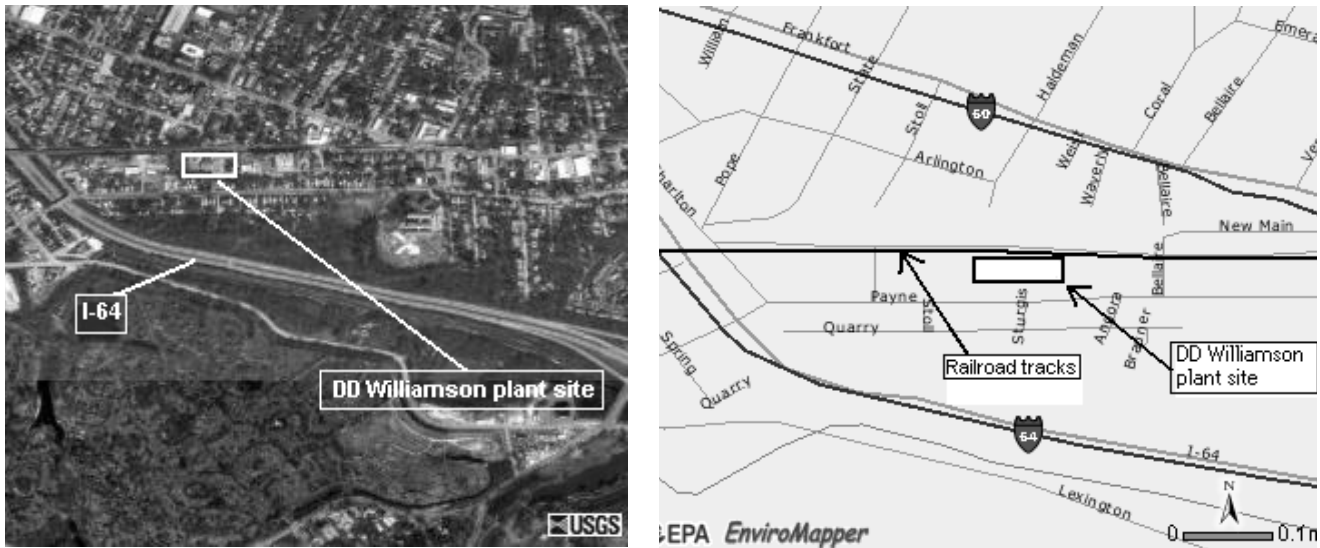
Figure 4. DDW aerial photograph and location map.

The aqua ammonia storage tank was knocked off its foundation and piping was ripped loose, which resulted in the 26,000-pound aqua ammonia leak. An ammonia vapor cloud traveled southwest from the storage tank, toward neighboring homes.

During the incident, the Louisville/Jefferson County EMA and the Metro Louisville Health Department obtained maximum ammonia readings of 50 parts per million (ppm) at the DDW fence line and 35 ppm on Payne Street.⁵ The Fire Department evacuated two blocks of Payne Street closest to the facility. Twenty-six residents were moved into buses at either end of Payne Street, but they did not leave the area. The Fire Department, emergency radio, and news media notified approximately 1,500 residents within 0.5 mile of DDW to shelter-in-place. No injuries were reported in the area of the ammonia release (Figure 4).
