U.S. CHEMICAL SAFETY AND HAZARD INVESTIGATION BOARD

INVESTIGATION REPORT

DUST EXPLOSION

WEST PHARMACEUTICAL SERVICES, INC.

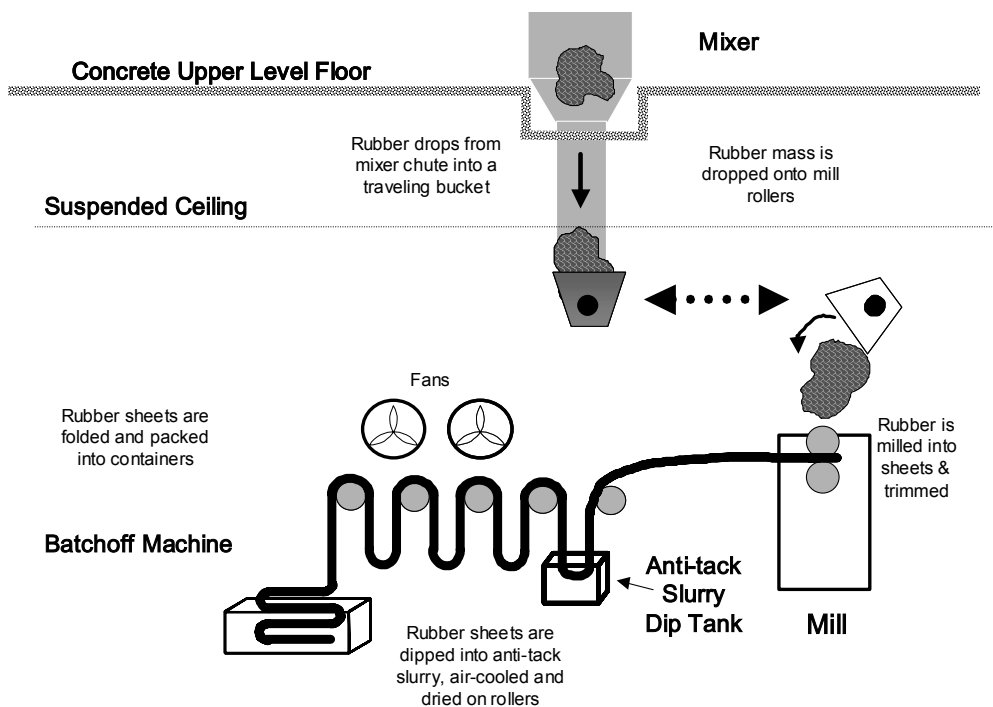
Figure 2. Simplified two-story rubber compounding process diagram.

A suspended acoustic tile ceiling hung 10.5 feet above floor level. The ceiling covered the entire room where the rubber was rolled, dipped, cooled, and folded (Figure 2).

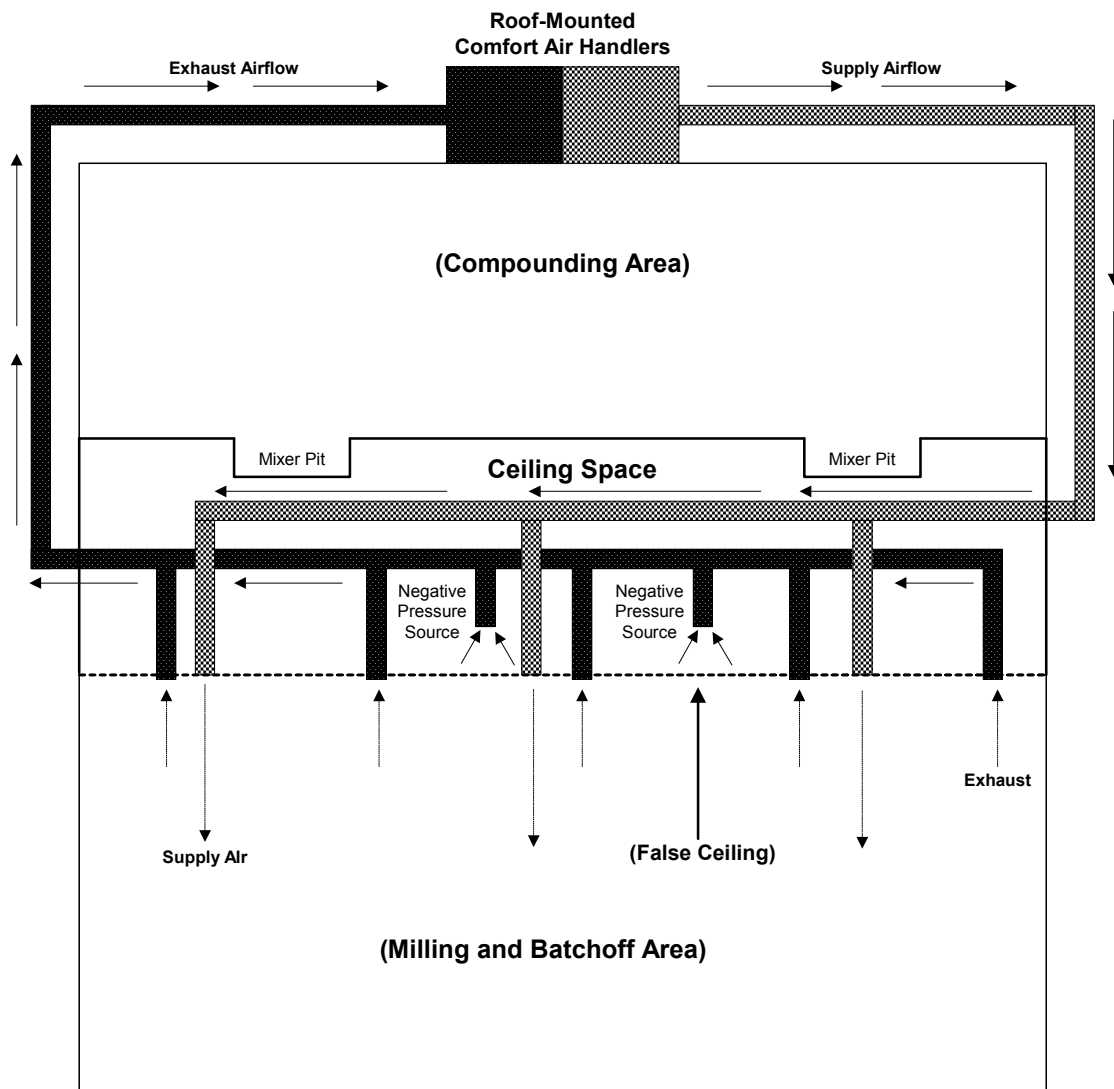
Figure 5. Comfort air system for milling and batchoff area.

Air handlers located on the building roof provided comfort air for the milling and batchoff area (Figure 5). They drew air from the room, filtered and heated or cooled it (mixing it with some fresh air), and then returned it. Air from the room generally flowed to the air handlers through ducts (equipped with diffusers) connected directly to the suspended ceiling; however, some ducts were not directly connected to the ceiling and instead drew air from the area above the ceiling into the air handlers. Because the zone above the suspended ceiling had a slightly lower pressure than the room it covered, a portion of the room air was drafted through the suspended ceiling into the open space above.
