# Storage Tank Explosion and Fire in Glenpool, Oklahoma April 7, 2003

## Pipeline Accident Report

NTSB/PAR-04/02

**Abstract:** About 8:55 p.m., central daylight time, on April 7, 2003, an 80,000-barrel storage tank at ConocoPhillips Company's Glenpool South tank farm in Glenpool, Oklahoma, exploded and burned as it was being filled with diesel. Gasoline had been removed from the tank earlier in the day. The resulting fire burned for about 21 hours and damaged two other storage tanks in the area. The cost of the accident was \$2,357,483. There were no injuries or fatalities. Nearby residents were evacuated, and schools were closed for 2 days.

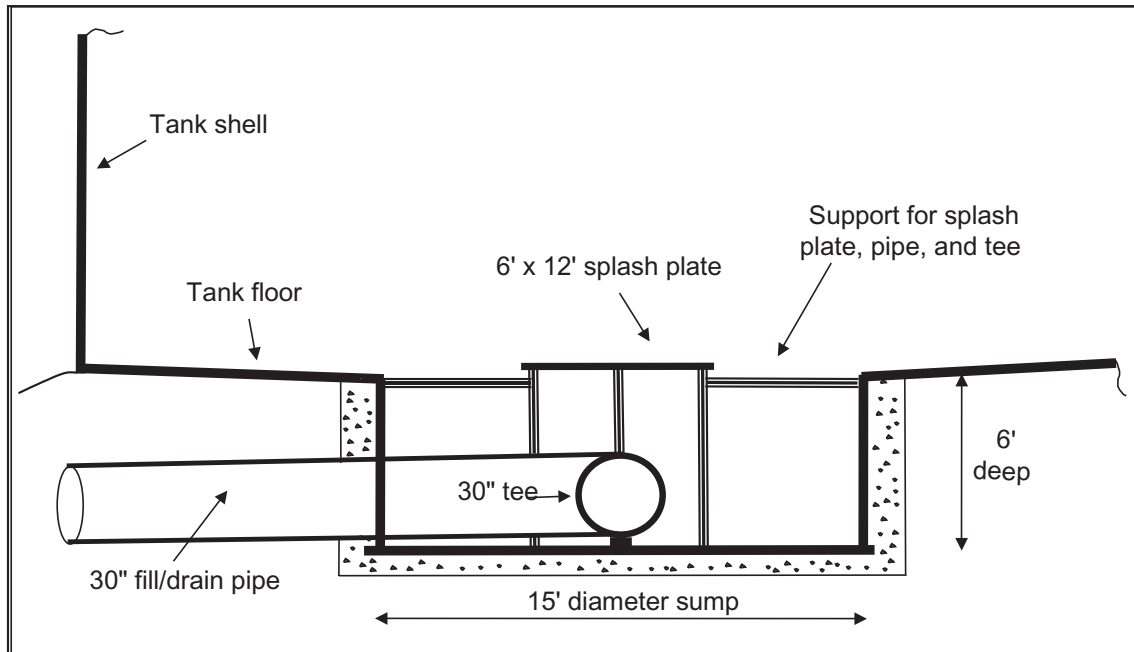
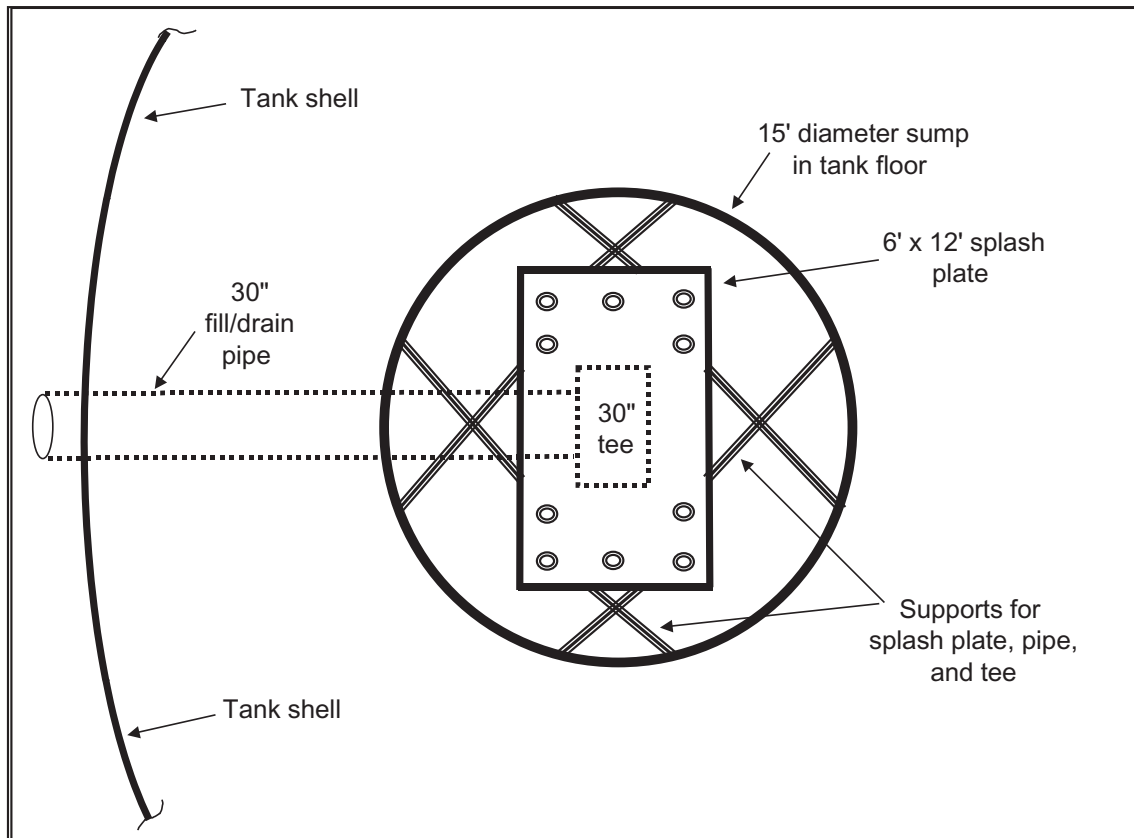
A 24- and 30-inch-diameter fill/drain pipe connected the manifold piping to the sump. A 30-inch-diameter tee was welded to the end of the 30-inch-diameter pipe inside the sump, which was about 9 feet from the tank wall. A 6-foot by 12-foot rectangular splash plate covered the sump about 6 inches above the tank floor. (The diagrams in figure 6 show the configuration of the sump in tank 11.)

**Figure 6.** Tank 11 sump and fill/drain piping viewed from the side (top diagram) and from above (bottom diagram).

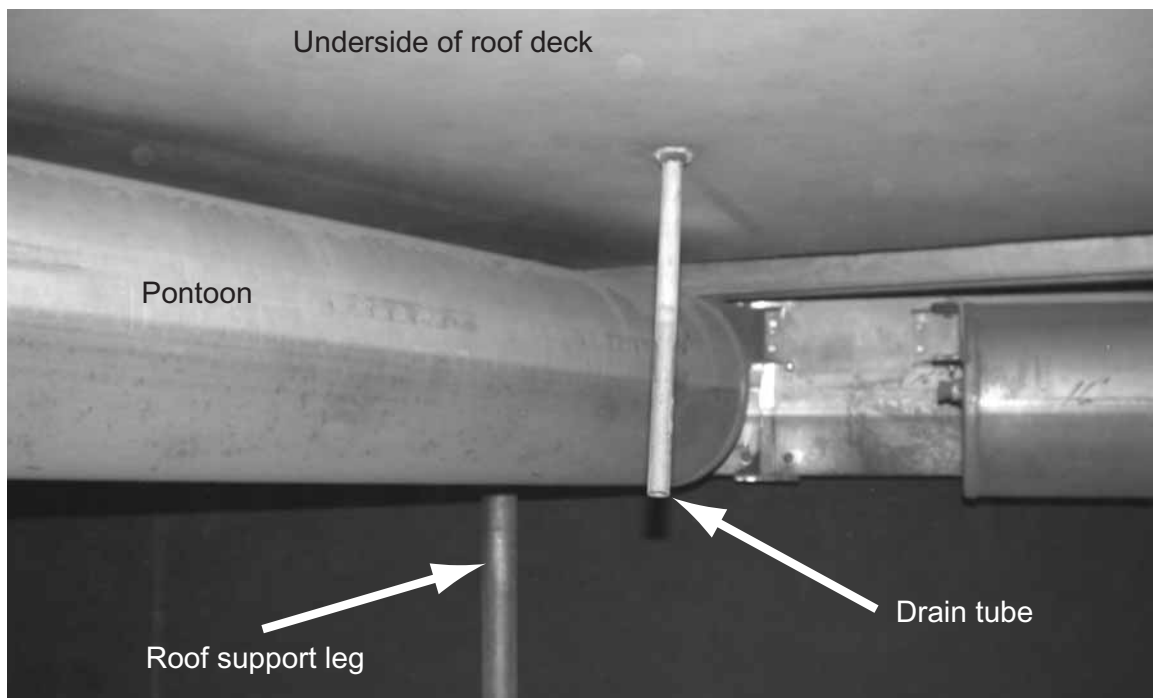
The legs of the floating roof were fitted through aluminum sleeves fastened to the floating roof. The legs could be adjusted to support the roof at different heights above the tank floor when the roof was not floating. Leg length was determined by placing bolts with nuts through predrilled holes in the sleeve and leg above the roof. A bolt and nut could also be placed in the leg below the floating roof to prevent it from descending all the way to the tank floor. Thirty-four legs extended around the interior circumference of the tank, approximately 4 inches inside the tank wall. The interior portion of the roof had about 14 more legs. The strapping table provided to investigators indicated that 7,180 barrels of product would be required to fully float the roof, and that product would first contact the pontoons at a volume of 6,390 barrels. Steel columns that supported the fixed roof extended from the tank floor through the floating roof to the fixed roof. Antirotation cables for the floating roof were installed. The roof had drains approximately 11 inches long. In tank 12, investigators observed that one drain tube was longer than the others and extended below the bottom of the nearby pontoon. (See figure 7.)

**Figure 7.** Drain tube extending down from floating roof in tank 12.

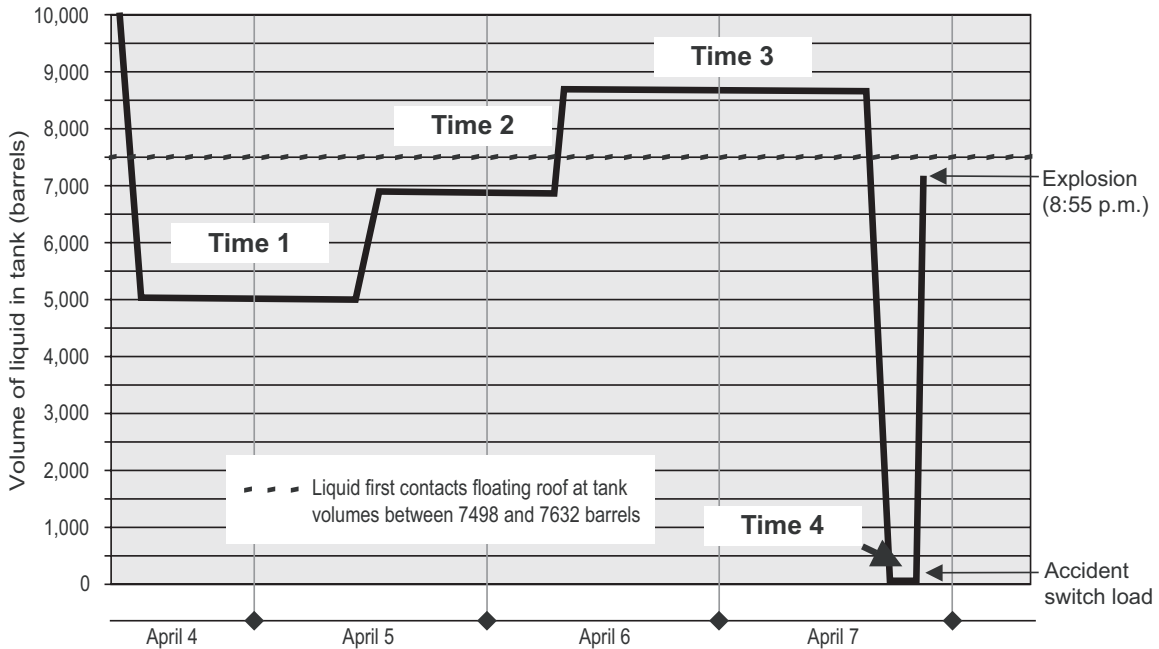
added to the tank. (This gasoline was displaced from a pipeline connecting to the Glenpool South tank farm when naphtha was delivered in this pipeline to tank 8.) Based on the corrected strapping table, the tank 11 roof was not floating until this gasoline was added on April 6. The switch load occurred on April 7. The graph in figure 8 illustrates the volume in tank 11 from the morning of April 4, 2004, through the time of the accident on April 7. It is based on data from the tank 11 level gauge.

**Figure 8.** Volume of fuels in tank 11 during the 84 hours before the accident.
