Naphtha Hydrotreater E-6600E Failure

Anacortes Refinery, Washington

TOP Investigation Team Report

Incident Tracking # 100402OPR038

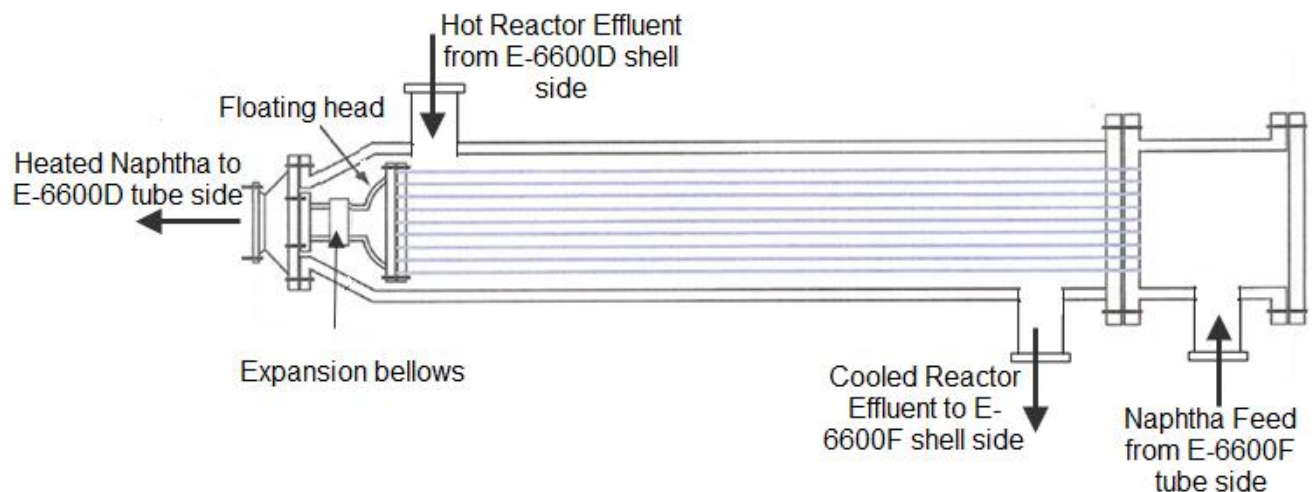
Figure 2: Feed/Effluent Exchanger E-6600E

The reactor effluent was on the shell side of the E-6600s; the feed was on the tube side (see Figure 2). The reactor effluent was released when the E-6600E shell failed and auto-ignited. A common industry practice places the hotter, higher risk fluid on the tube side of an exchanger. Other considerations, such as the need for online cleaning of fouled surfaces, may cause the designer to reverse the arrangement, as appears was the case for the design of the E-6600s. Each case must be considered individually.

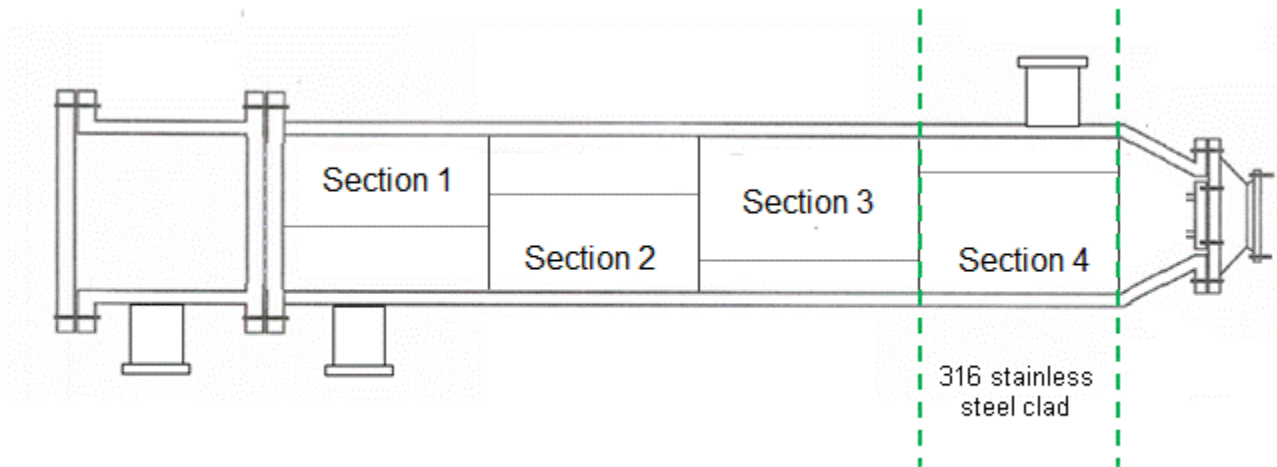
Figure 4: E-6600E sections

The exchanger ruptured adjacent to longitudinal weld seam LS-3 and circumferential weld seam CS-4 due to damage from advanced high temperature hydrogen attack (HTHA).

Mechanical testing in the form of Rockwell hardness, Vicker's 500 g load microhardness, Charpy impact, bending, and tensile was performed on specimens from unclad sections 1-3 (see Figure 4). Although E-6600E had been exposed to high temperatures during the fire, the measured properties of the shell were consistent with the requirements of materials specified in the design.
