If you go through the attached Incident Investigation (all references related to vessel and its company is intentionally omitted) you will see that the fire caused by shore fault.

M/T [REDACTED] before the Incident at Huelva Spain.

INVESTIGATION REPORT

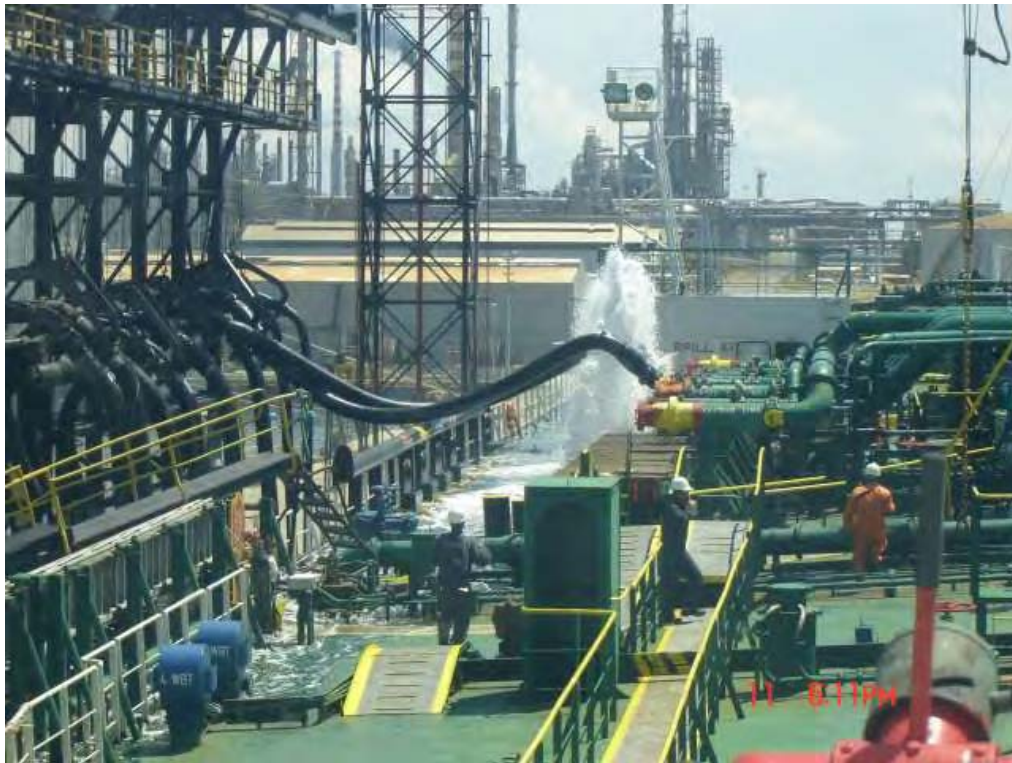
The undersigned Captain [REDACTED] was on board at the time of the incident, joined the M/T [REDACTED] at [REDACTED], [REDACTED] on 7 September for a routine inspection. He was in the officer's smoke room when he heard of the report on the radio and went to the window where he observed a leak and watched it expand significantly over a period of 2 – 5 seconds. Captain [REDACTED] took a photograph from this location and then went to the Cargo Control Room and the Bridge where he took additional photographs of the incident. Upon reaching the Cargo Control Room, he observed the master holding the VHF radio and ordering the terminal to cease pumping. (See photo in the next page).

From the photos above, it is quite clear that the cargo leak occurred in the flexible portion of the transfer hose, adjacent to its connection with Cargo Line no.1 of the vessel's manifold

The nozzle efficiency for a leak of this sort would likely fall in the range of 0.5 to 0.7. Using the Bernoulli equation and this efficiency, the line pressure at the time of the photograph is estimated to be between 15.7 and 22 psig, which is within the normal operating pressure range for cargo loading. Therefore, excessive pumping pressure can be effectively ruled out as the cause of failure.

During the loading process, the crew must continually alter the ballast of the vessel to account for the mass of the fuel loaded. If this process is not conducted properly, the change in draft could place excessive strain on the transfer hose. From Photographs 1 and 2, it is evident that the vessel is reasonably ballasted and that the transfer hoses are properly resting on the rail and not unduly stressed. Thus draft differential was clearly not the cause of the failure.

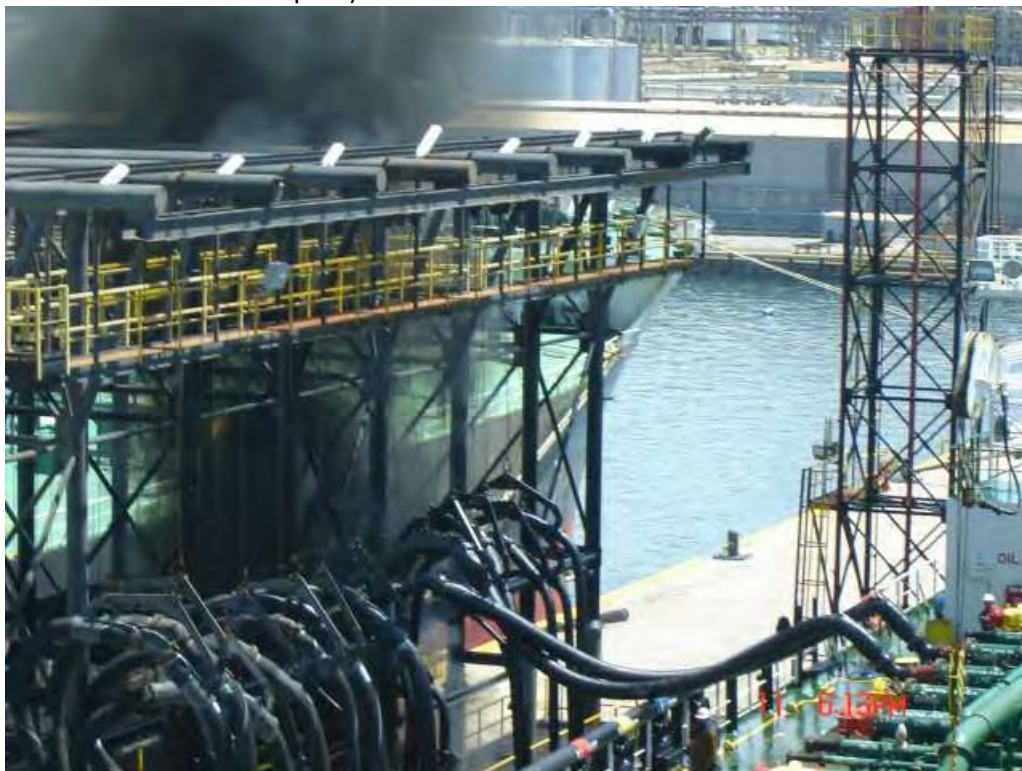
The vessel's Master Captain [REDACTED] stated that he called the terminal four to five times telling them in English and in [REDACTED] that the hose was broken. When he saw smoke from the jetty, he started the fire pump from the bridge and the crew began spraying the terminal. The flames grew quickly and spread to the vessel engulfing the manifold. As the vessel was trimmed by the stern, the leaking fuel flowed toward the accommodation, bringing the fire with it. (See following photos showing the commencement of the fire at the pier.)

Fire burning on jetty. Note vessel's fire stream directed upon jetty in bottom of photograph

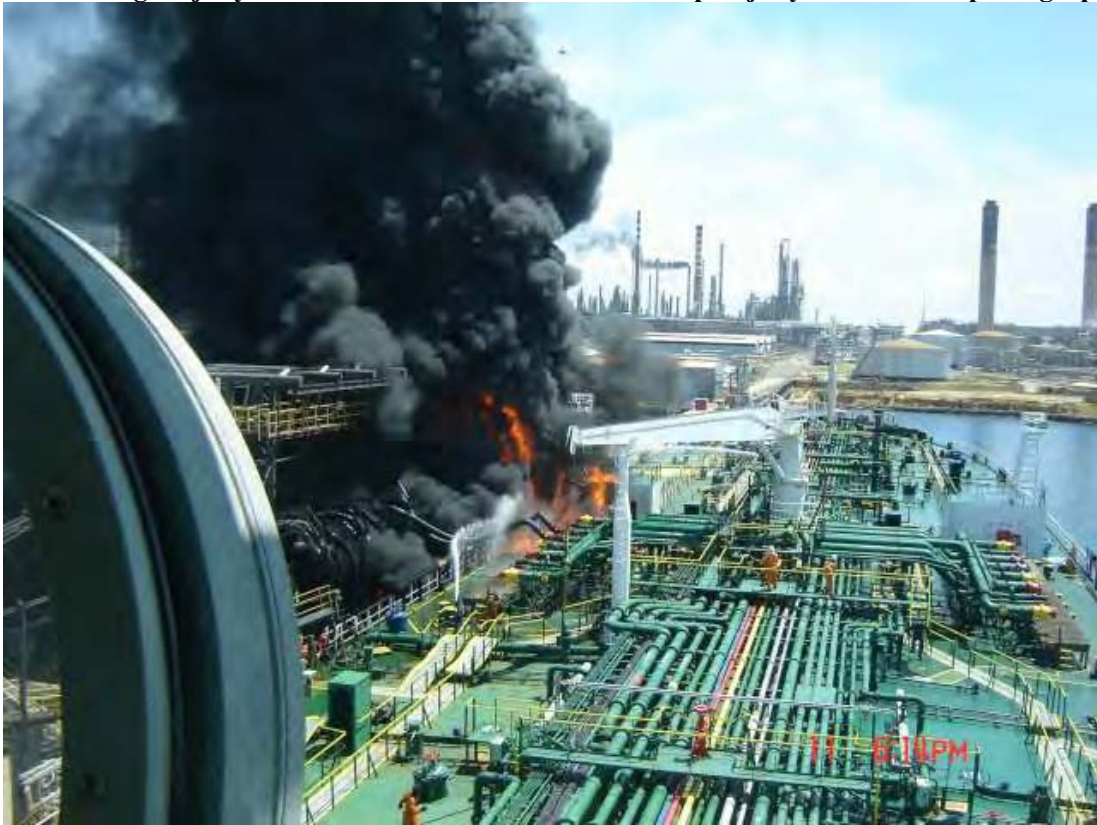
Fire burning on jetty and vessel

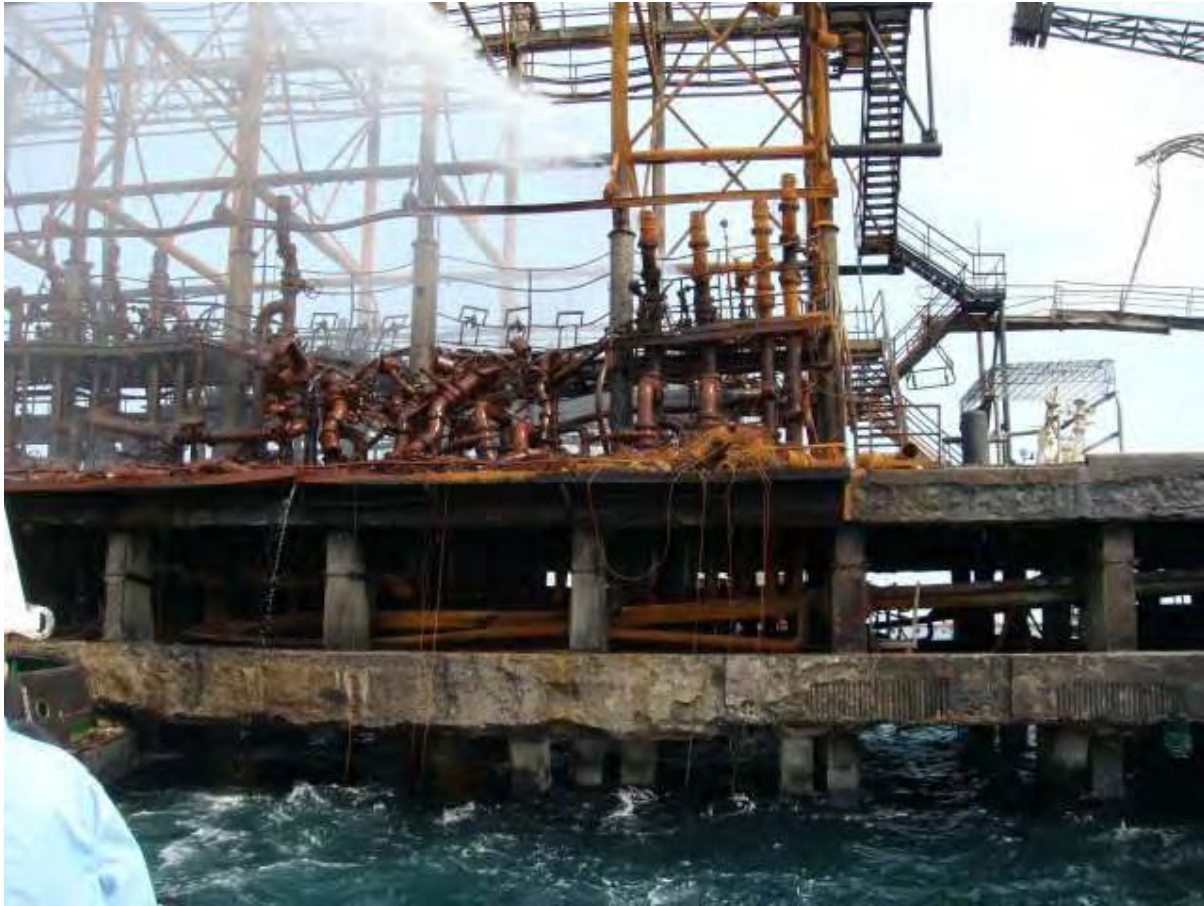
From sea, it was evident that the facility had suffered extensive damage.

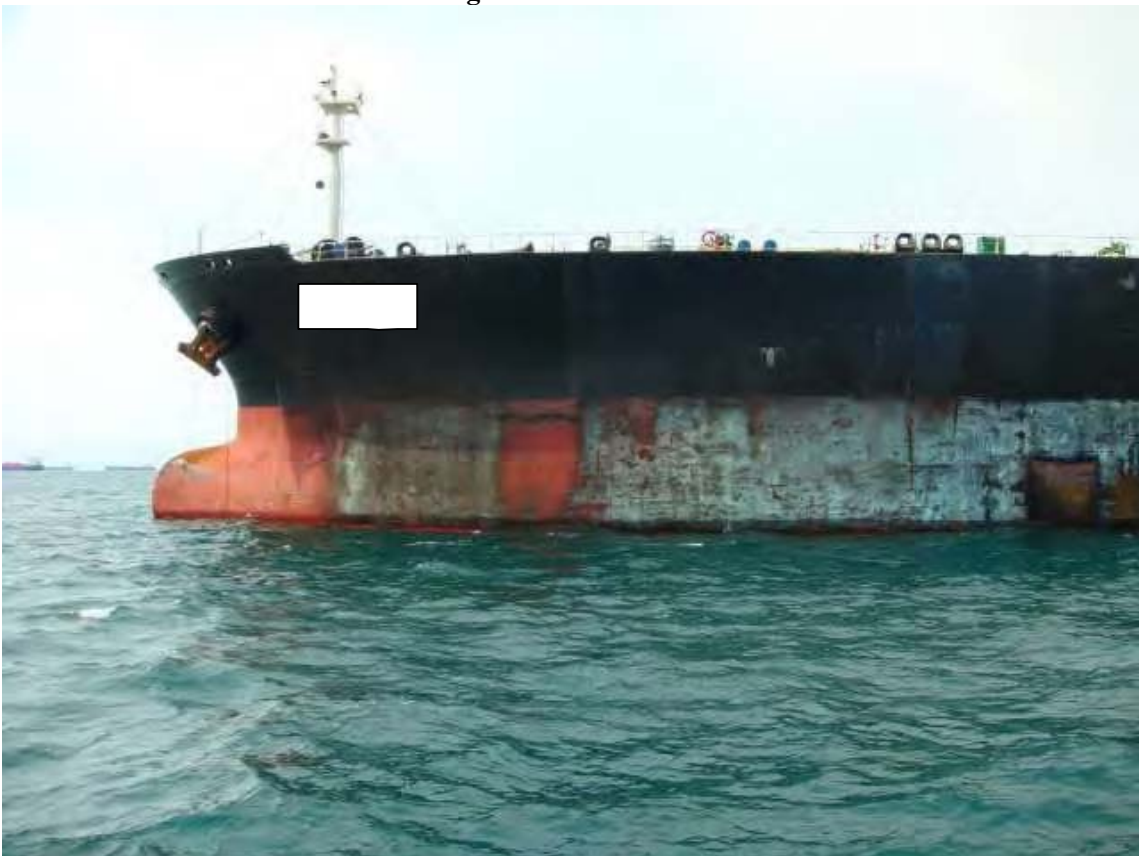
Damage to side shell of vessel

The vessel suffered external fire attack to its starboard side shell and deck. Scorching of the deck coating was evident from the front of the deck house to just aft of the midpoint of the manifold. From the exterior, there was no obvious distortion of the deck. The port side deck house, which contained cargo samples, and crane were also seriously affected by the blaze. Fire affects to the accommodation were minor, although the

port side lifeboat was destroyed, and appeared to be the result of fire beside the vessel rather than on its deck.

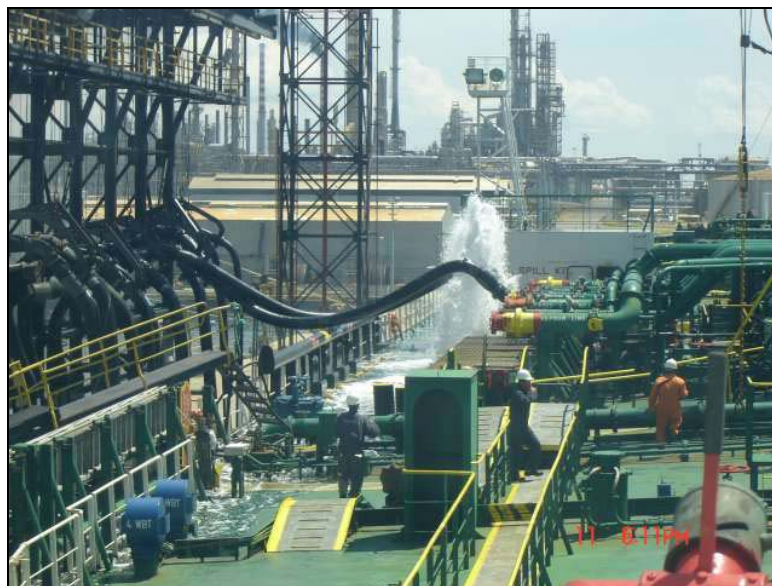
The Marine Superintendent Capt -- ----- was on board for a routine inspection. At the time of the incident, he was in the officer's smoking room when he heard the report on the radio and went to the window where he observed the spray of cargo and watched it expanding significantly over a period of 2 – 5 seconds. **Capt. ----- took a photograph from that location inside accommodation and then went to the Cargo Control Room where the Master was staying and later on to the Bridge where he took additional photographs of the incident. Upon reaching the Cargo Control Room, he observed the master holding the VHF radio and ordering the terminal for emergency stop. This happened a few minutes later the terminal had eventually stopped pumping. (See photo below).**

During the loading process, the crew must continually alter the ballast of the vessel to account for the mass of the fuel loaded. If this process is not conducted properly, the change in draft could place excessive strain on the transfer hose. From Photographs 1 and 2, it is evident that the vessel is reasonably ballasted and that the transfer hoses are properly resting on the rail and not unduly stressed. Thus draft differential was clearly not the cause of the failure.

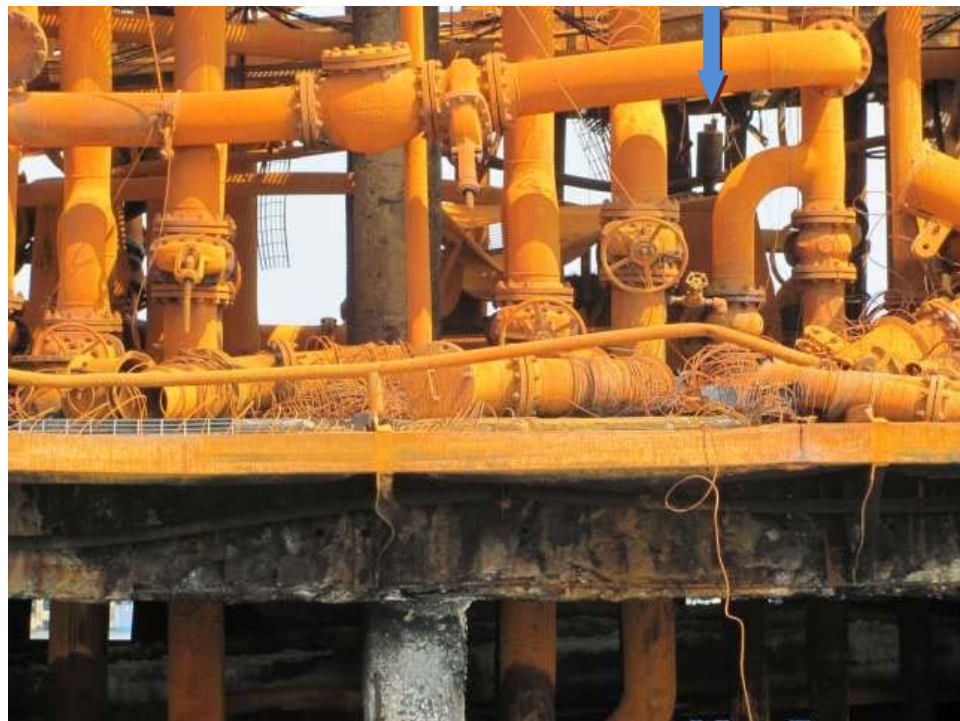
While the available evidence does not permit a conclusion as to the source of ignition, hearsay evidence suggests that the fire may have been started by an operating Diesel powered air compressor.

Presence of Internal Combustion Engine Compressor behind the pipes on the jetty

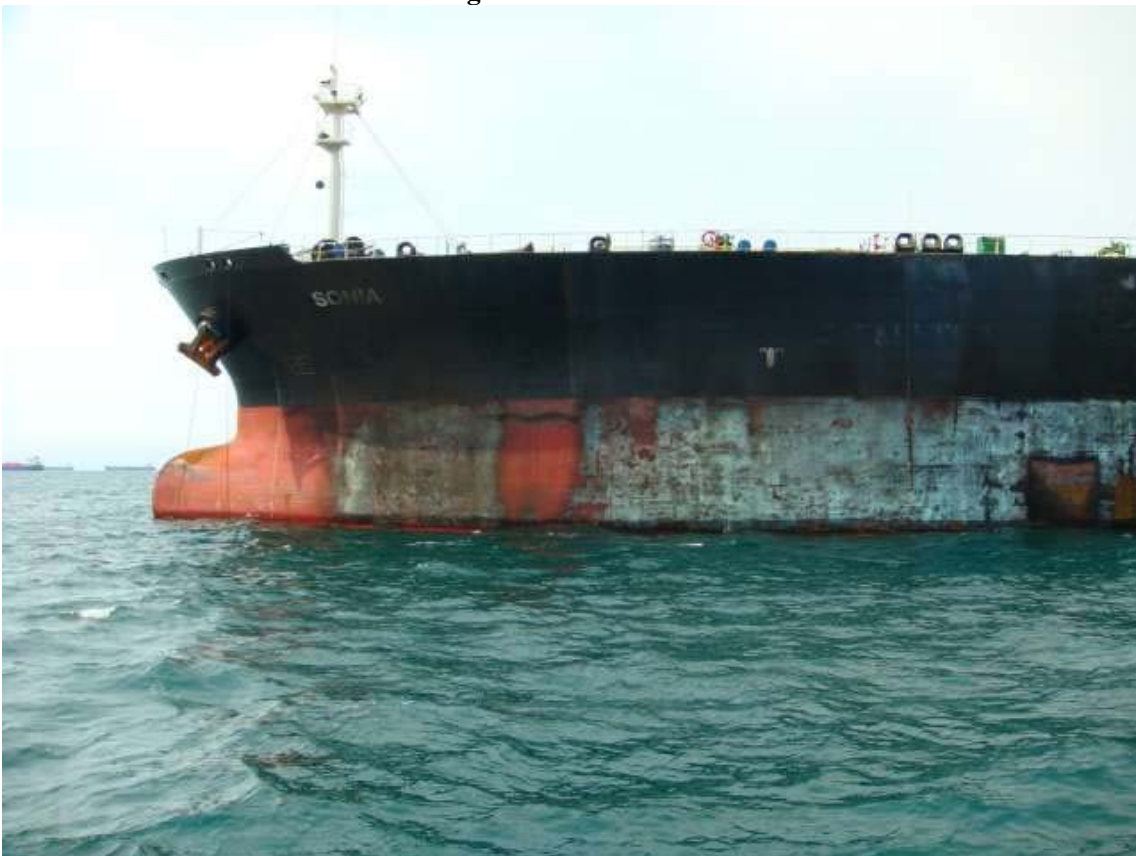
Damage to side shell of vessel

The vessel suffered from the fire to her port side shell and main deck. Scorching of the deck coating was evident from the front of the deck house to just aft of the midpoint of the manifold. From the exterior, there was no obvious distortion of the deck. The port side deck house and ship's crane were also seriously affected by the fire blaze. All that remained from the terminal cargo hoses was the flanges and the

reinforcing and grounding wires. While the wires were discontinuous, the ends showed no evidence of electrical arcing.
