Investigation report

Report title Gas leak on Gullfaks B 4 December 2010	Activity number 001050014
--	------------------------------

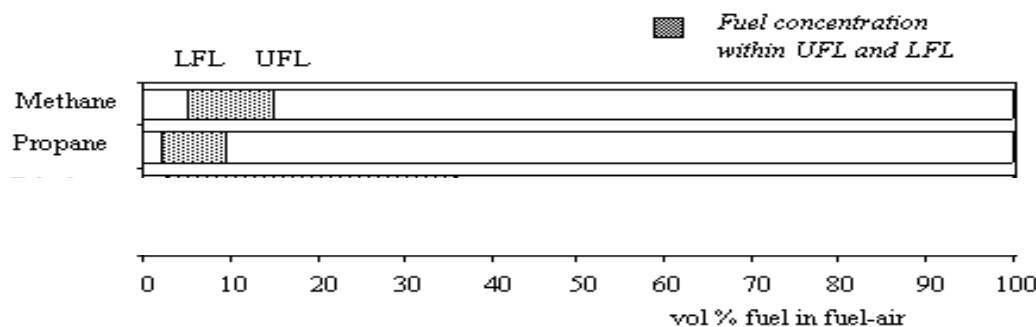
Figure 10 LEL/LFL and UEL/UFL for methane and propane

Figure 10 below shows the LEL/LFL and UEL/UFL for methane and propane. The exact composition of the gas which leaked out in M14 is not known.

The investigation team has assumed that methane was the dominant gas type, but that there was also some content of heavier HC gases such as ethane, propane, butane and so forth. The larger the content of these heavier gases, the lower the LFL of the mix will be.
