Steam Turbine Failure During Overspeed Test

Eskom Duvha Unit No. 4
9 February 2011

Updated Presentation Rev 2

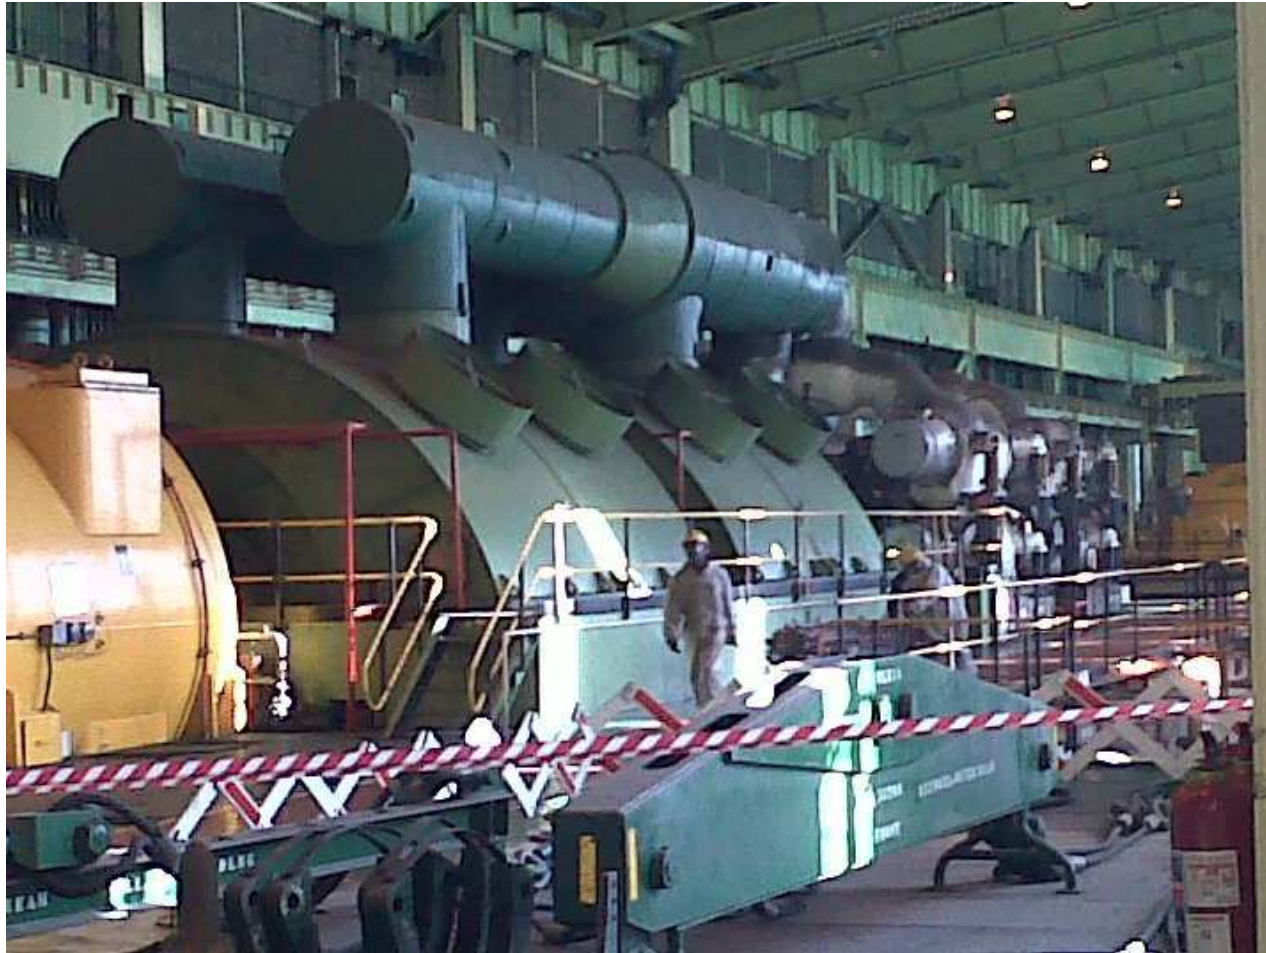
Intact Unit from Generator End

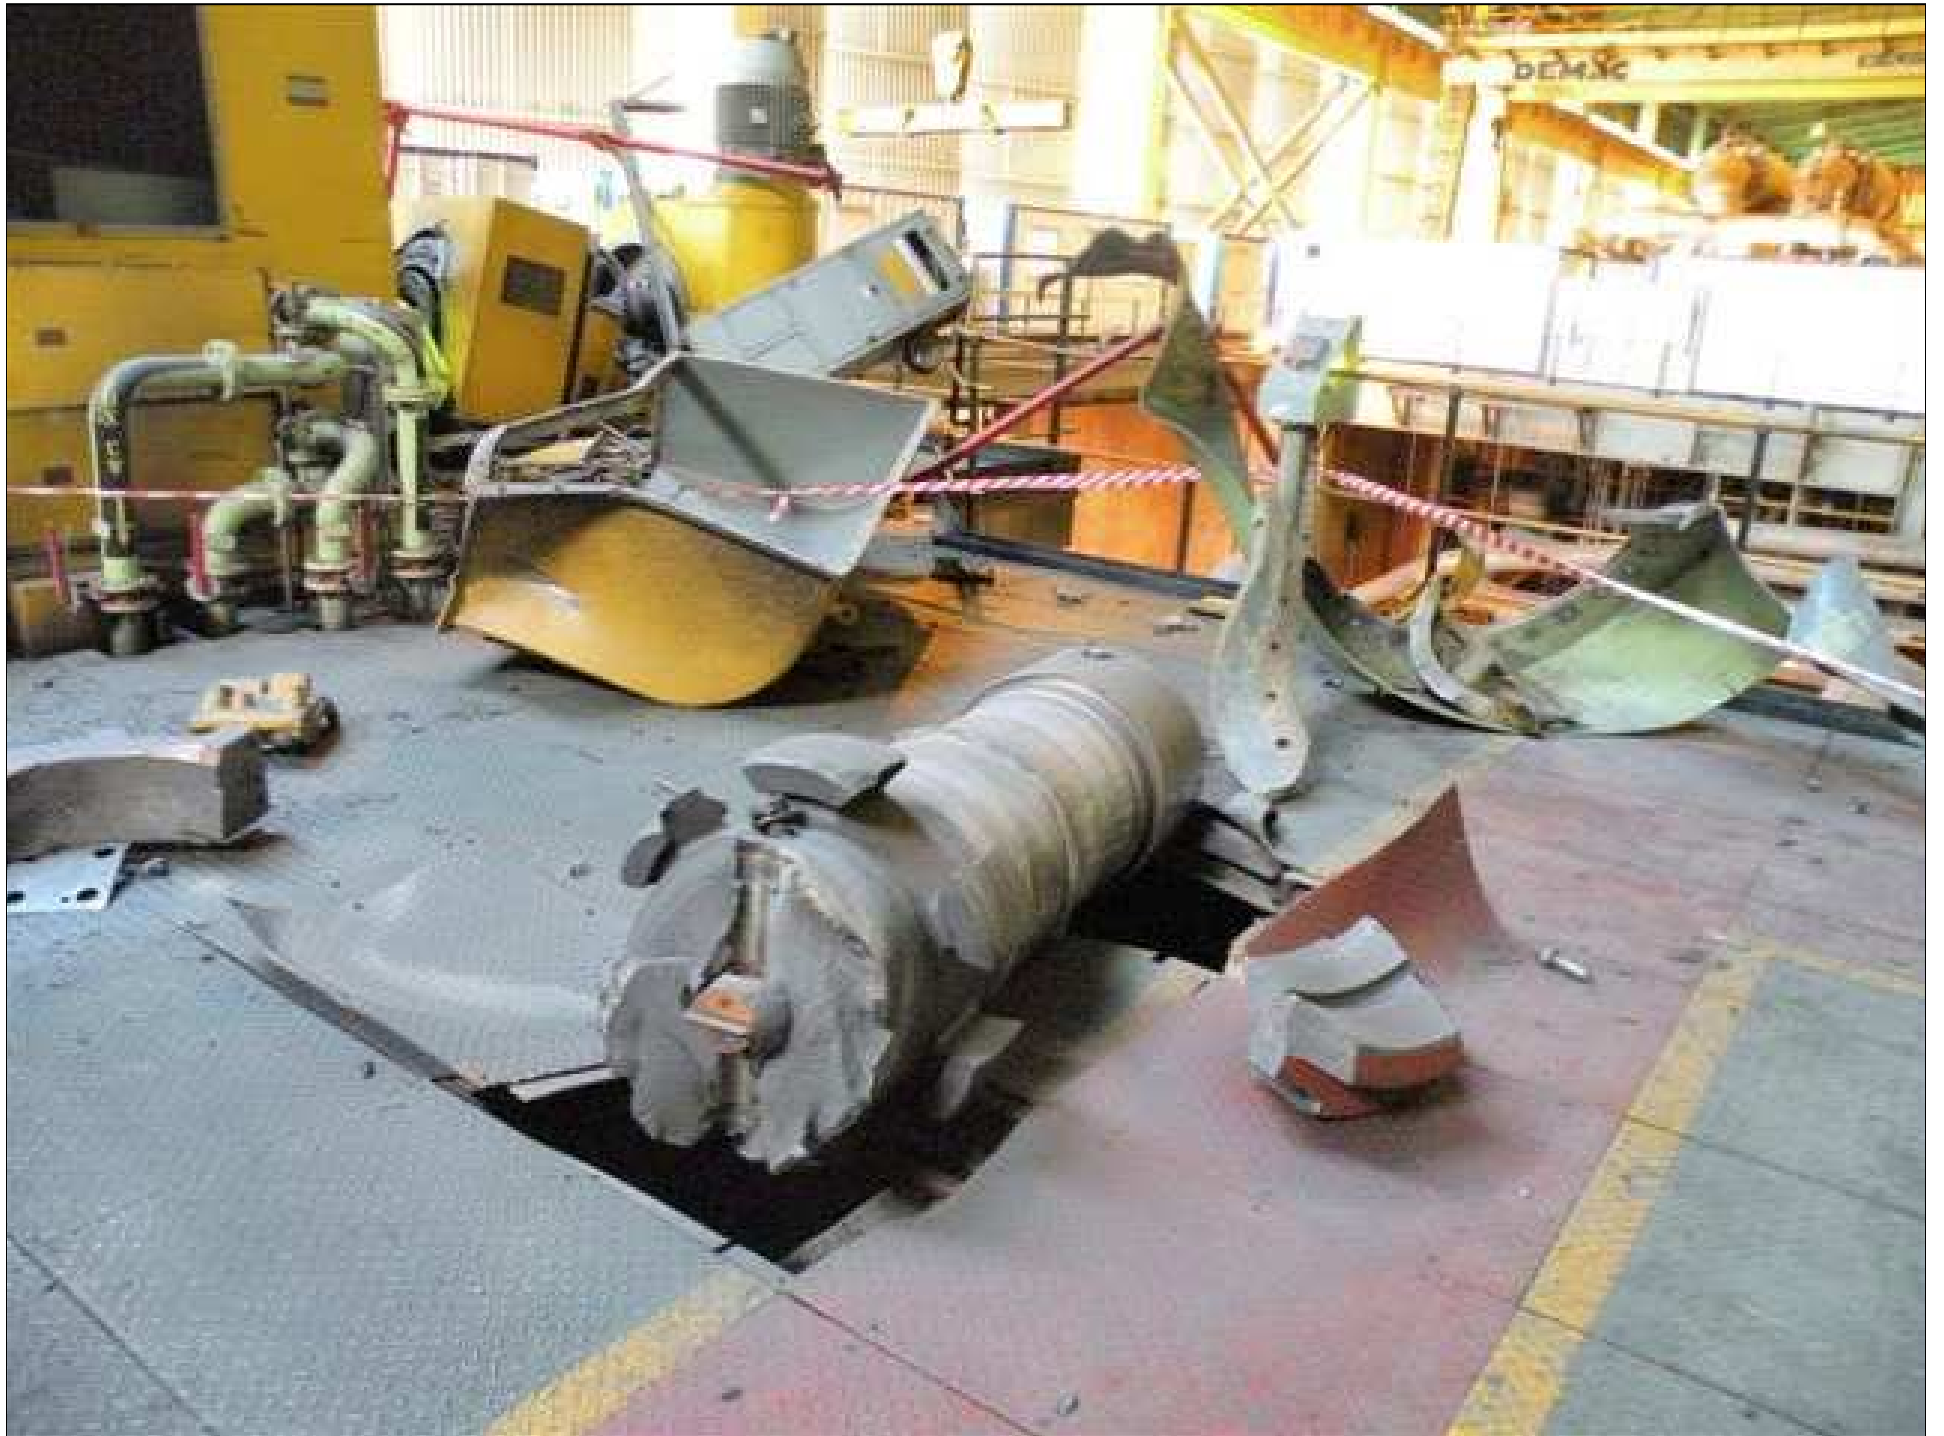
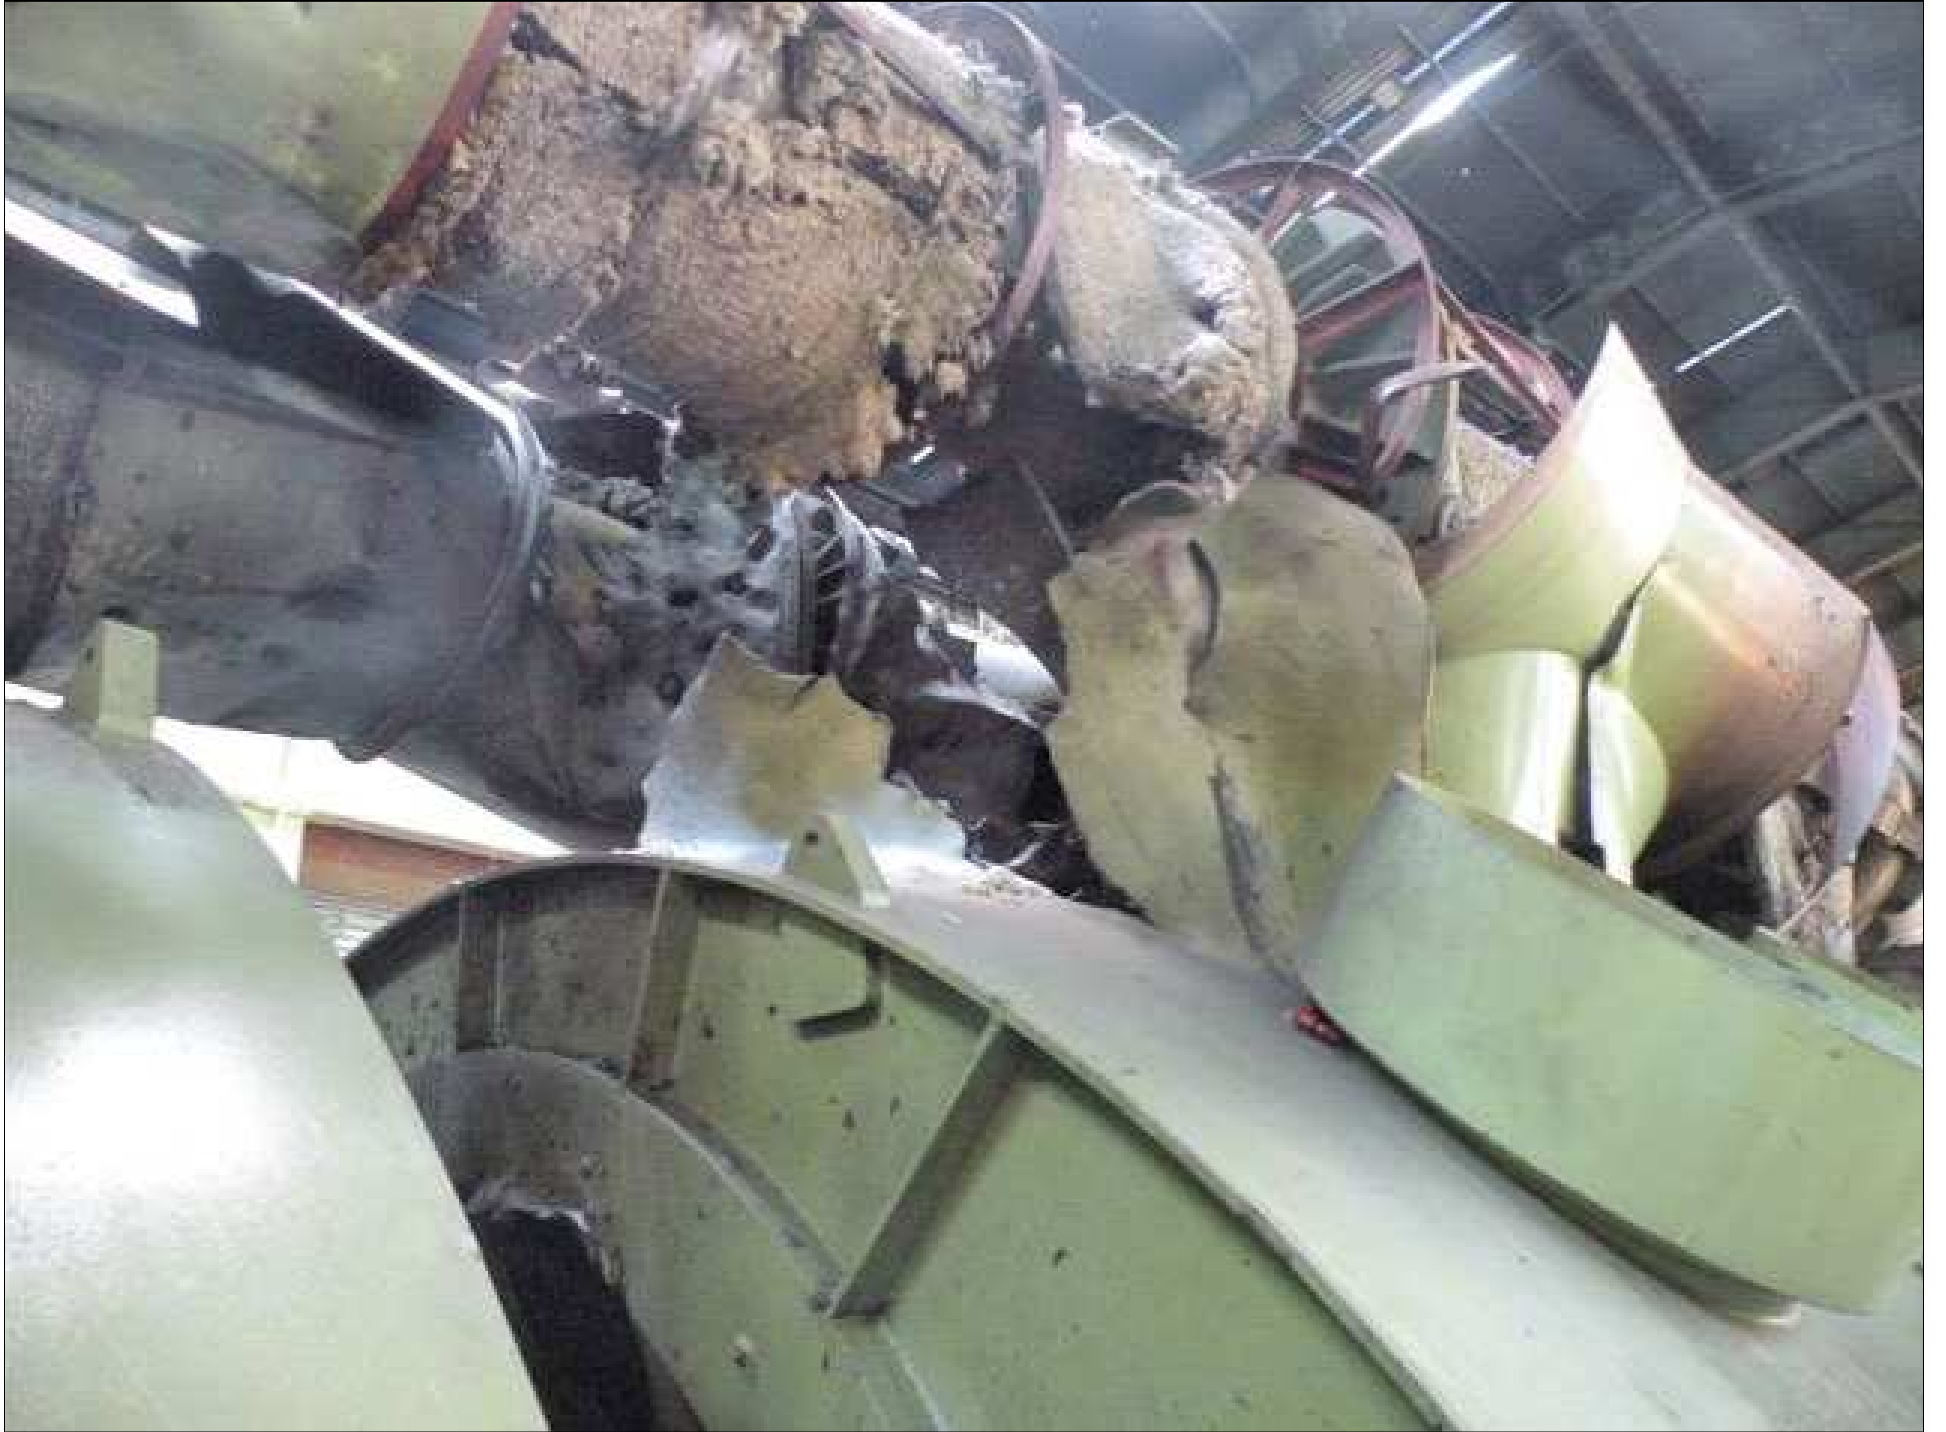
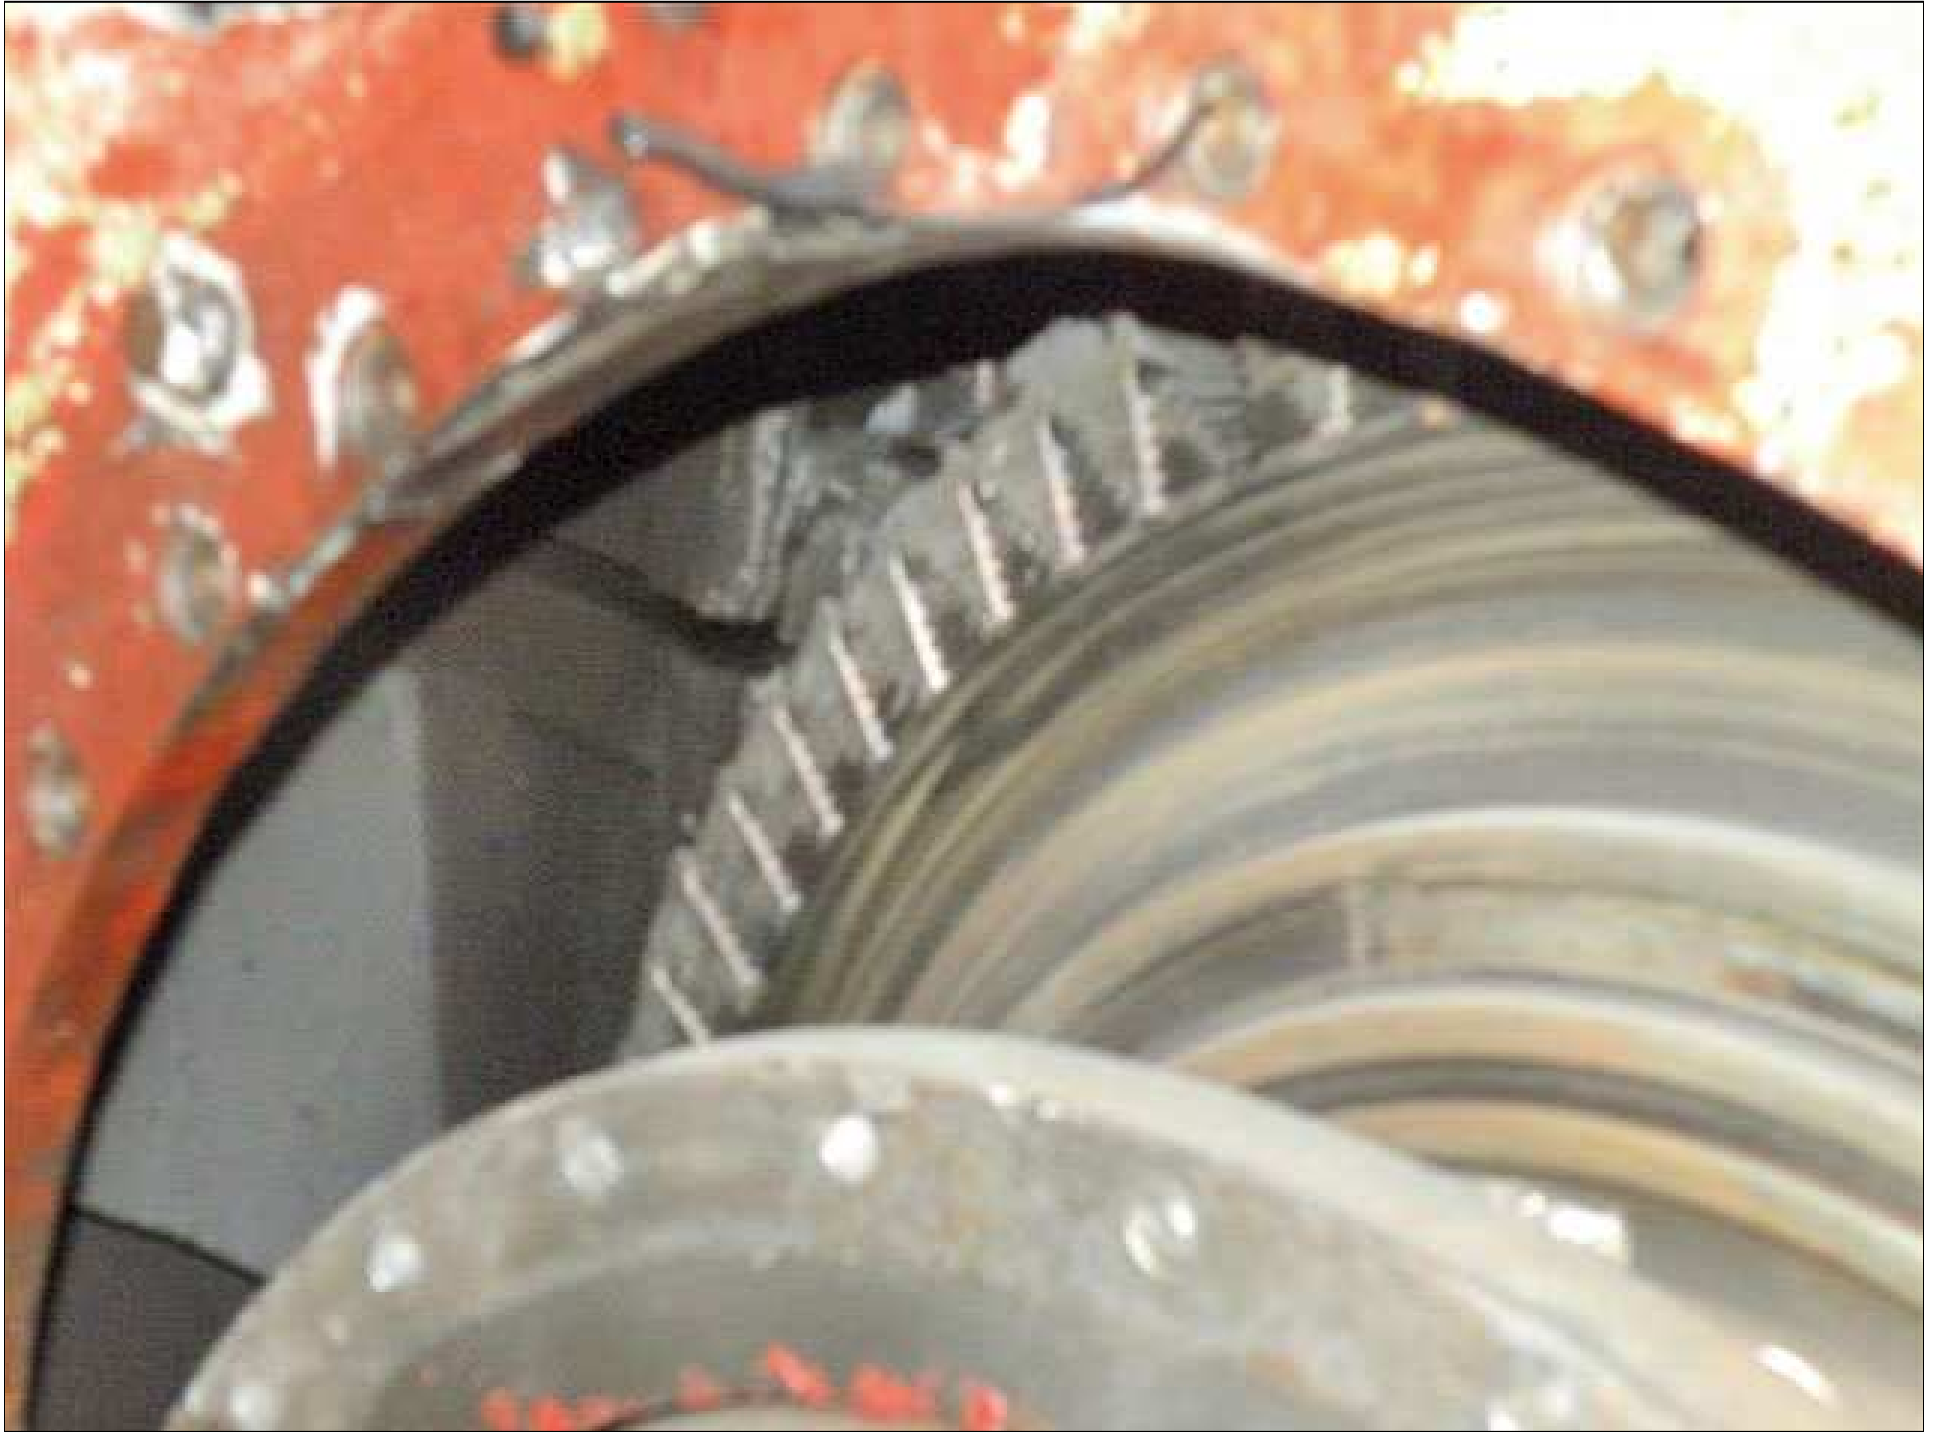
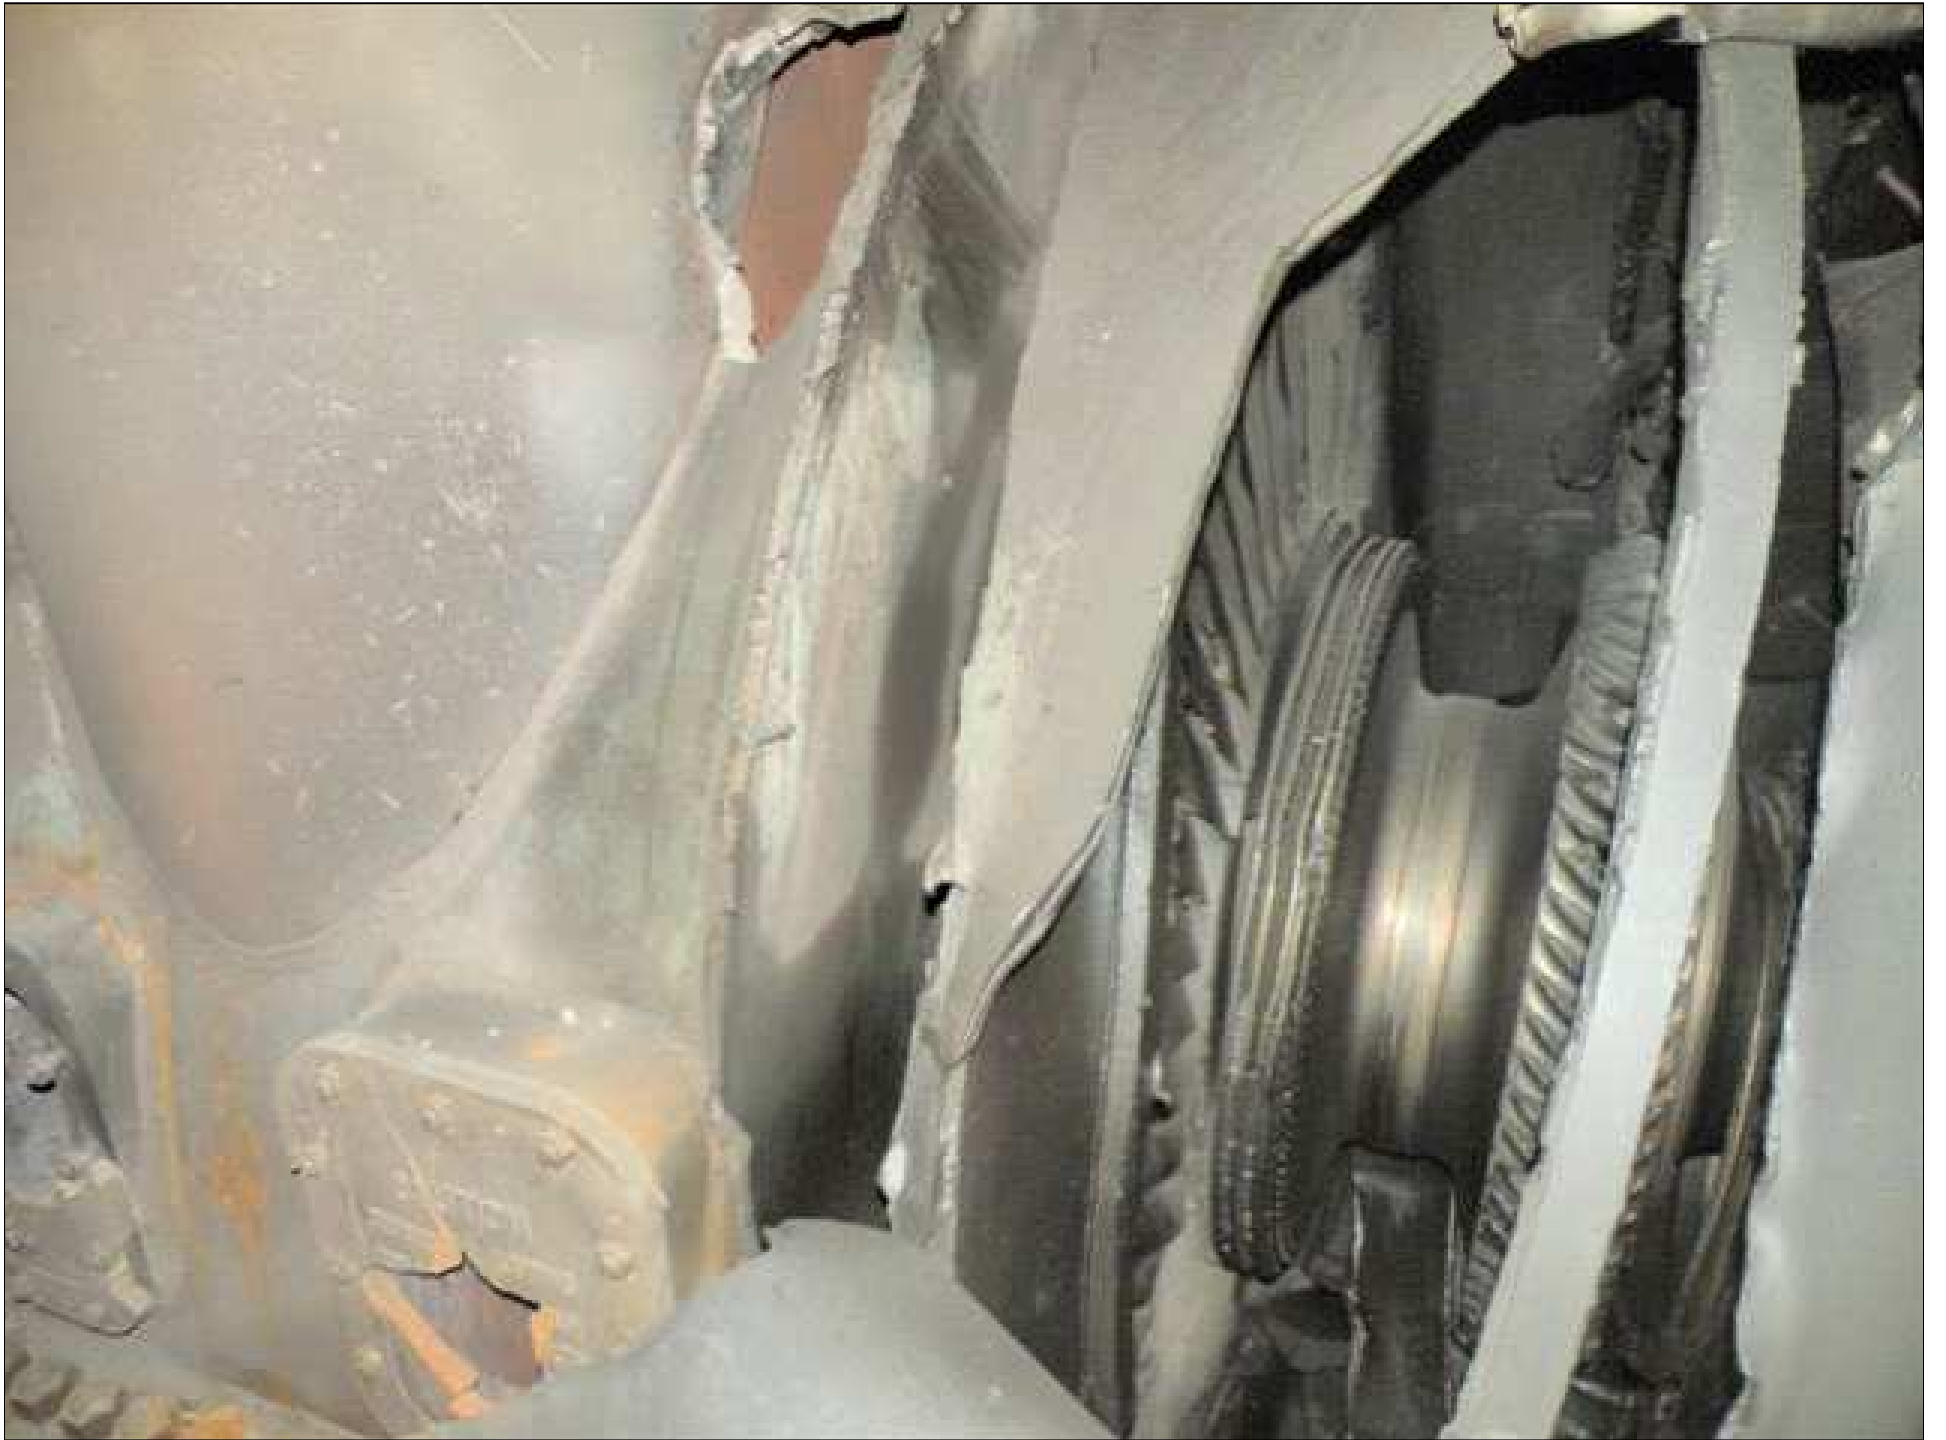
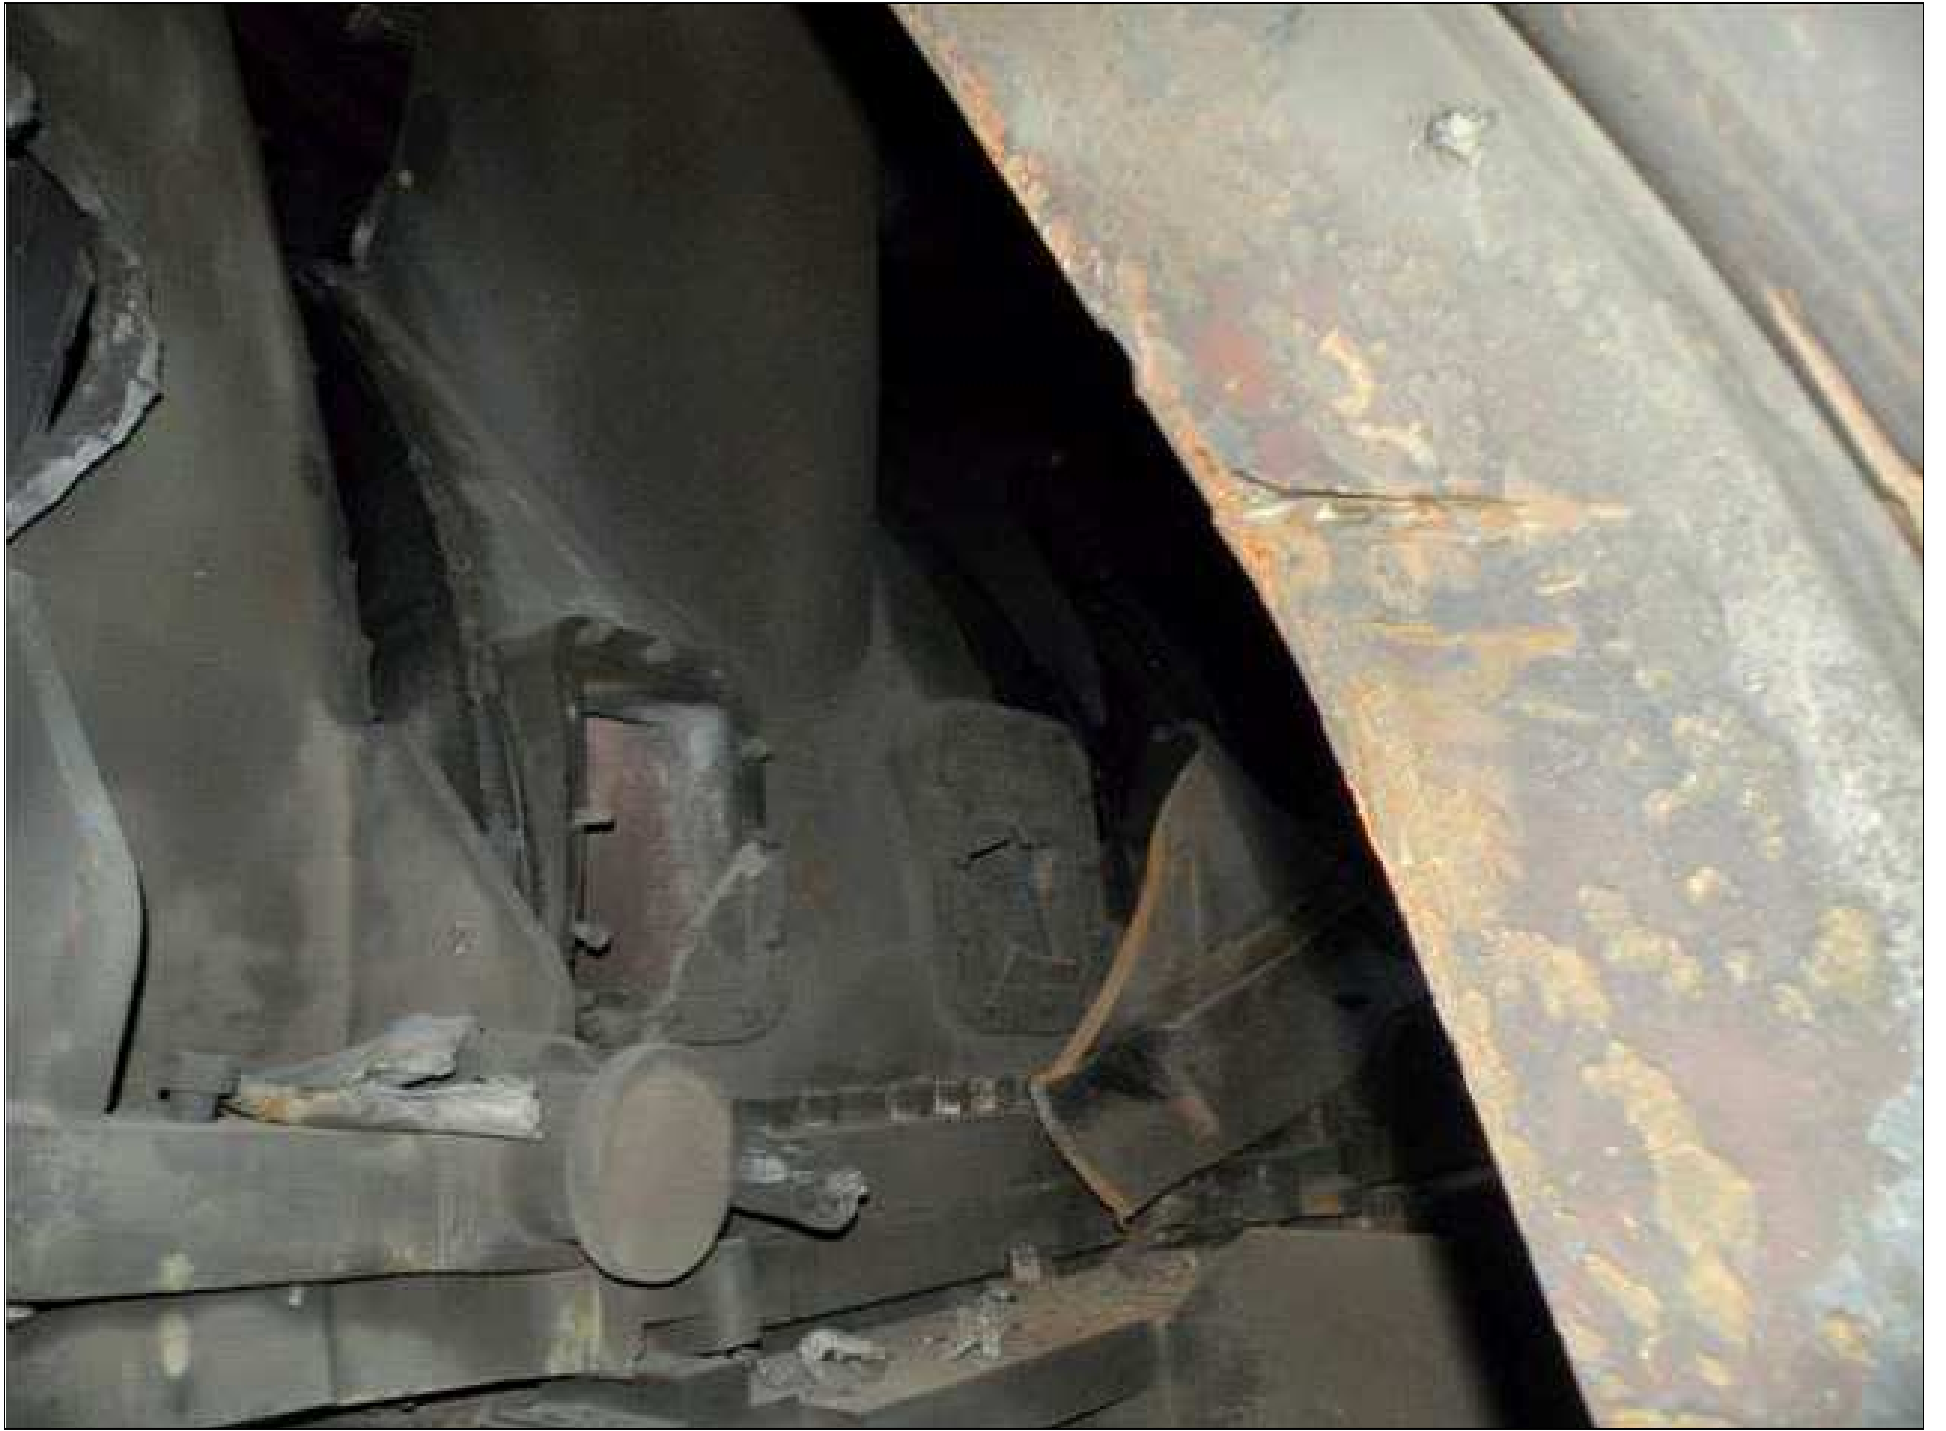
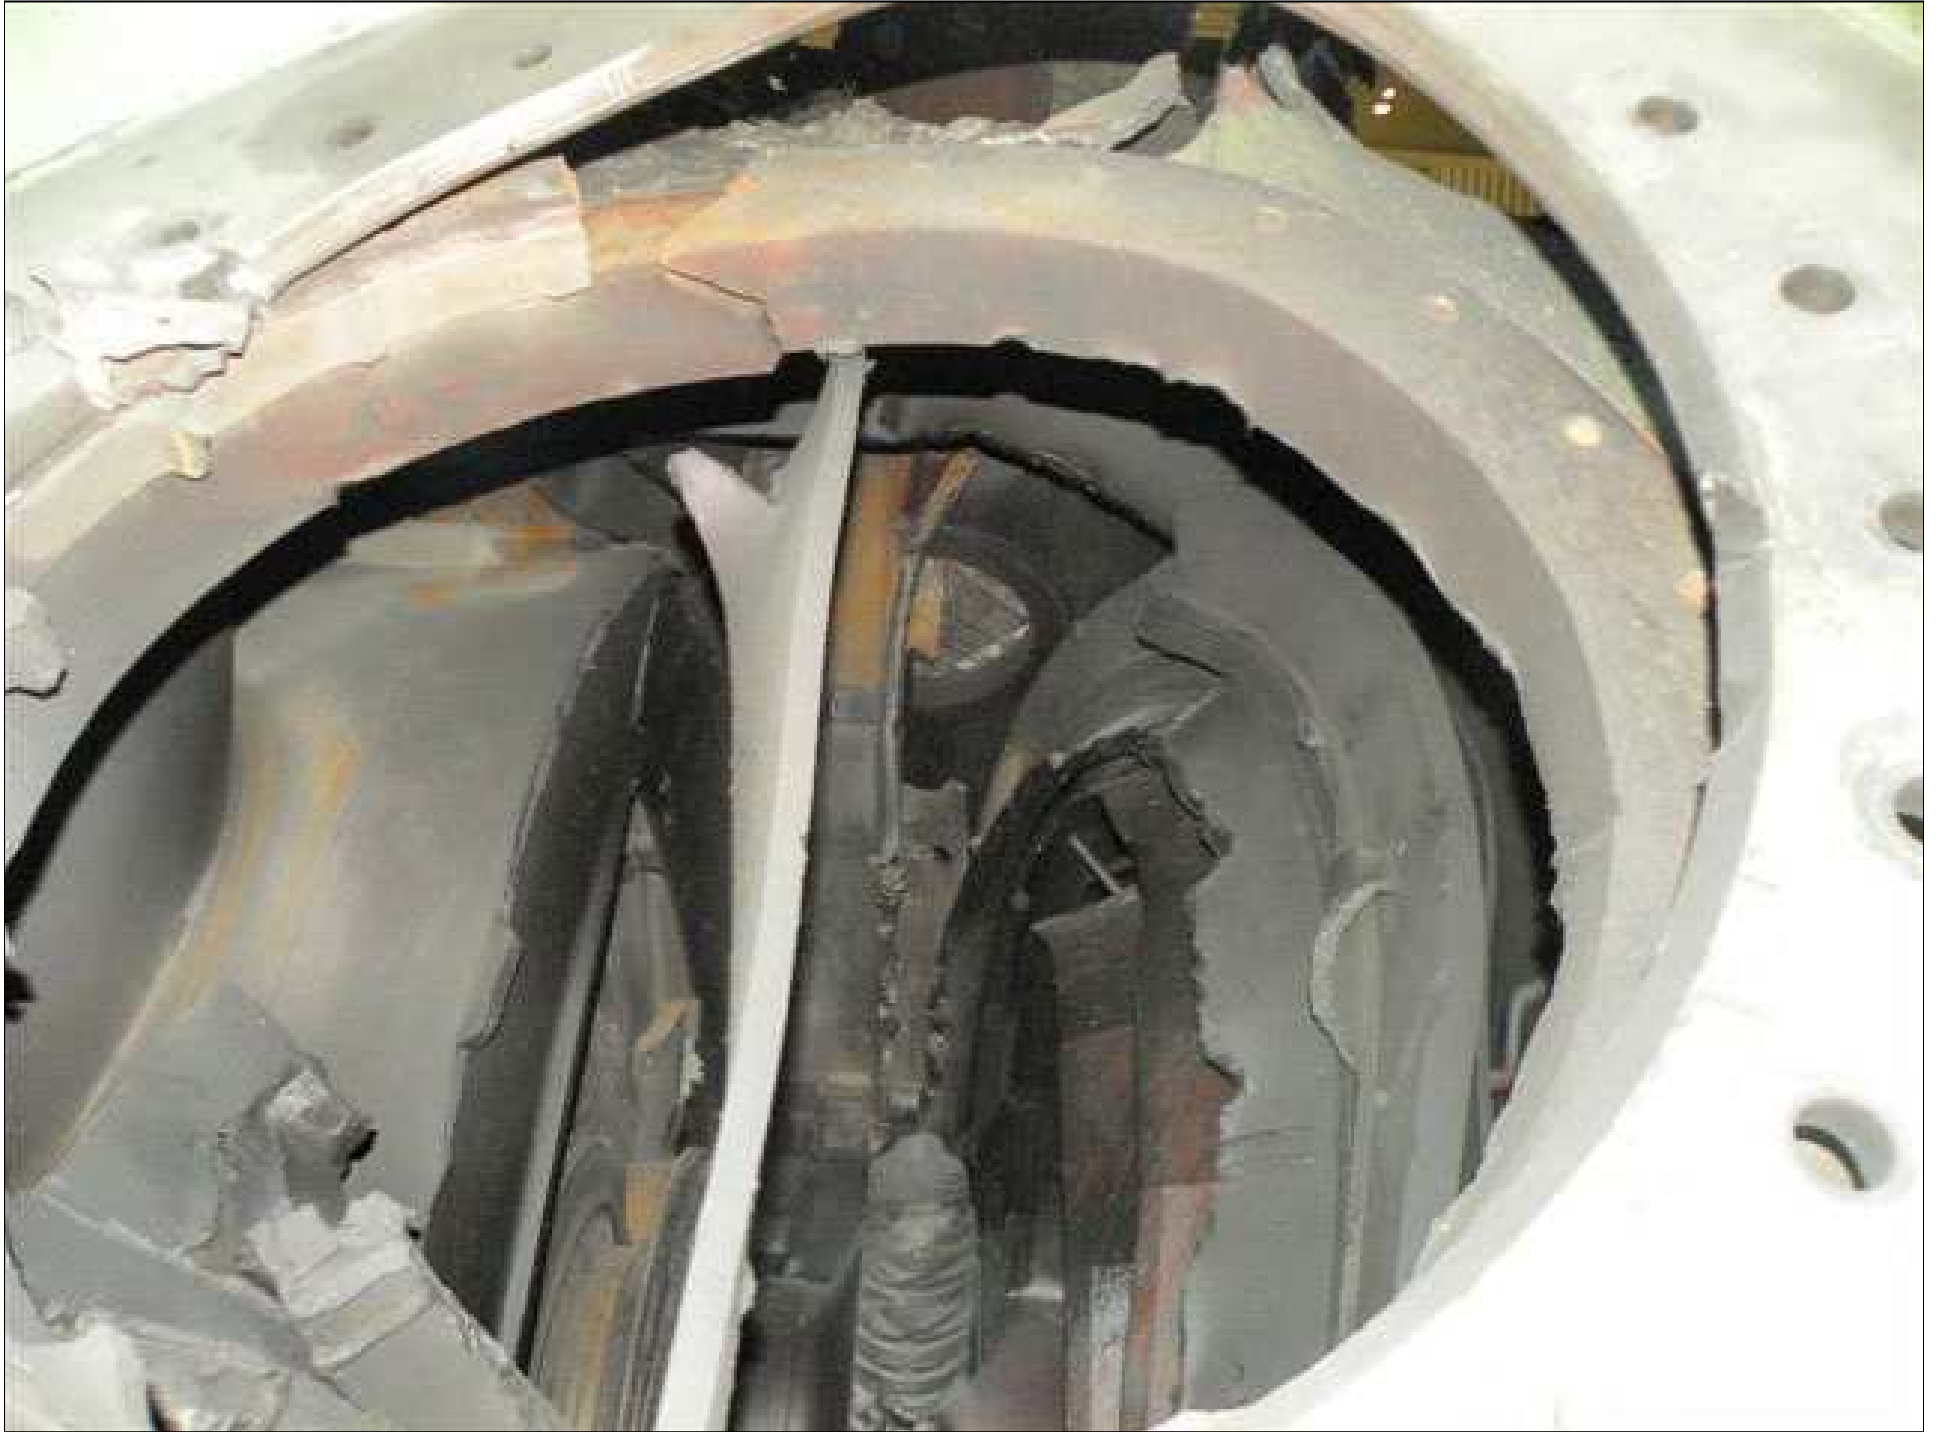
- The following pictures were received in April 2011, after the initial batch, and continue to show the damage to the turbine generator set.
- The pictures also show extensive damage done to the plant by 'missiles' created by thrown machine components.
