LOSS CONTROL NEWSLETTER

2012 – EDITION 1

CONTENTS

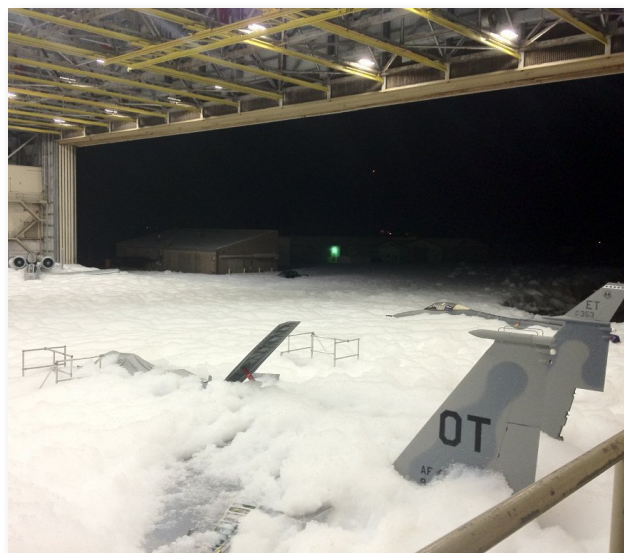
Whilst this air hangar could be mistakenly perceived as floating in the clouds, it is actually the result of a welder's spark triggering the fire suppression foam in a US aircraft hangar. According to [The Aviationist](#) website the 90,000 square feet (8,400 m²) hangar was filled with high expansion foam within two minutes – sufficient to submerge most of the F-15s, F-16s and A-10 within the hangar.

Such systems are commonplace, as airplanes tend to be kept fully fuelled to prevent water contamination of the fuel tanks. Fire protection systems, therefore, need to be able to respond in seconds to prevent millions of dollars' worth of damage and will also need under-wing foam protection for those areas shielded from any overhead foam pourers.

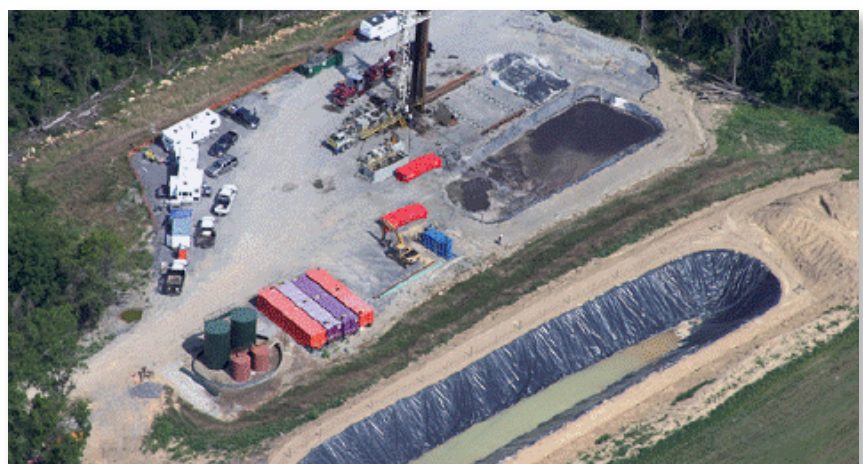
Marcellus shale gas operation

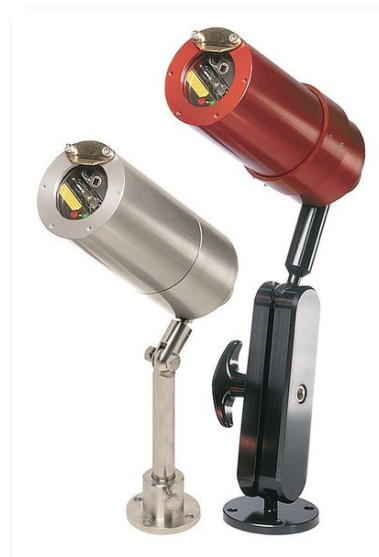
Fire detectors

For areas where the inherent risk is deemed unacceptable then, as a minimum, fire detection systems should be installed. Examples of fire detectors include infra-red (IR) or ultra-violet (UV) sensors which are linked to the overall site's distributed control system. For reliability purposes two different types of fire detector are recommended. A more economical alternative is to use a linear heat detector in combination with a fire detector on an instrumentation-voting basis. Moreover, fire detectors should be appropriately located in order to realize the benefit. Line-of-sight type (UV/IR) detectors (as shown on the right) should be focused on areas prone to leaks, such as flanges and joints.

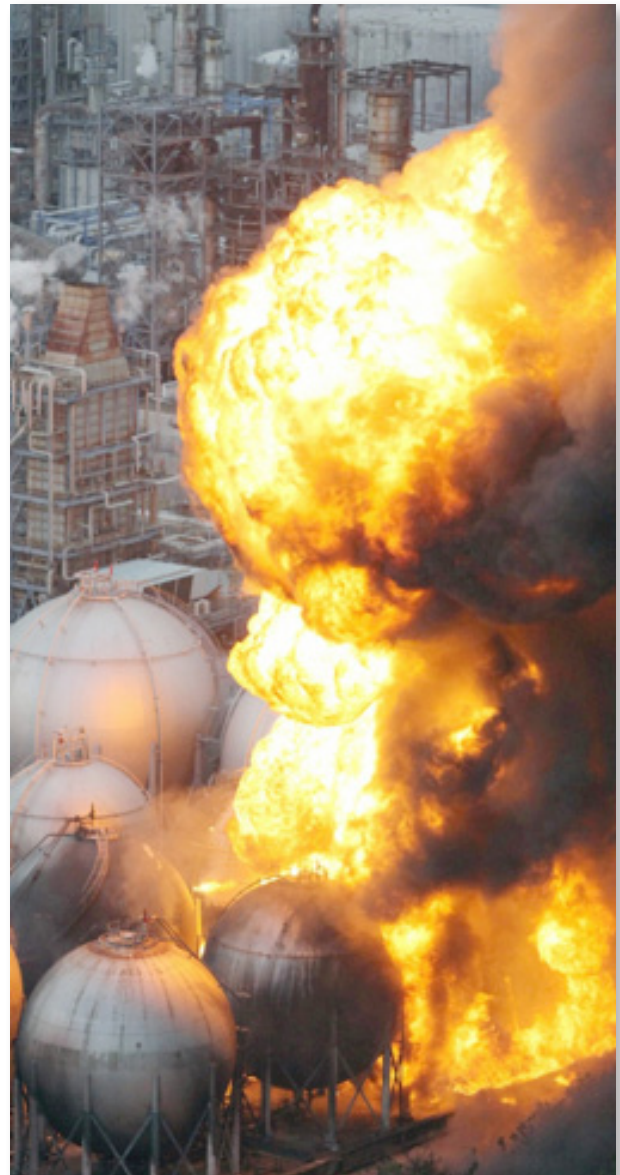
Chiba Refinery at time of BLEVE
Note the height of stacks compared to the fireball

- At 15:15, another earthquake of the fourth degree on the seismic scale occurred off the coast of Ibaraki Prefecture.
- Several legs holding up LPG tank No. 364 bent and the tank collapsed. The collapse led to the damage of several pipes near the tank which resulted in significant leaks of LPG with subsequent ignition.

- Due to the fire, the LPG tank adjacent to LPG Tank No. 364 exploded, spreading fire from one tank to another.
- As a result of the spreading fire, a number of neighboring LPG tanks exploded, further expanding the fire.
