Process Safety Forum

Process Safety Alert 006

Floating Roof Tank Rainwater Drains Integrity Issues

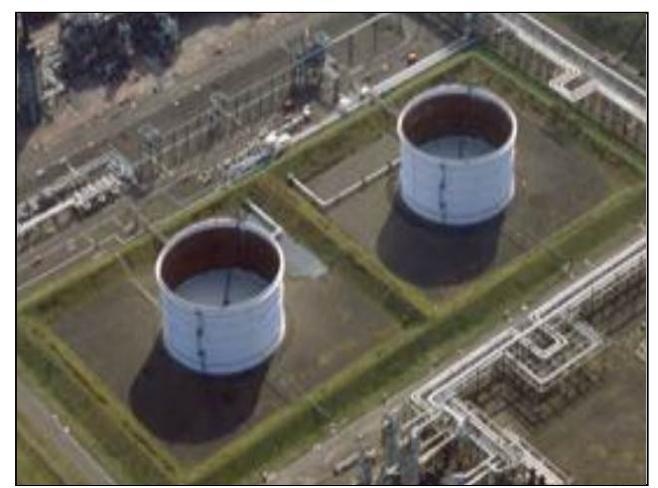
A gas detector alerted operations to a possible hydrocarbon leak near the tankfarm area. Shift personnel immediately investigated the area and found gasoline/condensate

escaping from the roof drain outlet at one of the double deck floating roof tanks. The gas cloud that formed had triggered a nearby gas detector. The release led to excess emissions and a difficult cleanup but no injuries.

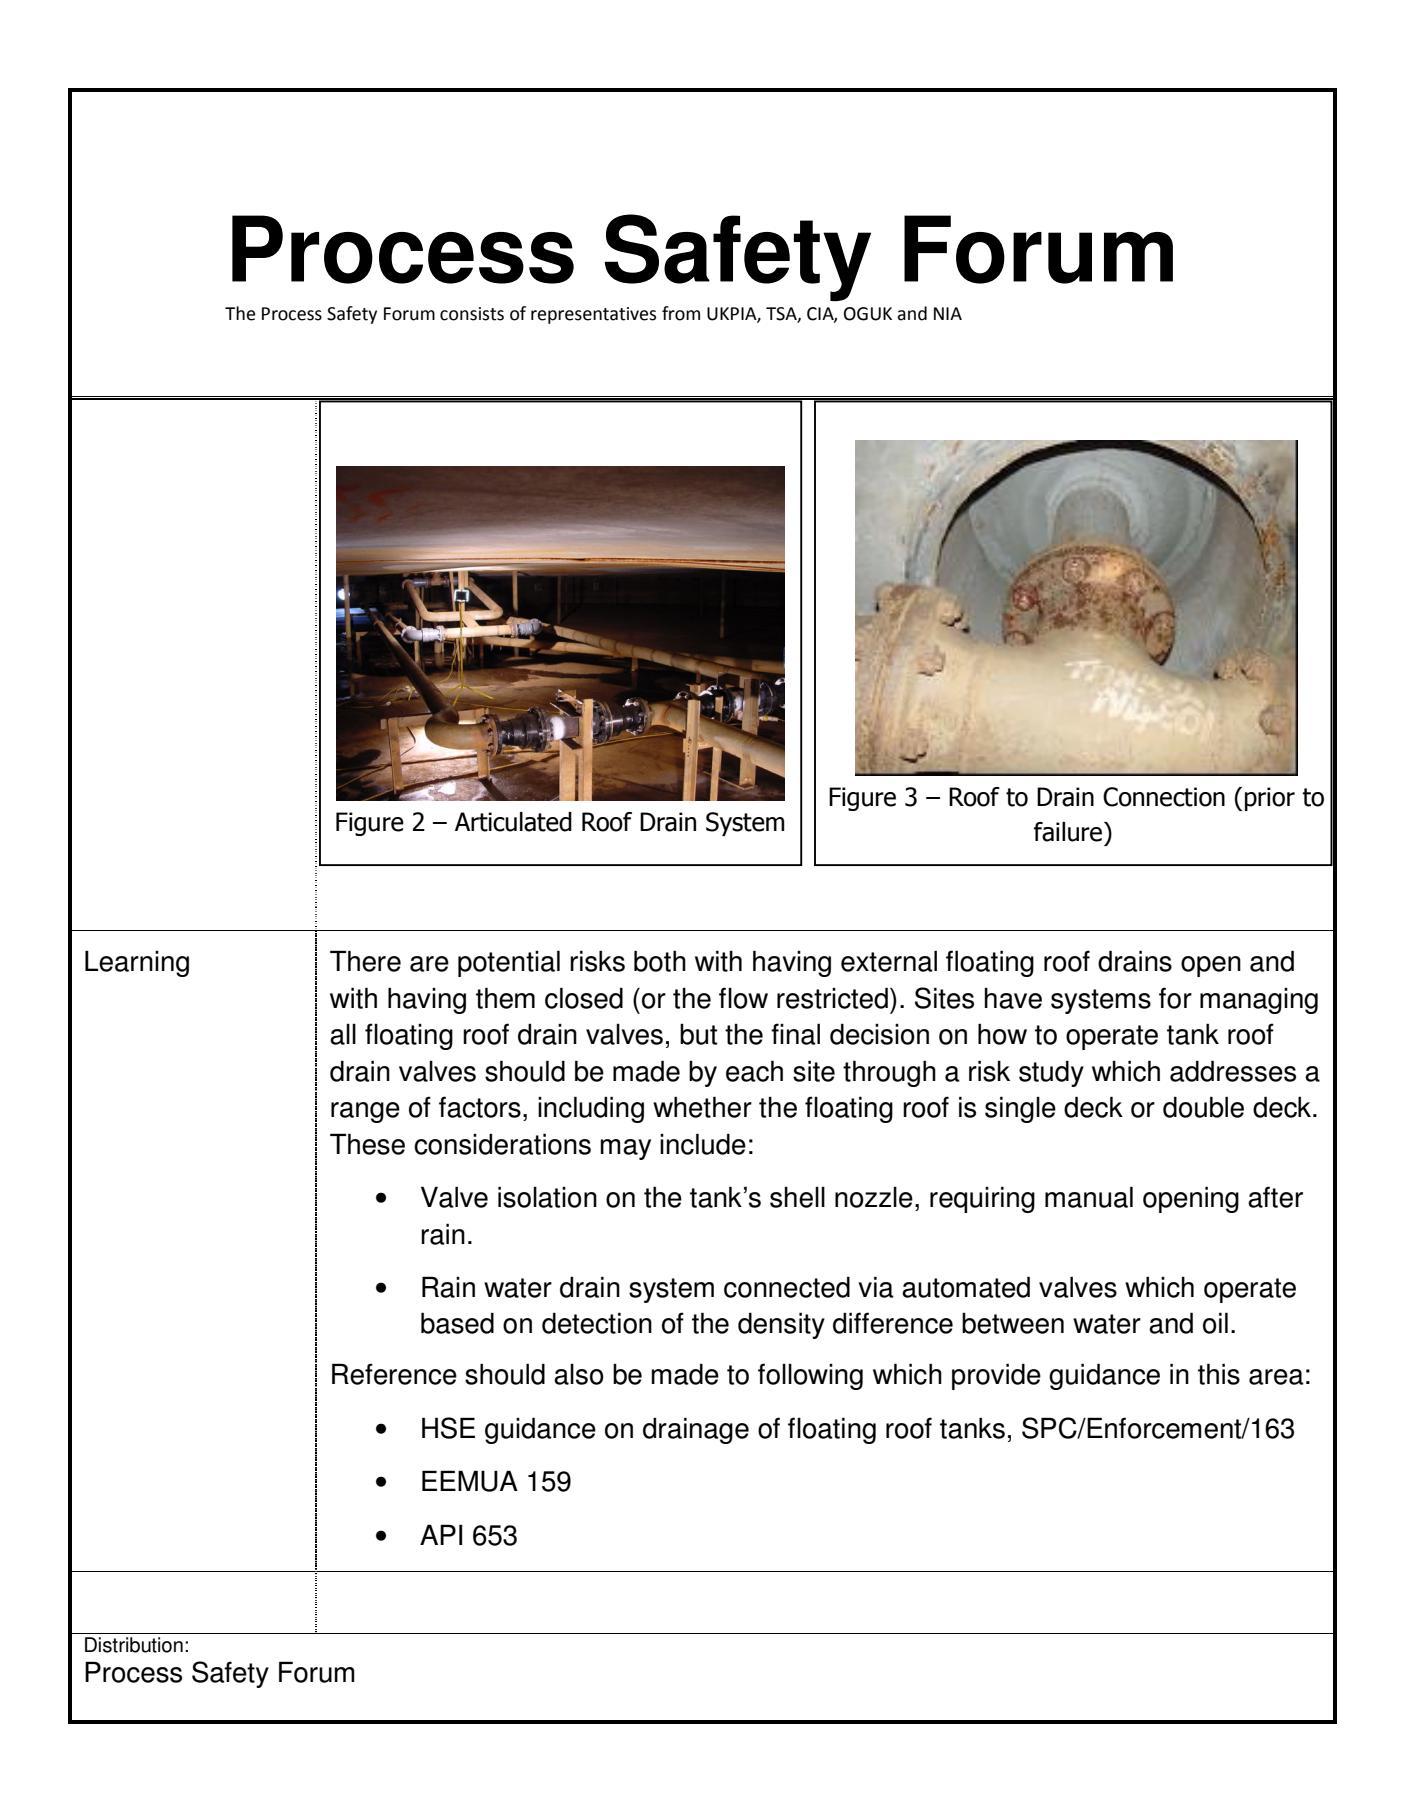
The release of gasoline came from a six inch floating roof drain system that is provided to remove rainwater from the tank roof to the tank bund. The system has a series of arms moving at the swivel joints as the roof moves up and down (see figure 2).

The connection between the drain system and the floating roof failed. The failure of the drain system led to material flowing through the normally open drain valve into the dike area.
