Tank Fires

Review of fire incidents 1951–2003

BRANDFORSK Project 513-021

**SP Sveriges Provnings- och
Forskningsinstitut**
SP Rapport 2004:14
ISBN 91-7848-987-3
ISSN 0284-5172
Borås 2004

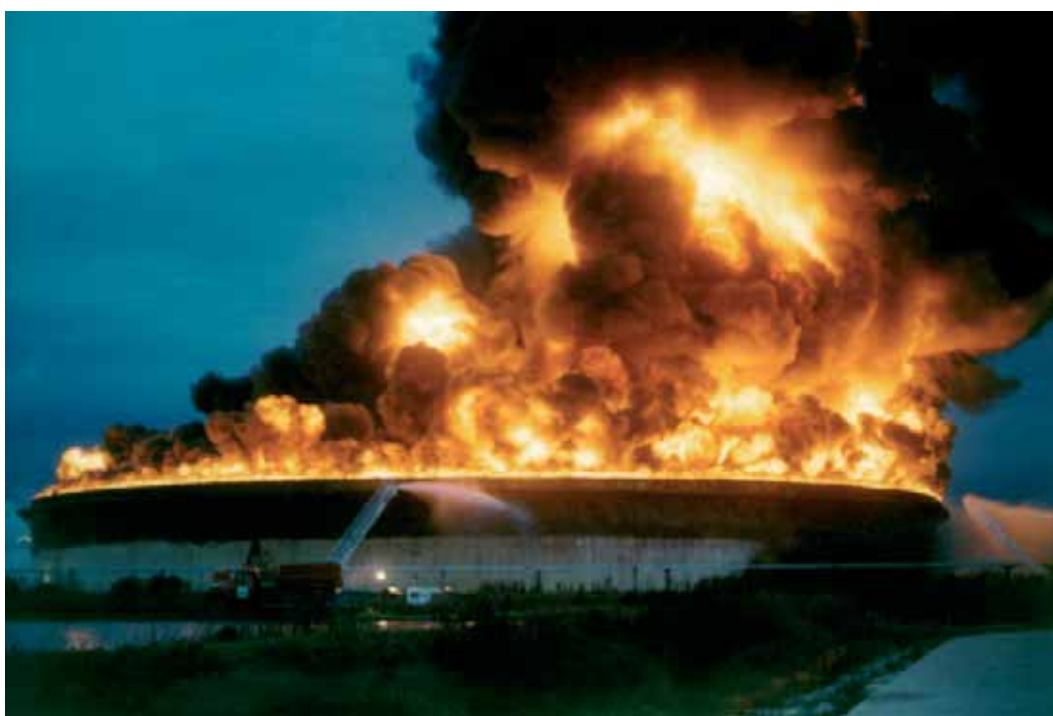
*The Orion Tank Fire in 2001, world record in tank fire fighting.
Photo courtesy of Industrial Fire World*
